**THE GUILDHALL
HIGH STREET
NEWPORT
ISLE OF WIGHT**

Building Condition Survey Report

The Guildhall, High Street, Newport, Isle of Wight PO30 2EH

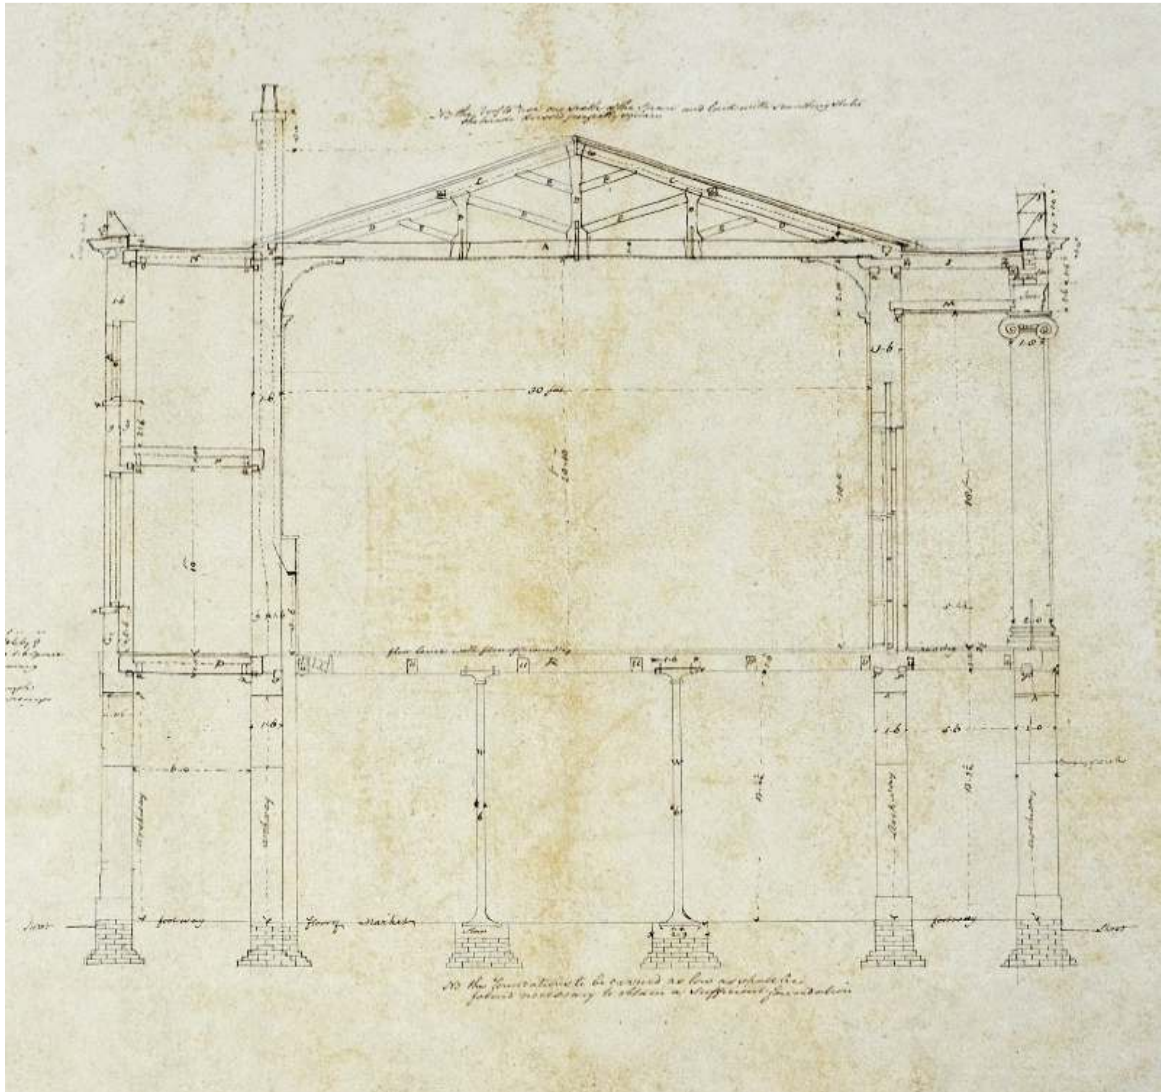
Figure 2: Drawing of the section immediately behind the west portico

OBSERVATIONS	RECOMMENDATIONS	PRIORITY
3.1 Chimney stacks	The building is no longer served by any chimney stacks.		
3.1.1 Removed stack	The drawing of the section of the Guildhall immediately behind the portico for the design of the building [Fig. 2] shows an apparent single flue chimney stack, probably serving a fireplace in the west first floor room [Council Chamber].	The presence of any reduced chimney stacks, internal chimney breasts and fireplaces needs to be recorded when encountered within any future repair works.	D

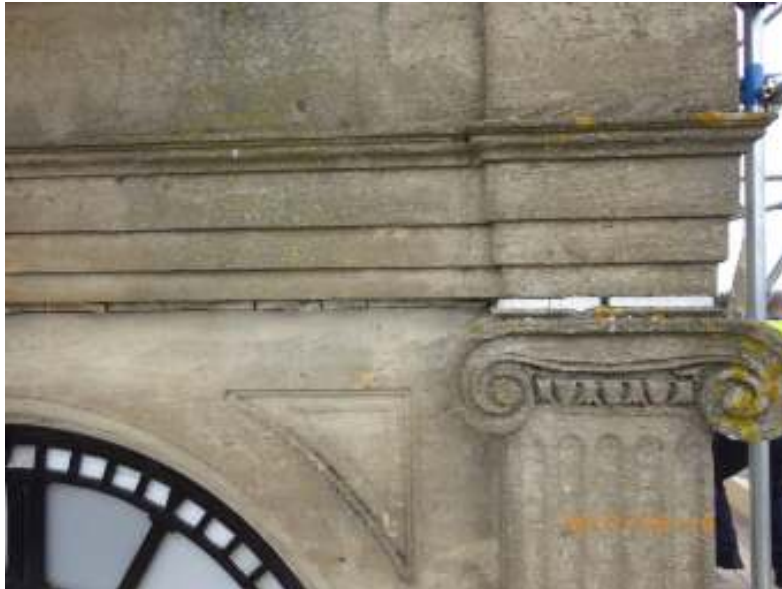
Figure 3: Detail of clock tower 2017

Photographs [selected examples provided below] taken during inspections of the clock tower in 2017 provided by Martin Gibson. The photos show that the movement is established, with the 'mastic' repairs having cracked and become detached. The cracking is symptomatic of the raising of the stonework caused by the corrosion and expansion of the metal framework [3.4.1.1].

3.4.1 Structural movement	Refer to Figures 3 - 6 [above] and PS06.		
3.4.1.1 Clock Tower	The clock tower has suffered from extensive cracking around the east, west and north clock faces [PS06 and Figures 3 - 6]. The cracking reflects corrosion, and associated expansion, of the metal framework. The expansion of the metalwork has caused some damage and deflection of stonework. The external cracking has been repointed with a white mortar or mastic, this helps highlight the areas that have suffered from movement. There is no evidence of progressive ongoing movement, as the repairs to the external cracks remain intact with no new cracking or opening-up evident. Internally, there is no fresh [clean] cracking to indicate any significant ongoing movement.	Based on the findings of this initial inspection it is anticipated that the most effective means of reducing the risks of further corrosion and, therefore expansion of the metalwork and associated cracking, is to improve the weather-tightness of the tower. This can be achieved by fully raking out and repointing all cracks to reduce the risk of water reaching the metalwork. The cracks and damaged stonework can be stitched and/or pinned to strengthen weaknesses caused by the movement.	B

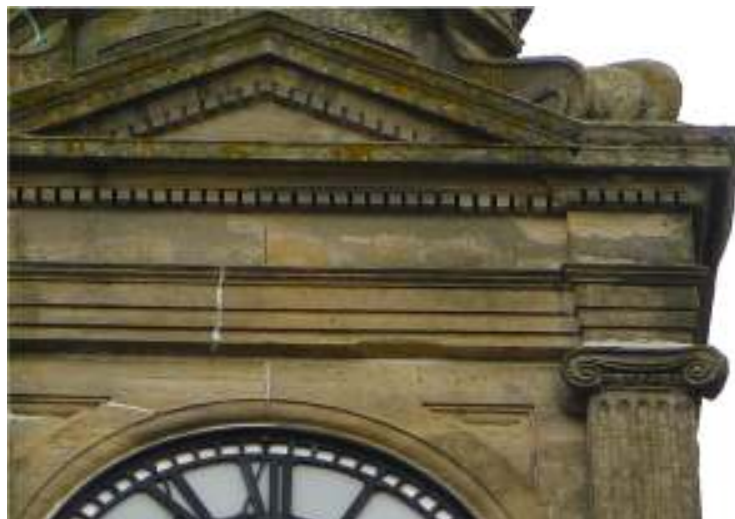
Figure 6: Photo [2021] repointed cracking to west face of the clock tower - which has not re-opened
