Condition Report

Ryde Town Hall

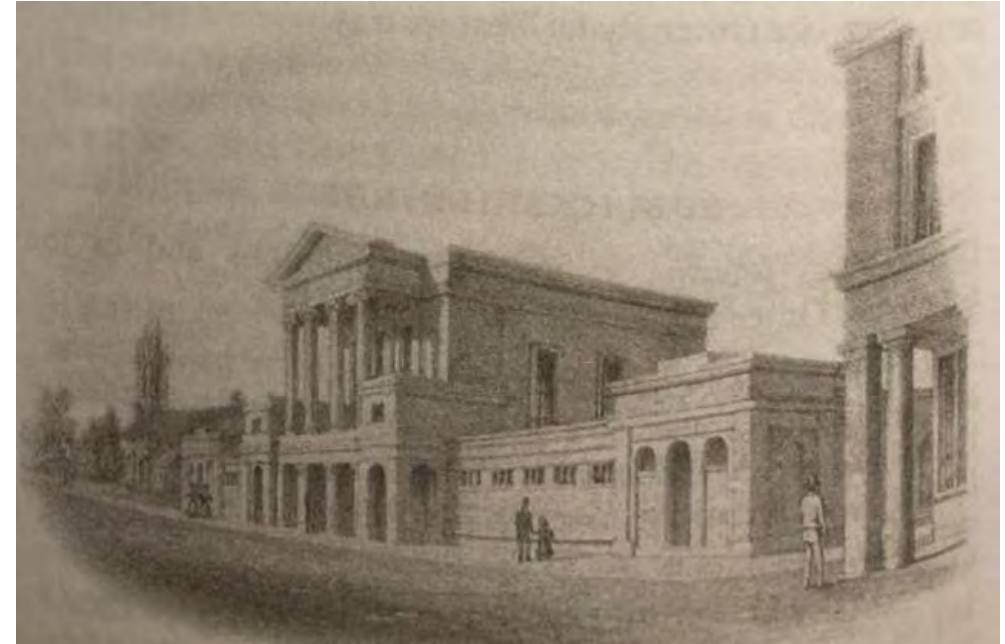
The Market Hall 1831

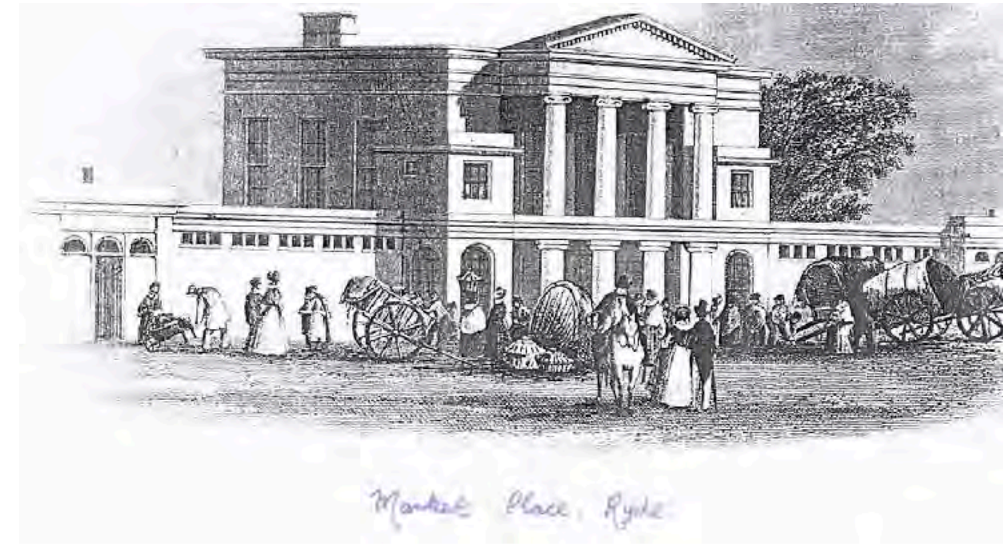
The original Market Hall

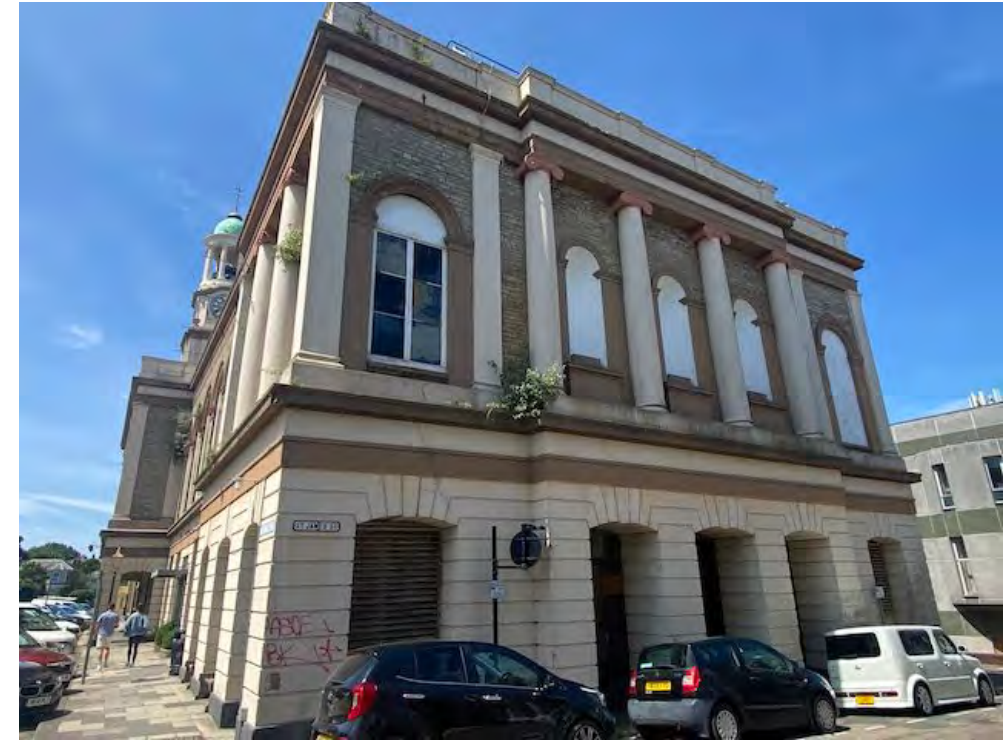
Ryde Town Hall from the East

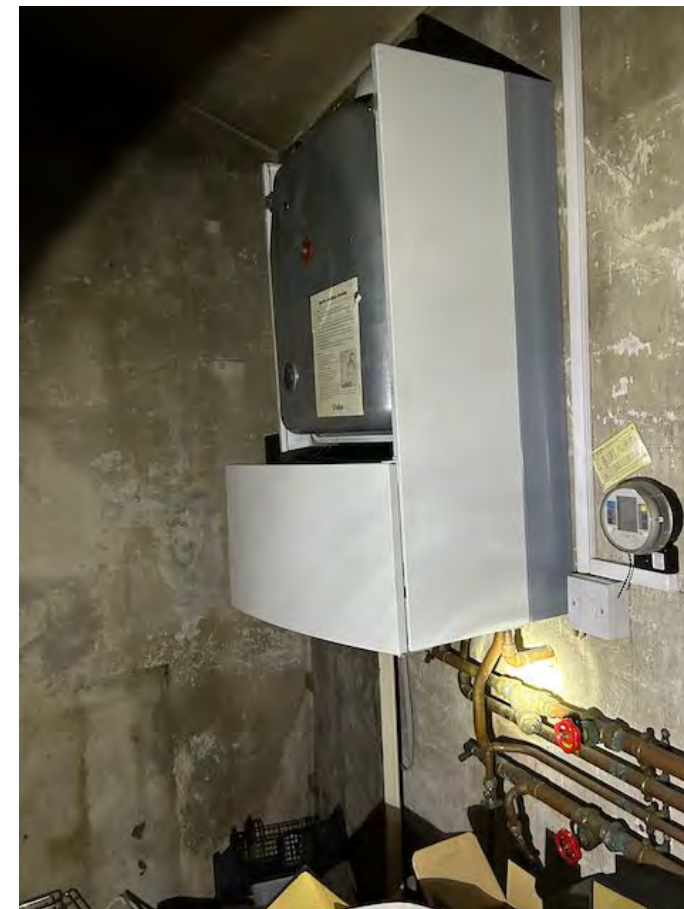
One of the boilers found within the building

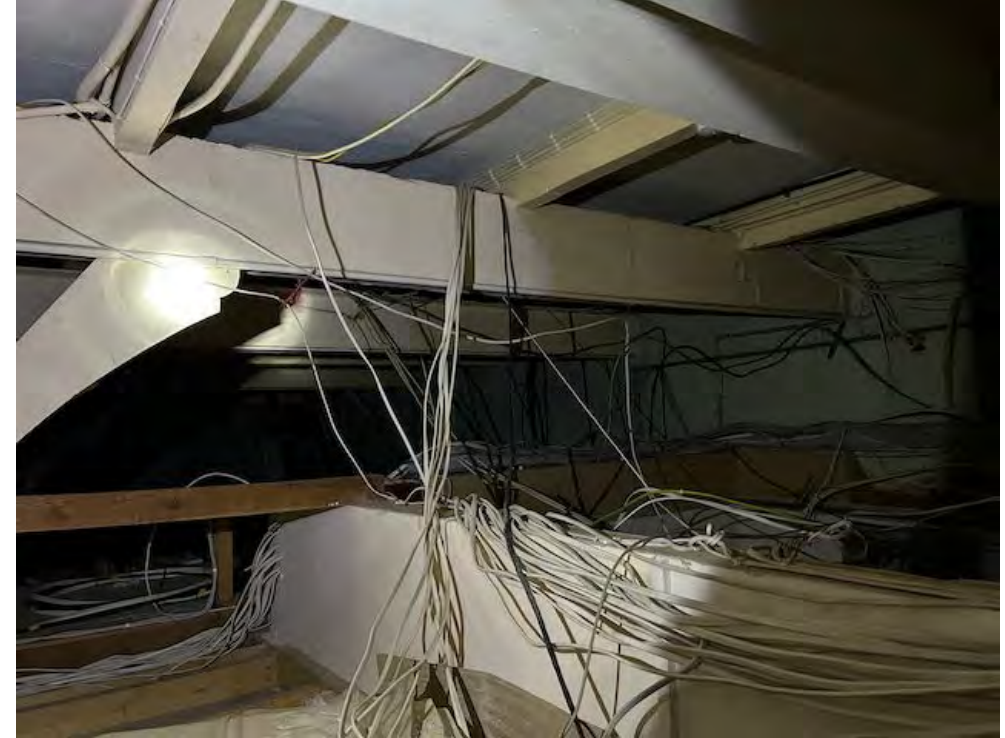
Vast quantities of wiring threaded through the building above the ceilings (East range)

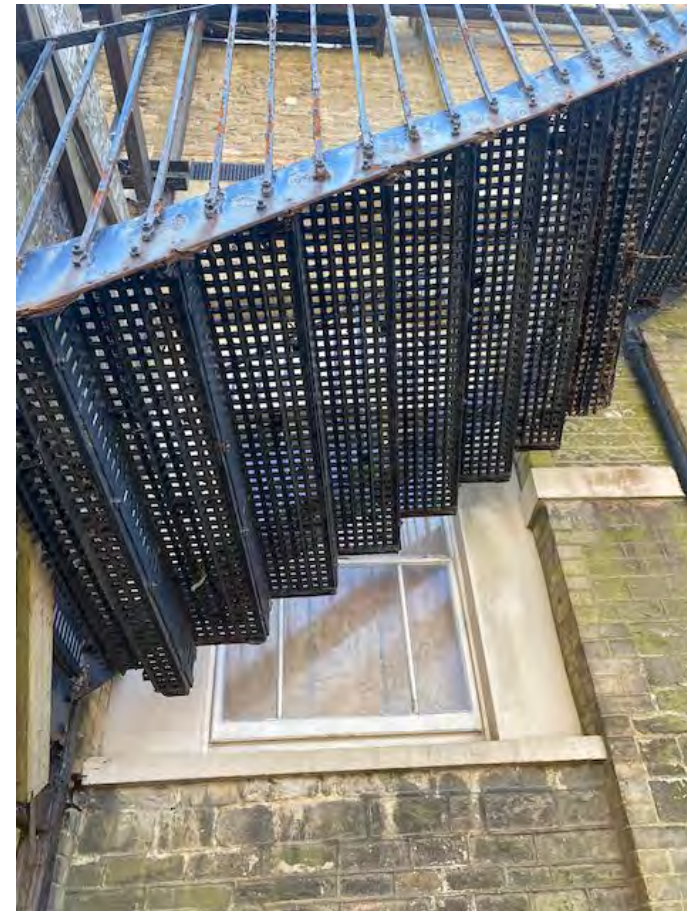
Damaged section of fire escape in imminent danger of falling (unsupported to inside edge). Urgent Work

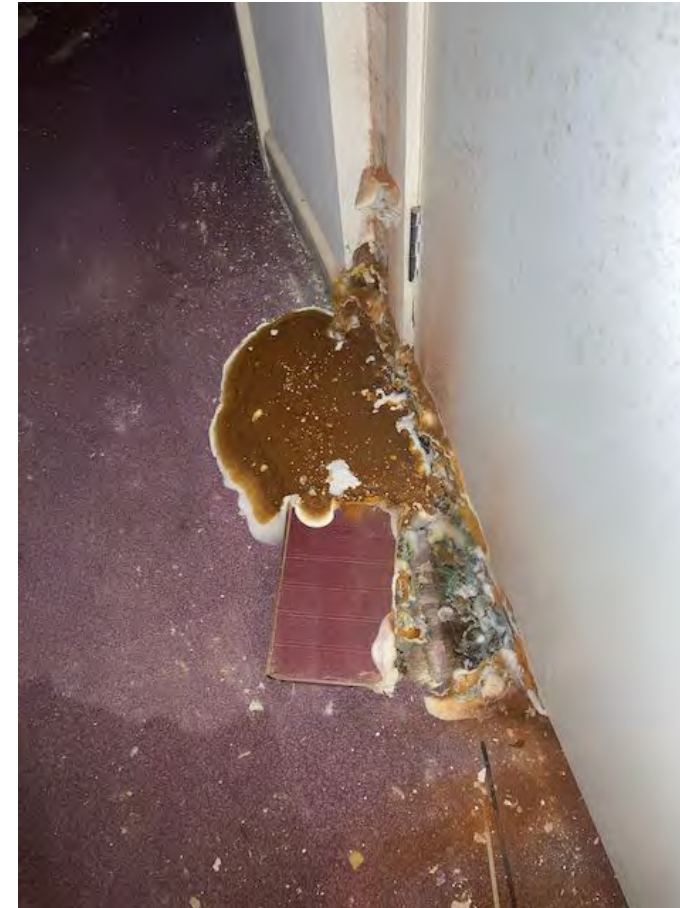
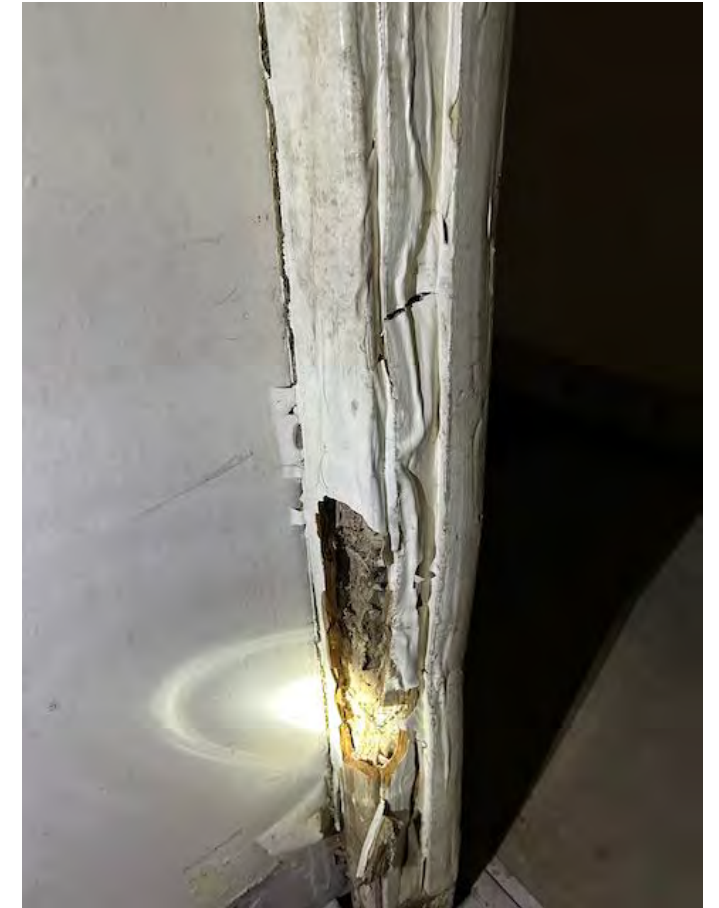
Dry rot (Serpula Lacrymans) fruiting body on ground floor

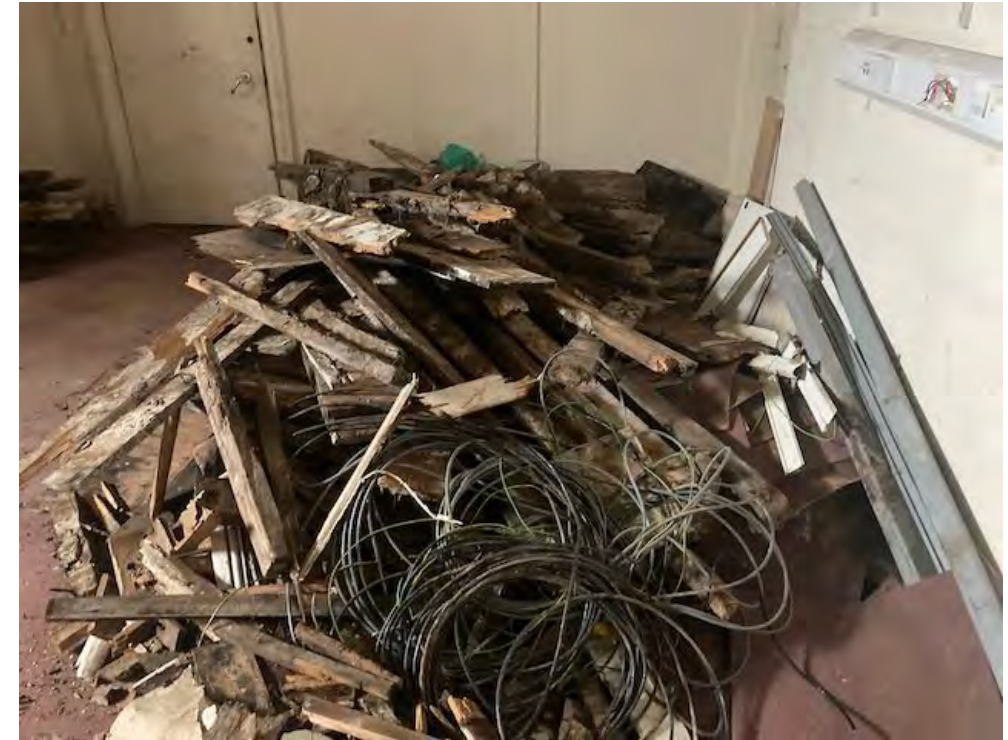
Removed dry rot damaged flooring stored on ground floor risking further contamination.

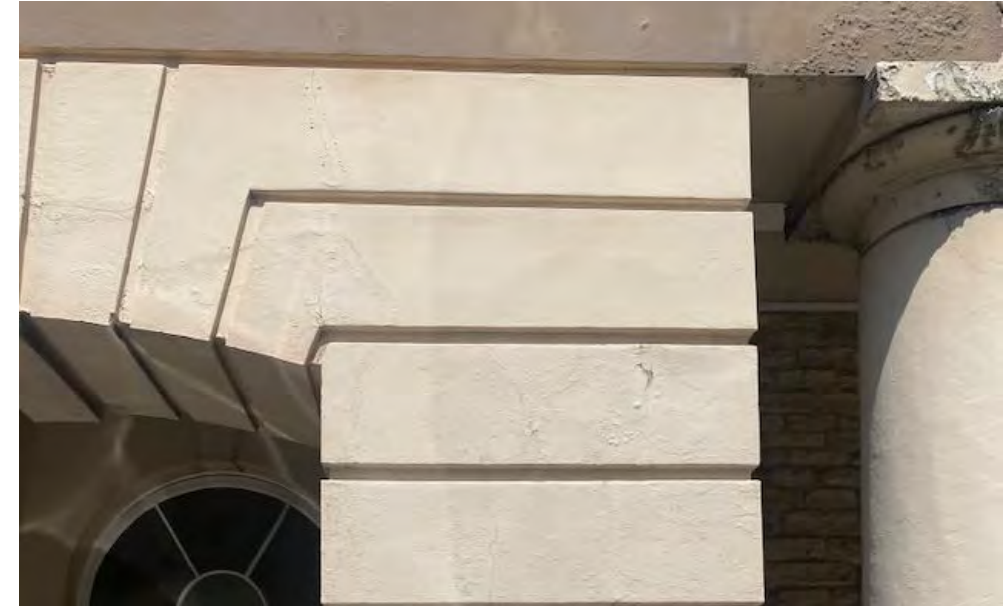
B.2.6. Other risk items, include the extent of render repairs, and the condition of the timber floors, but these can only be answered with more certainty, following the in high level inspection (combined with the removal of the buddliea), and the clearance of the interior.

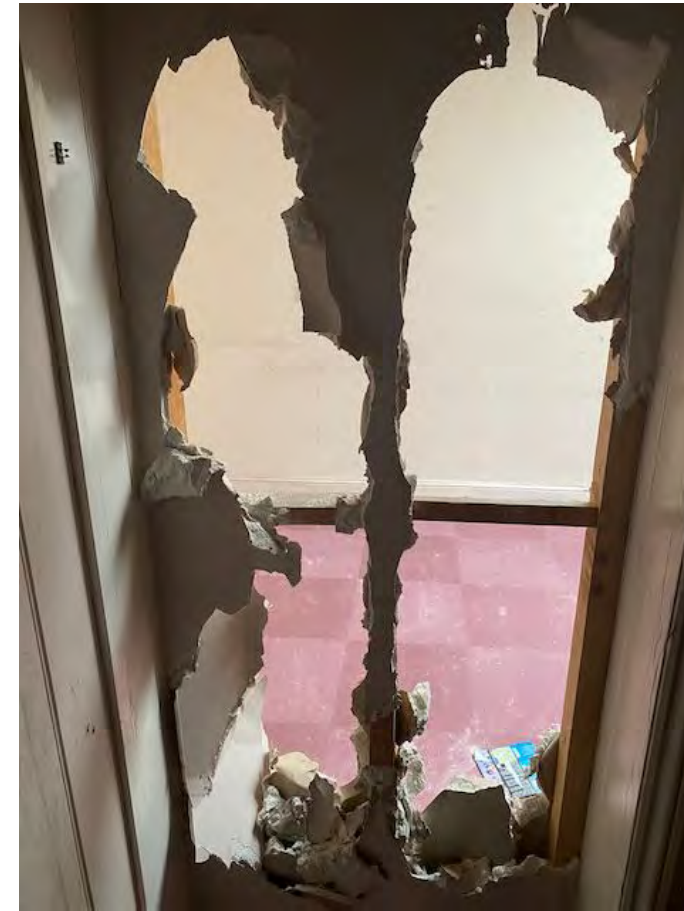
Deliberate damage to internal building fabric

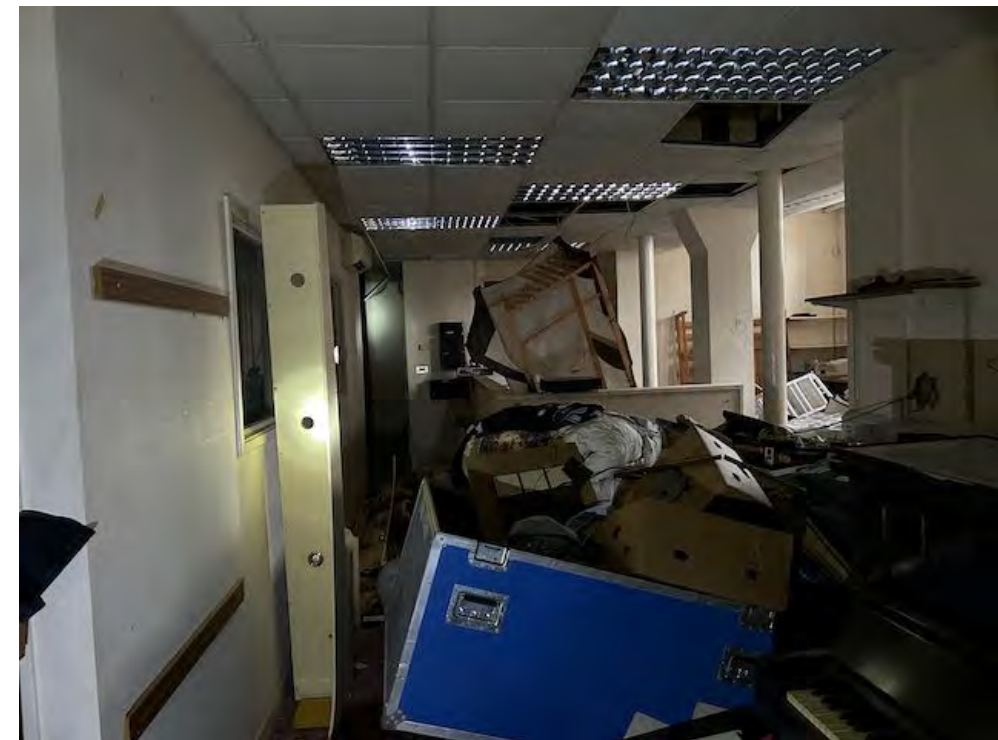
Extensive clearance of areas of the building required.

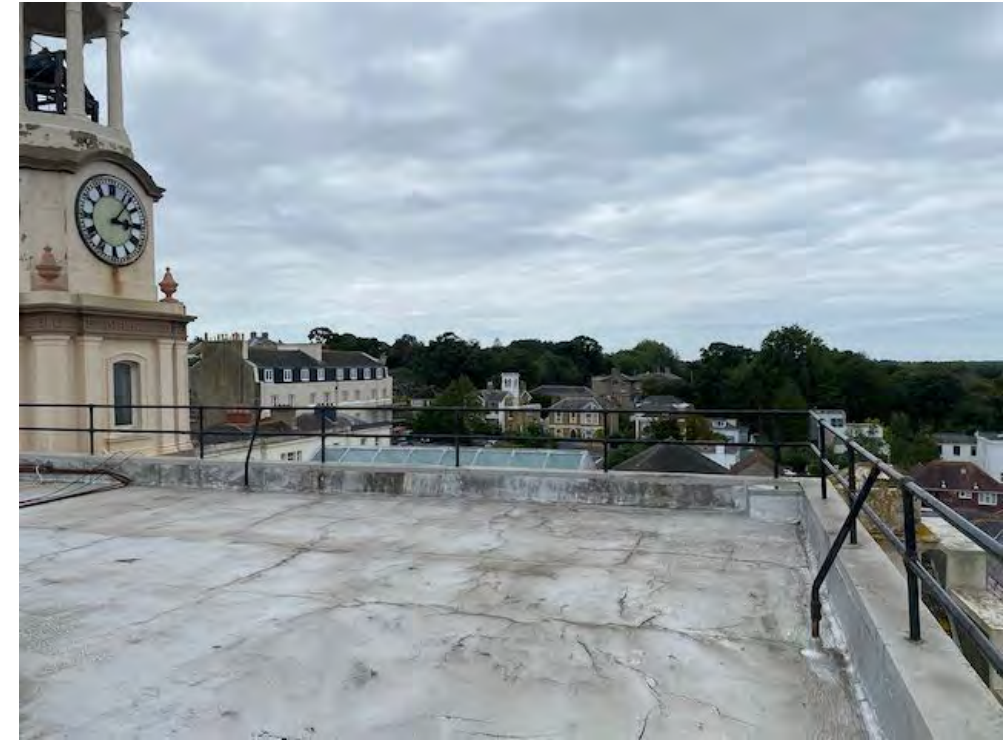
Cracked asphalt roof covering above the auditorium

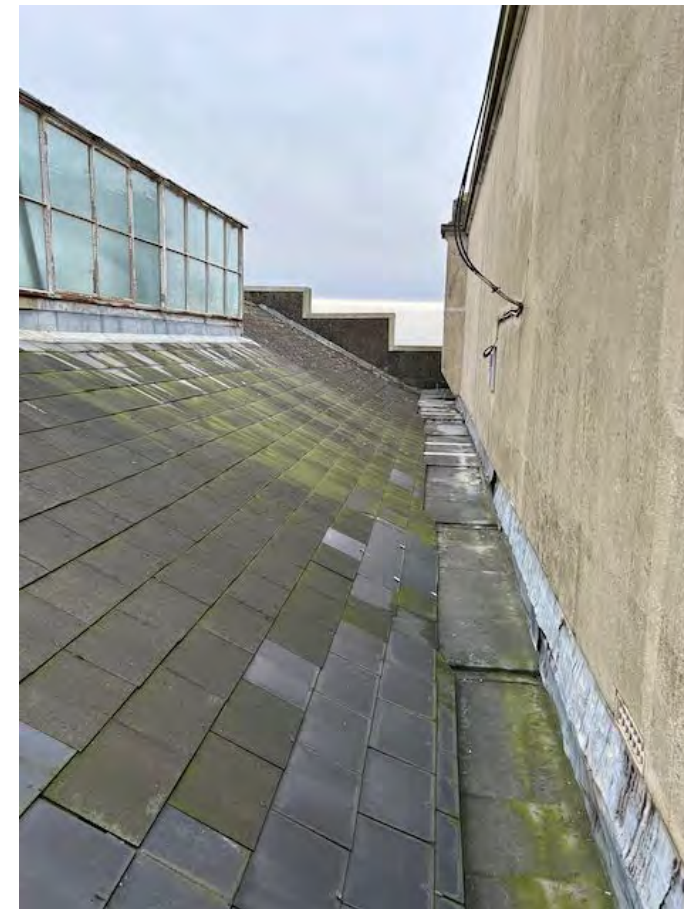
Cracked lead in valley gutters causing

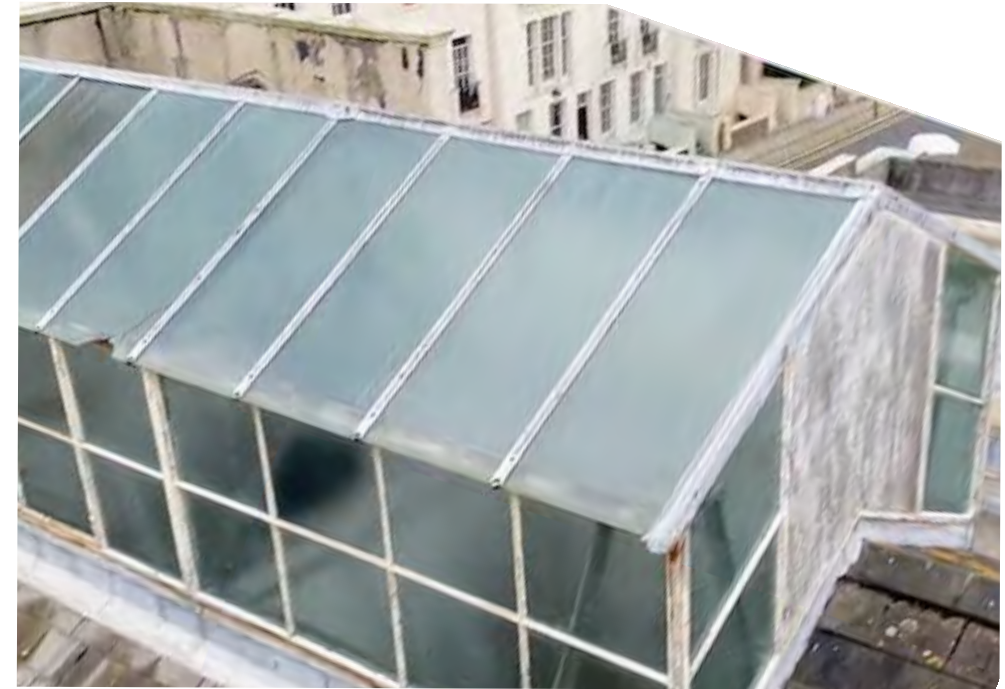
Lantern on ridge to the central slate covered roof behind the clock tower.

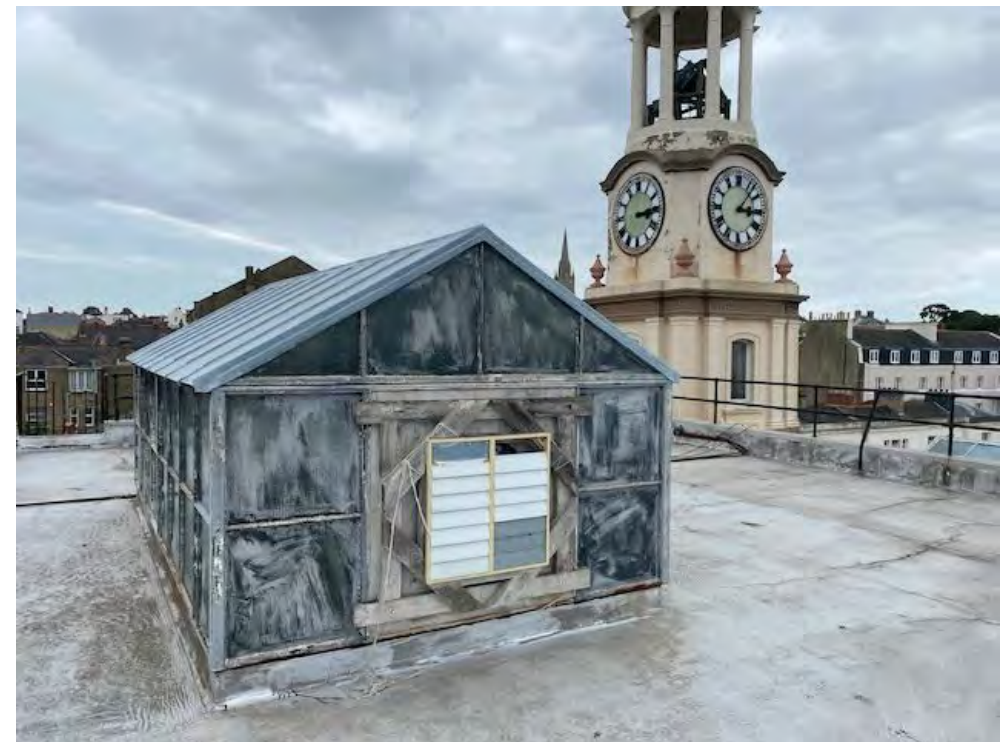
Main auditorium roof, lantern and cupola

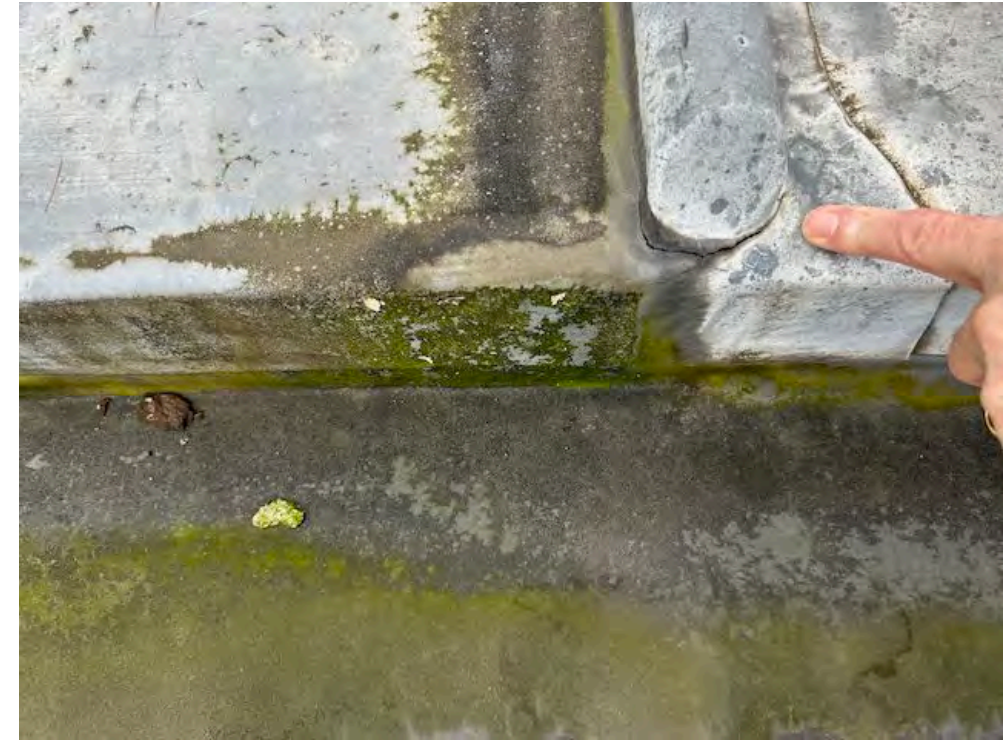
Overworked lead at the ends of each timber roll

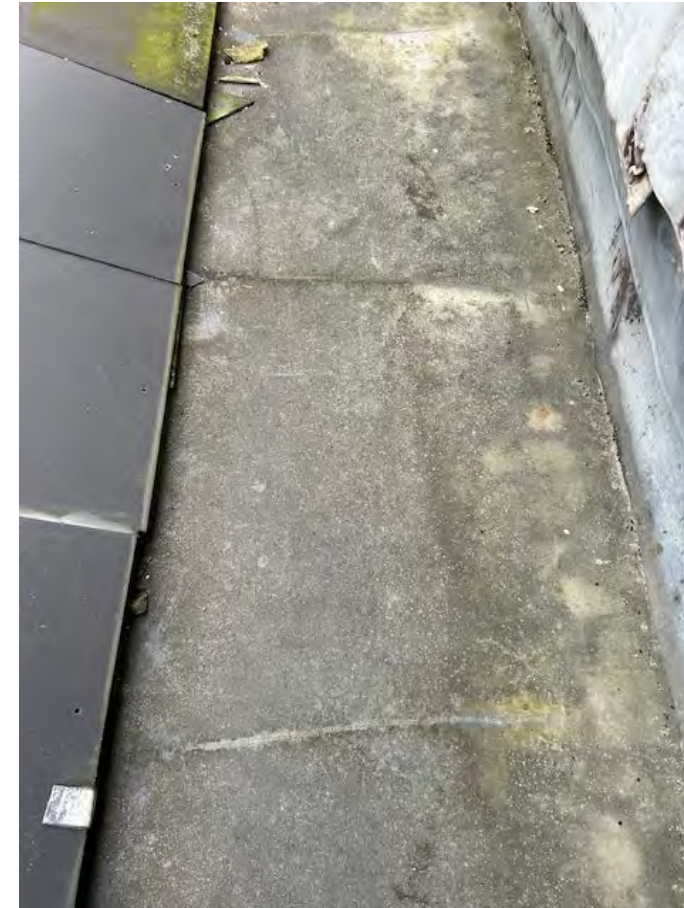
- B.4.21. In the longer term the roof needs to be stripped, and re-covered using natural slate. This will be coordinated with the repairs to the lantern and the lead. The steps in the lead bays to either side will also need to be re-configured to allow the correct increase in height to be achieved.

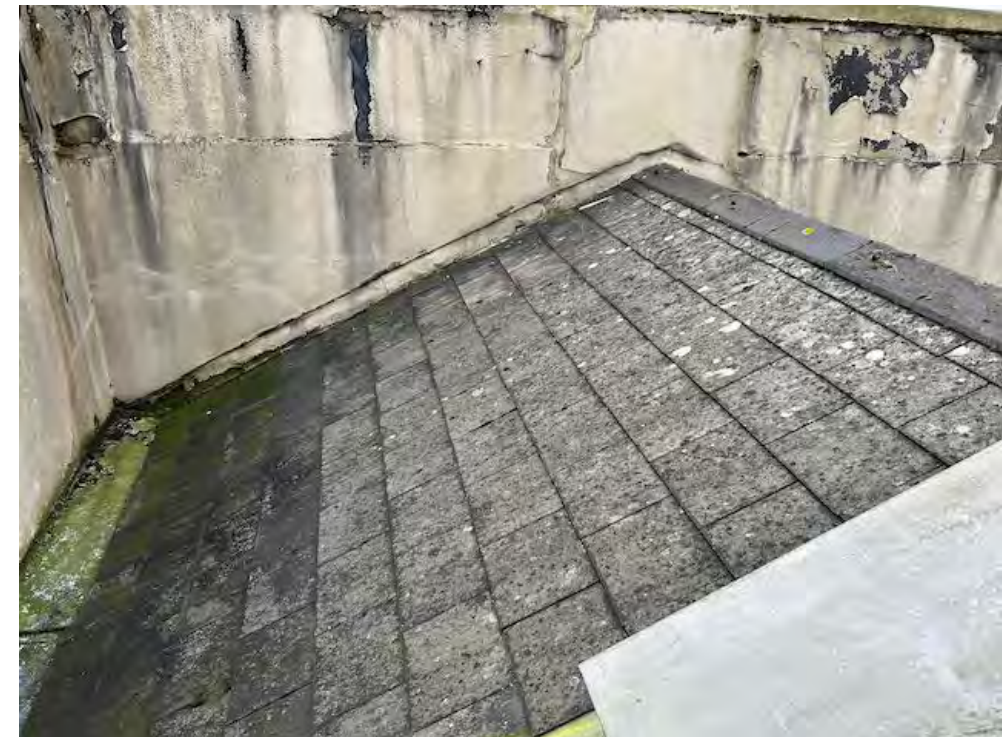
Asbestos slates (High Probability but not tested)

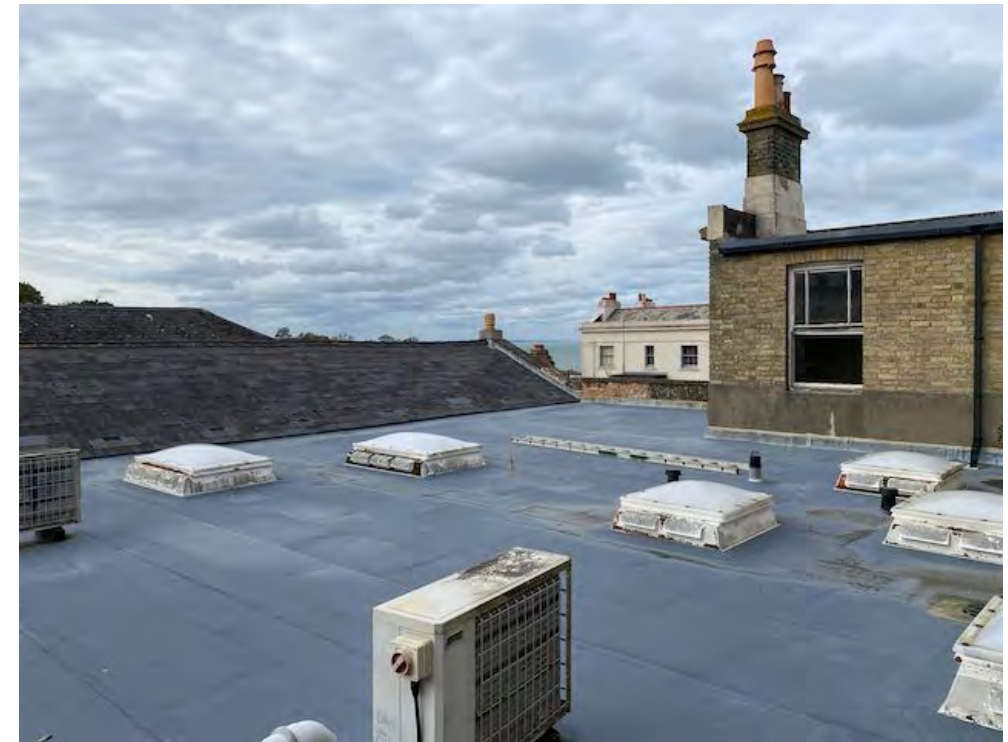
Flat roof between Council Chamber and the western pitched roof

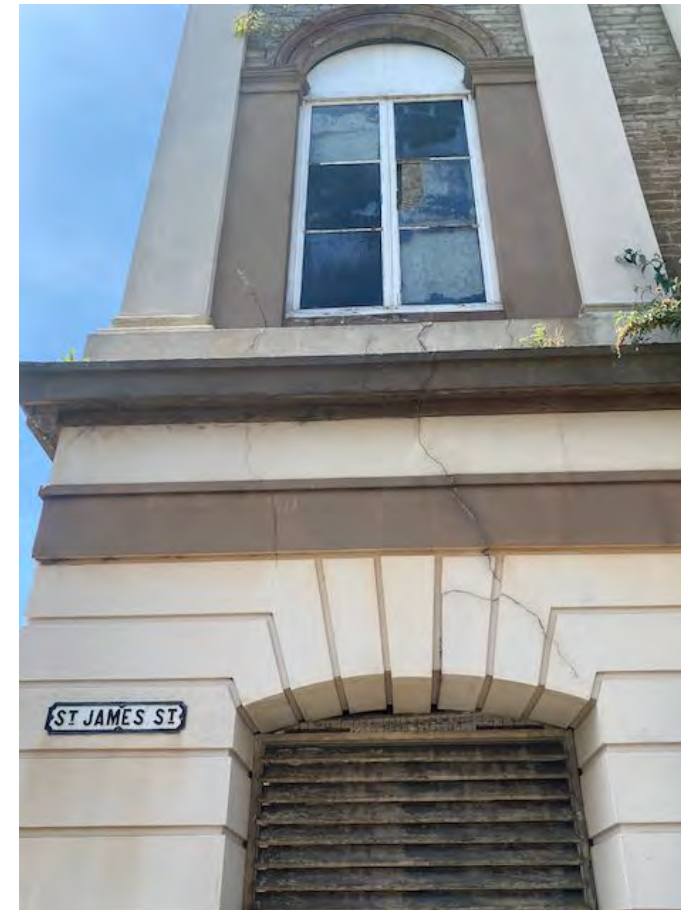
Cracks on the south east corner of the building

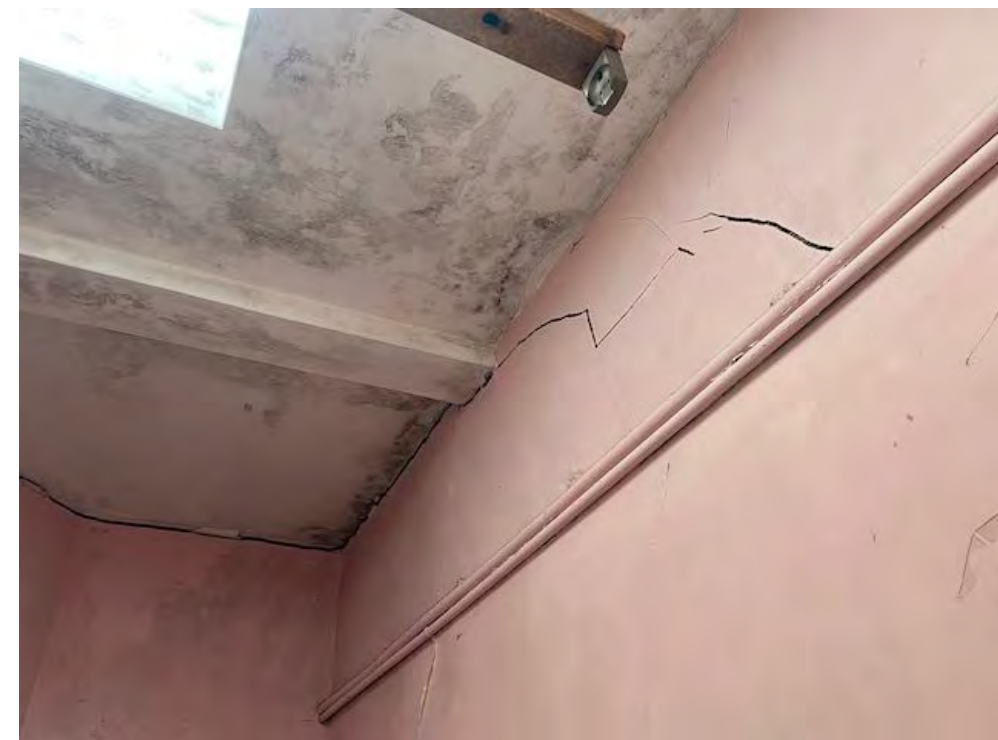
Structural movement evident within the building

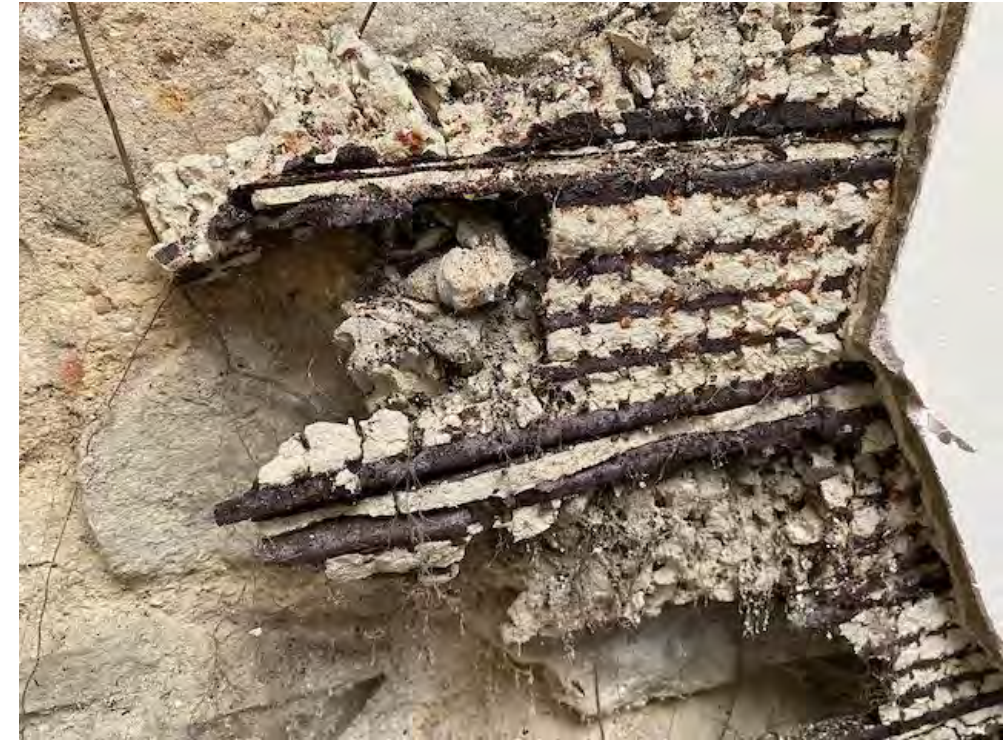
Corroded mesh within the plaster in the dressing rooms

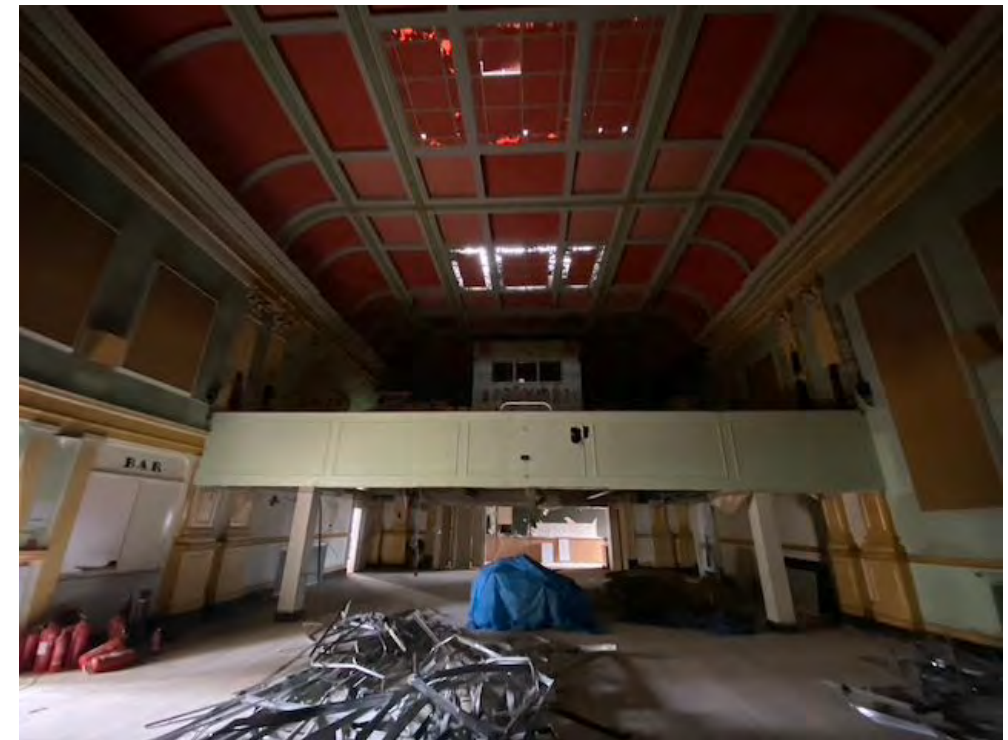
The coffered concrete roof of the auditorium

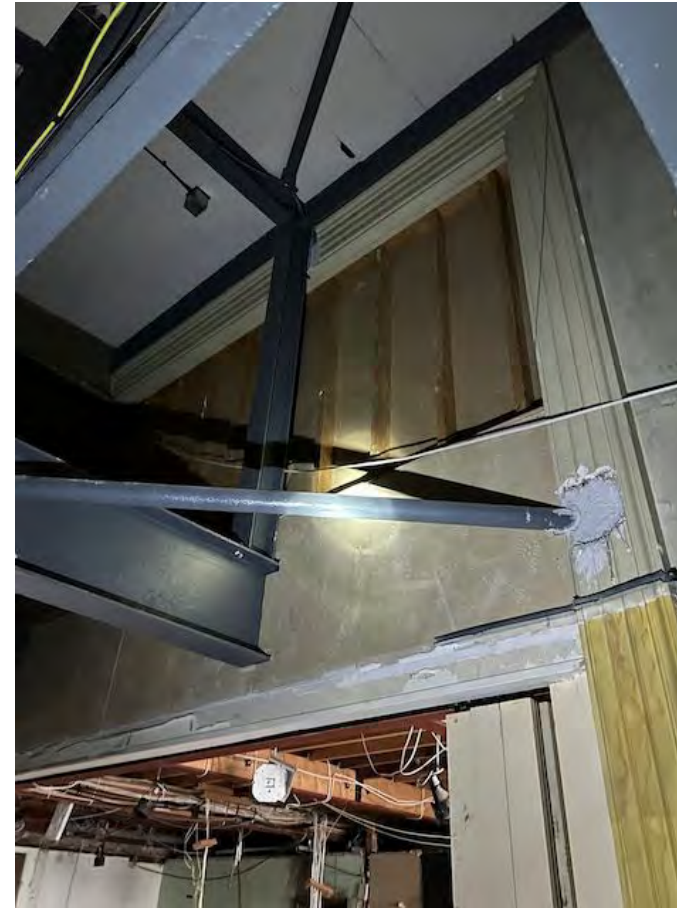
1990's insertions and damage to 1930's fabric

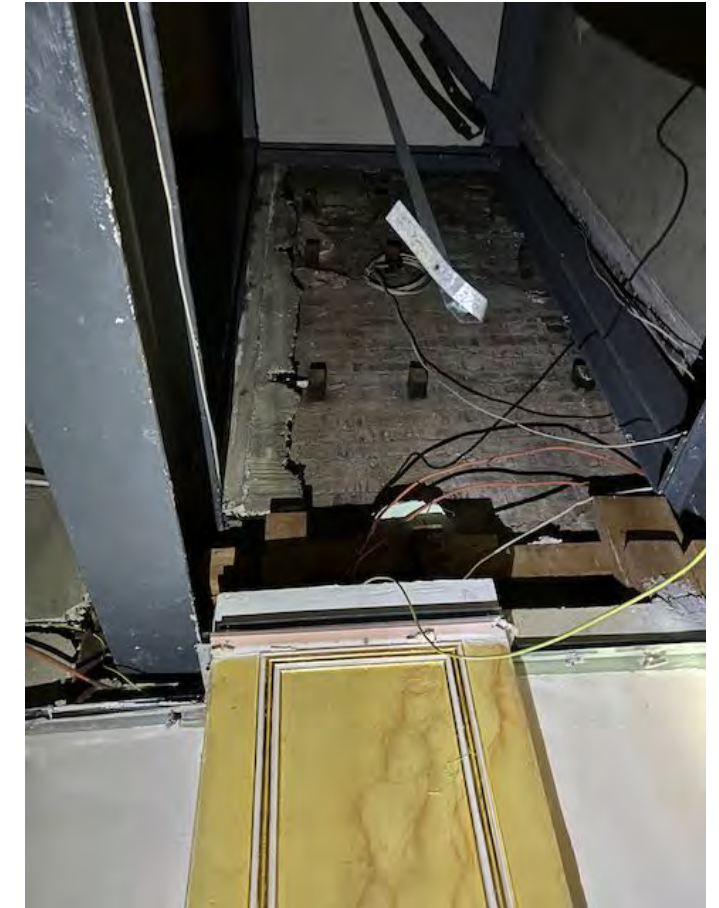
Modern plasterboard pilaster strips below balcony c.f 1930's Plaster of Paris originals

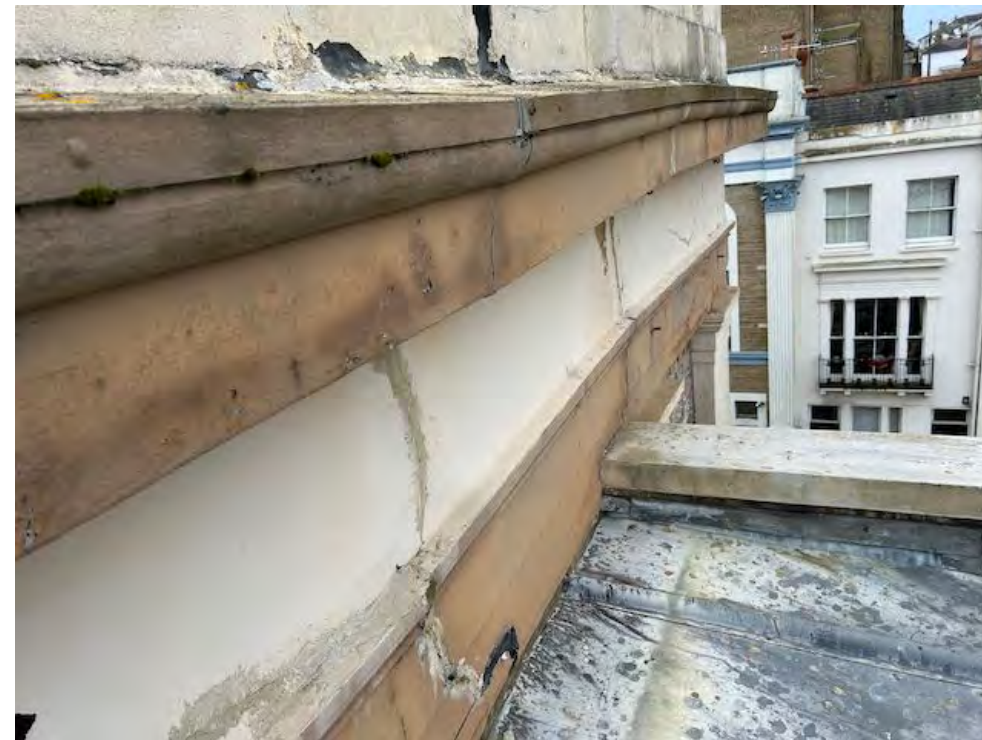
(Historic?) Movement below clock tower on West elevation visible in cornice.

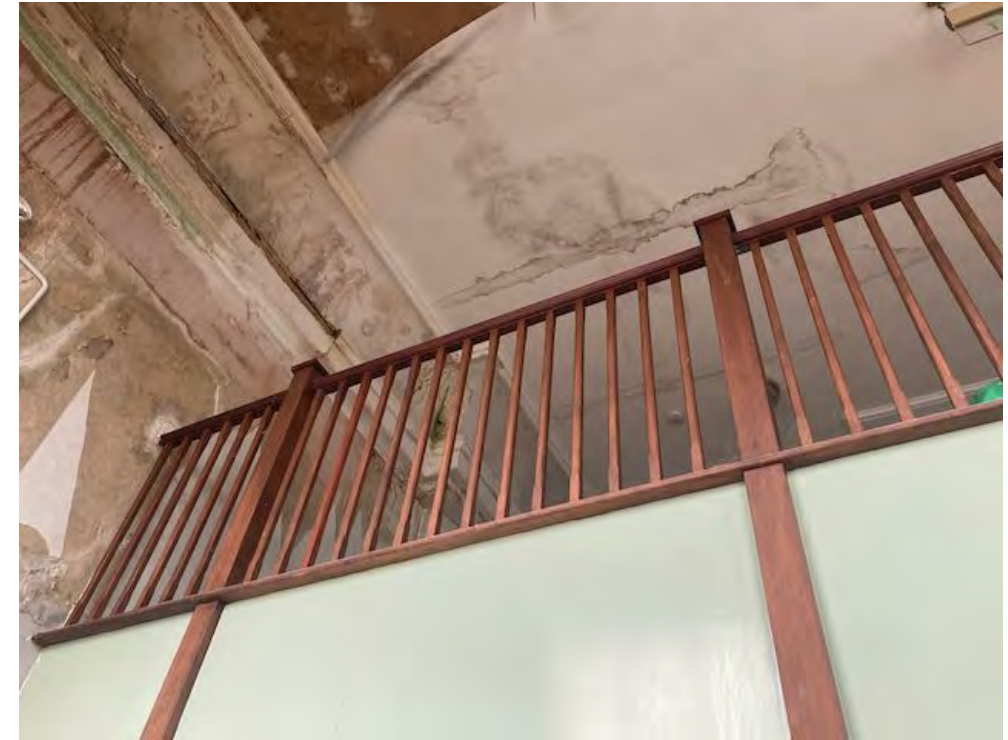
Damp penetration arising from spilt in lead lined gutter above (See pp17).

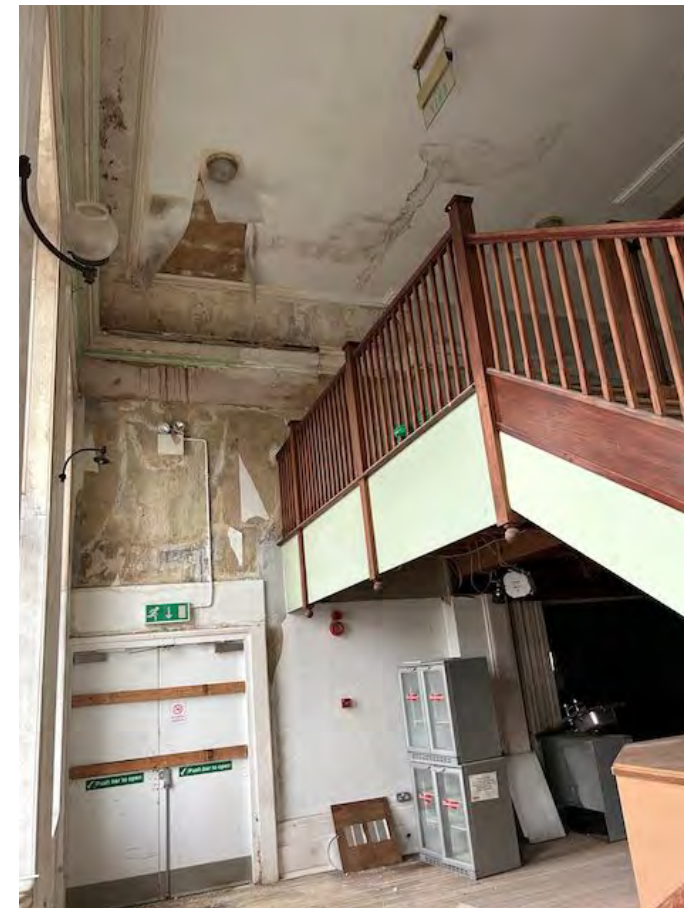
New mezzanine altering proportions of the hall

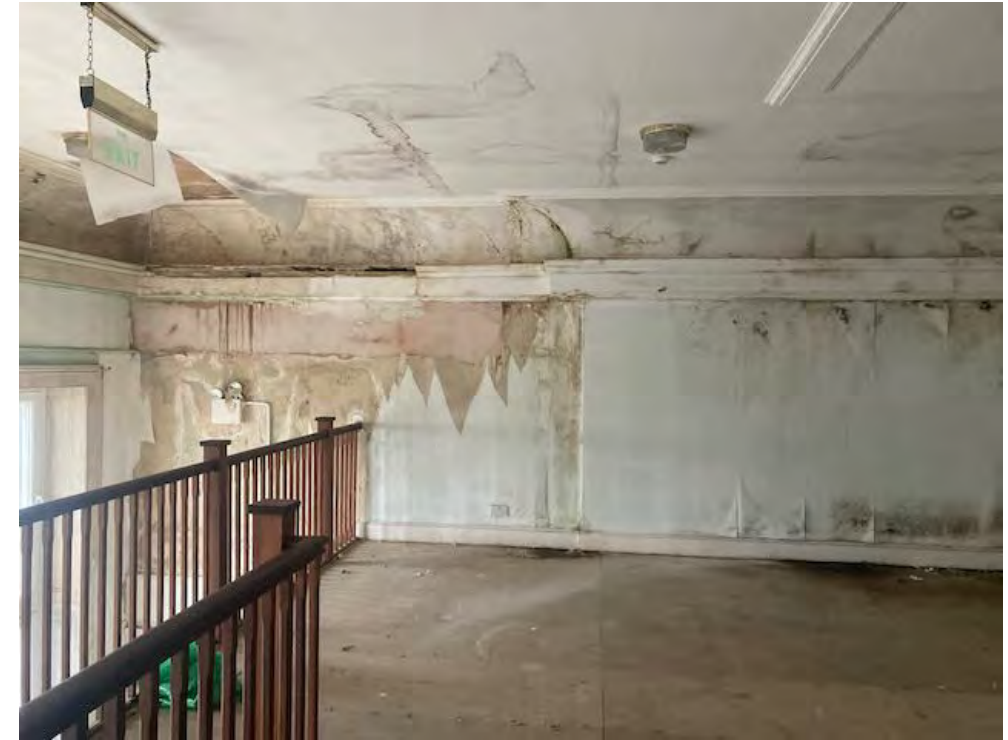
Penetrating damp upper part of bar (mezzanine)

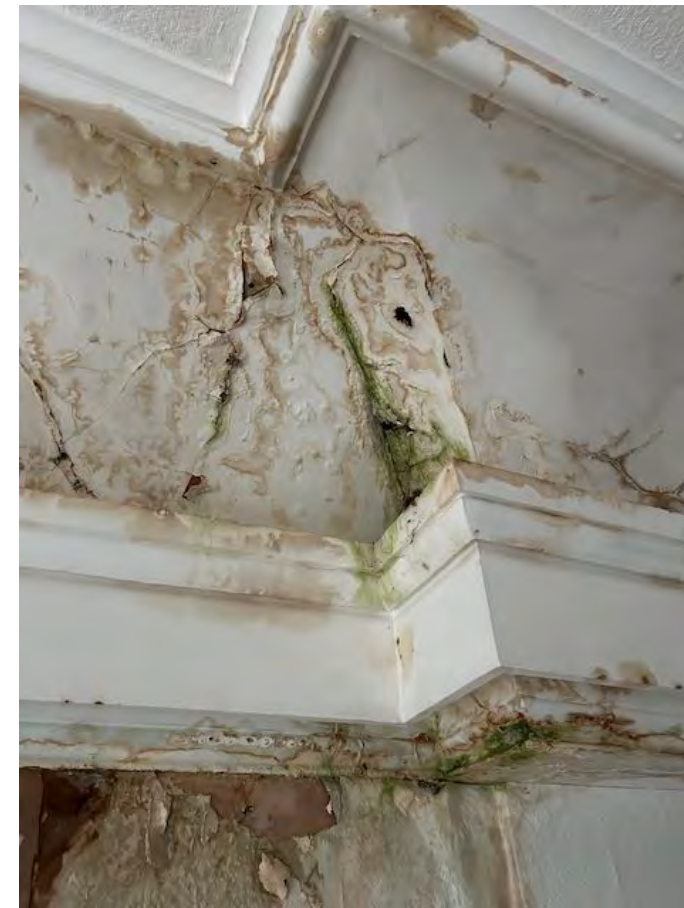
Active areas of damp below failing lead gutter. Very urgent repair required.

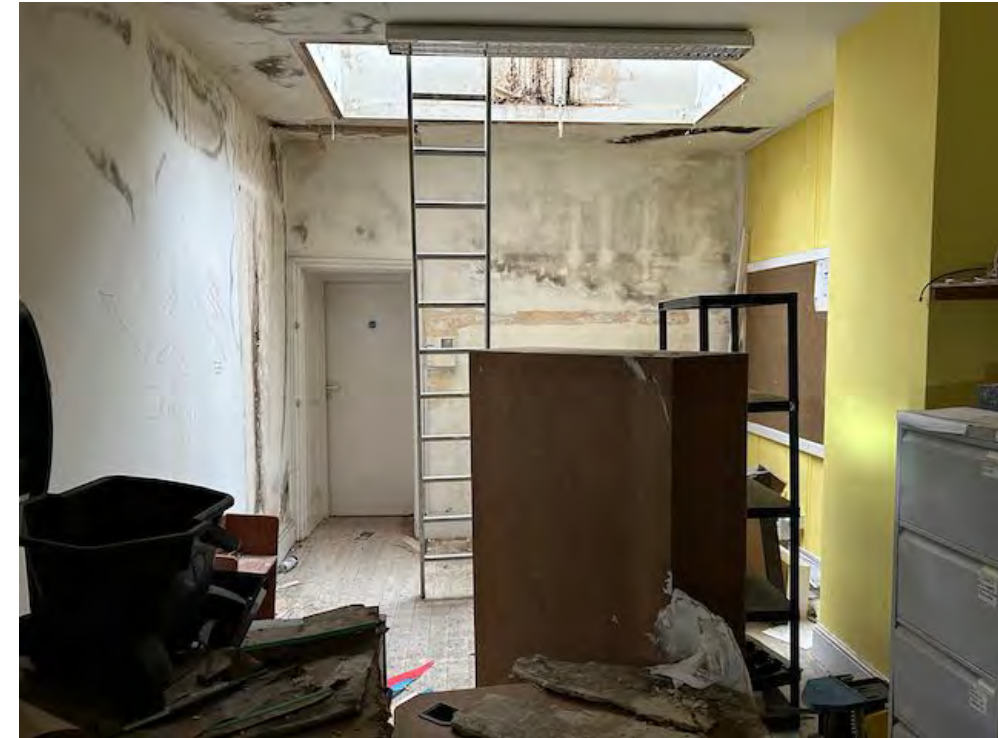
Upper office below clock tower. Note condensation where ceilings not insulated or ventilated.

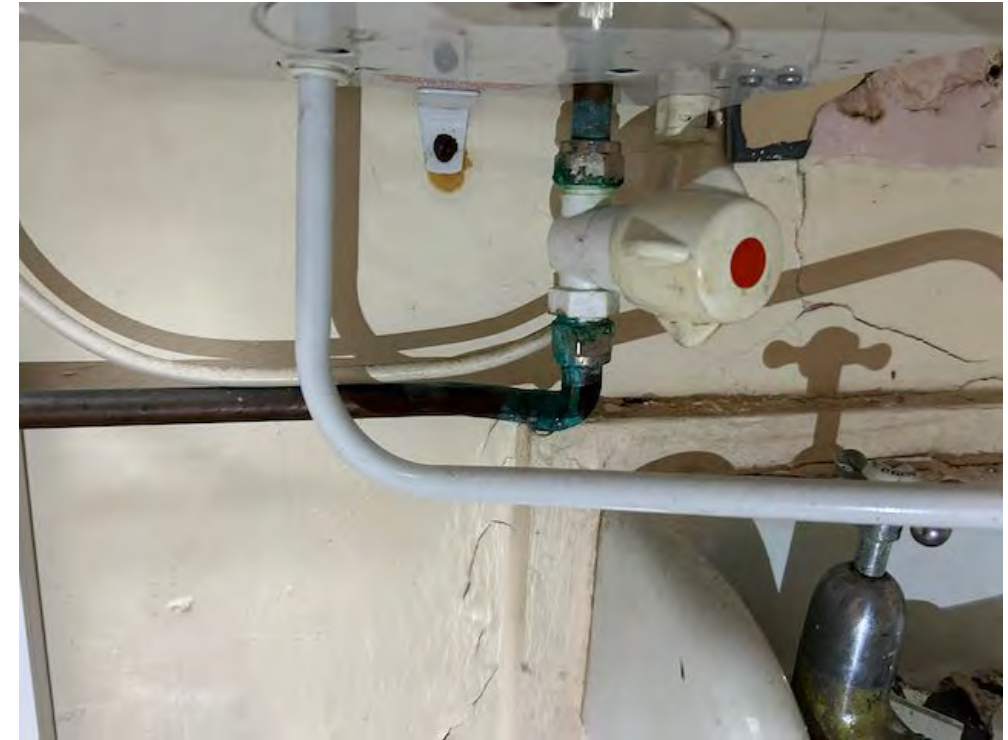
Leak below a sink in the changing rooms
