Condition Report

Ryde Town Hall

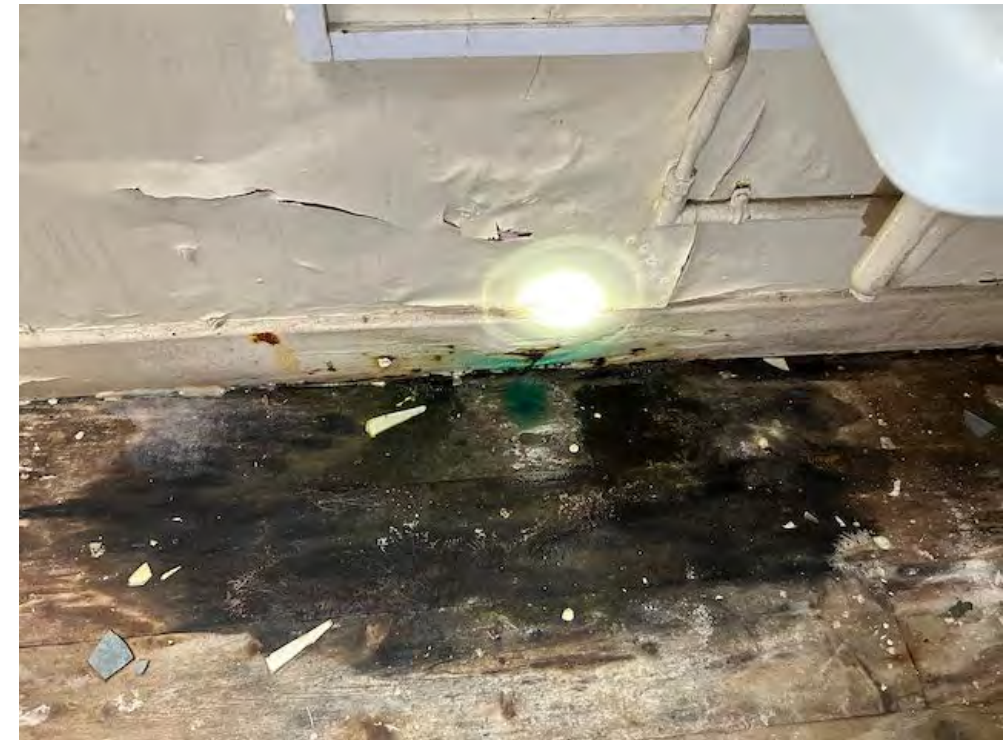
Very damp floor beneath active water leak in changing rooms, increasing risk of dry rot.

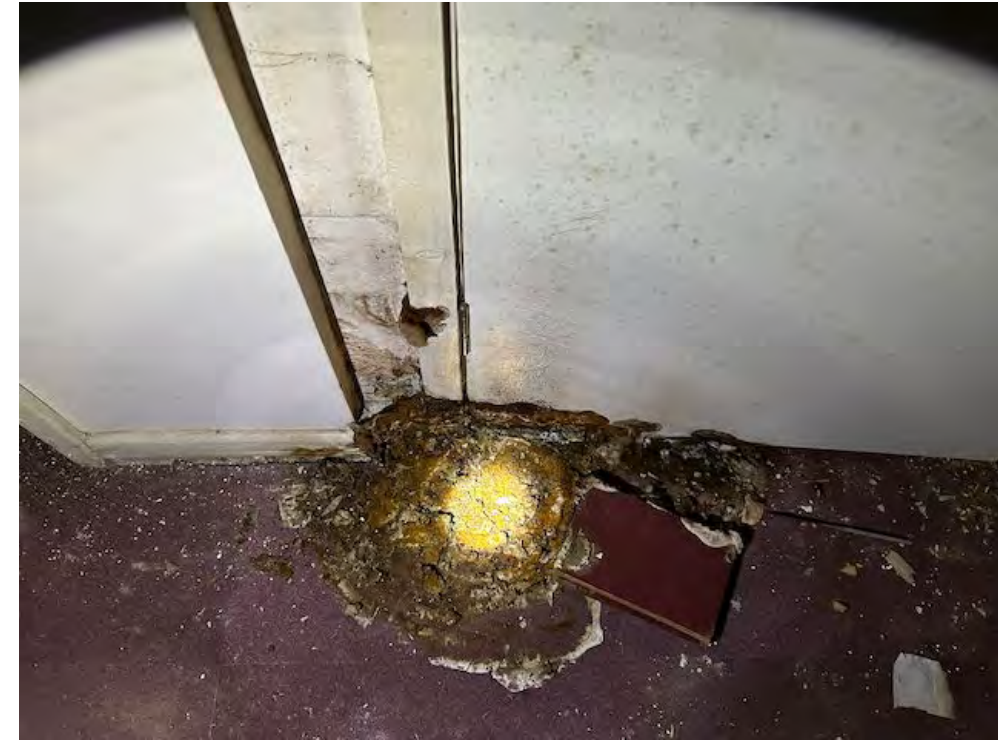
Active dry rot infestation now visible above the floor. The concealed area of decay will be very significantly larger.

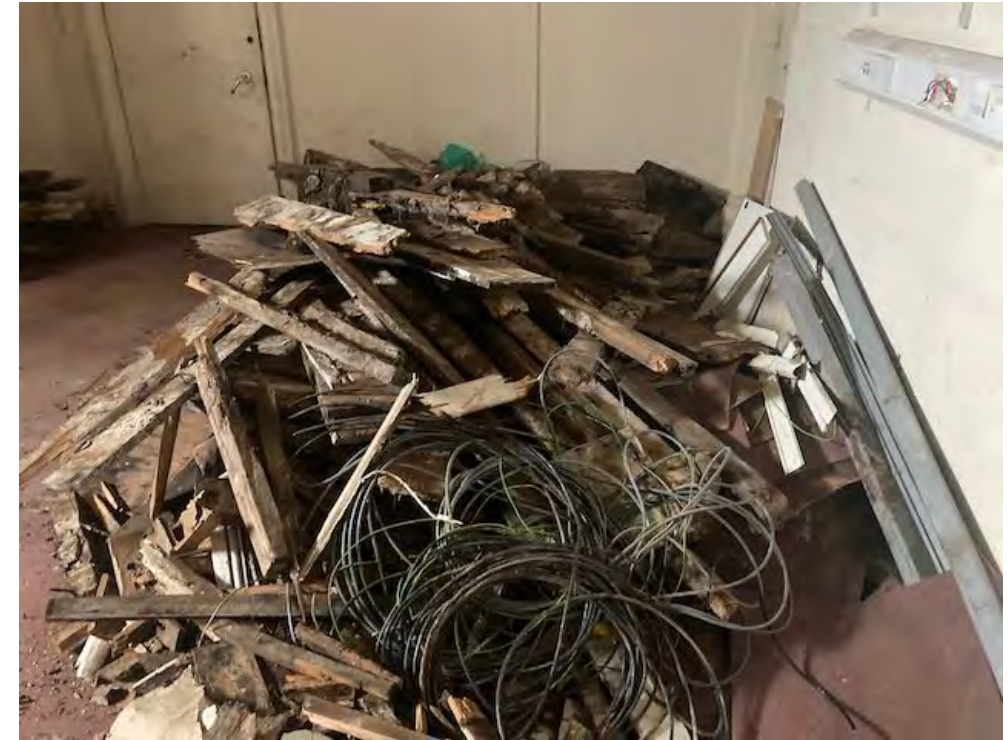
Flooring damaged by dry rot (G40)

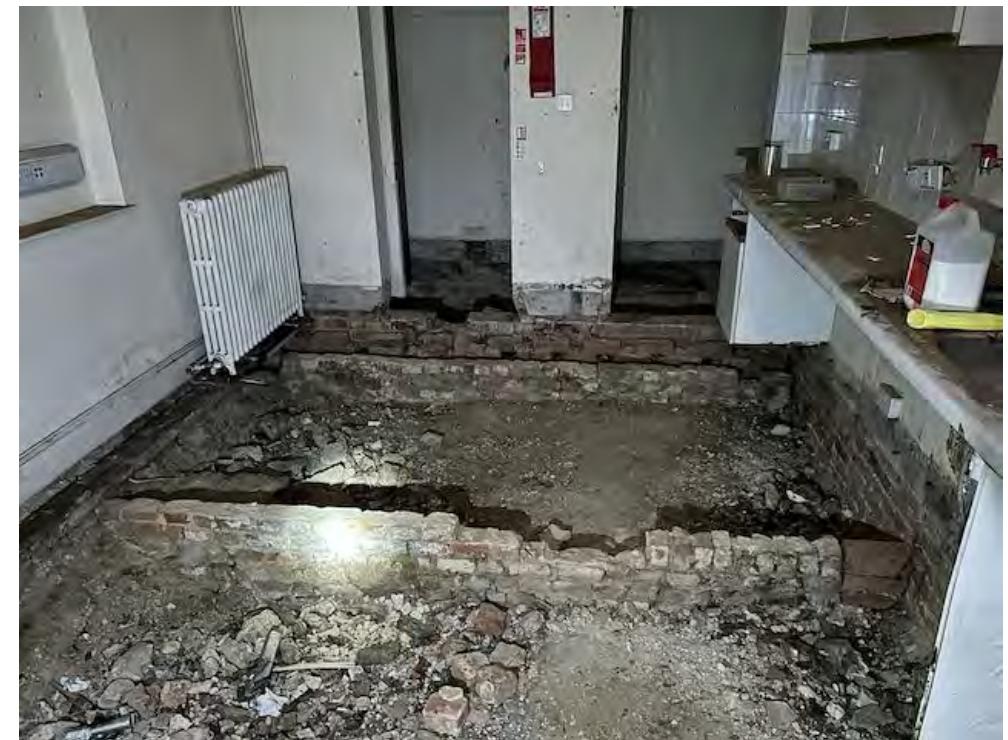
Expected original location of dry rot with contaminated material moved to G40

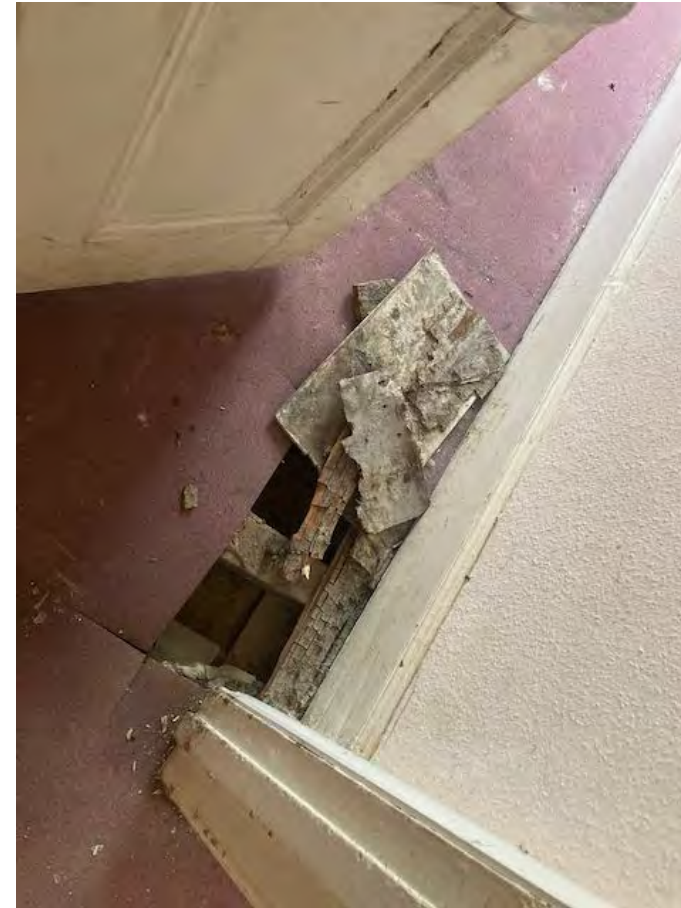
Floor boards and floor joists damaged by dry rot (G18)

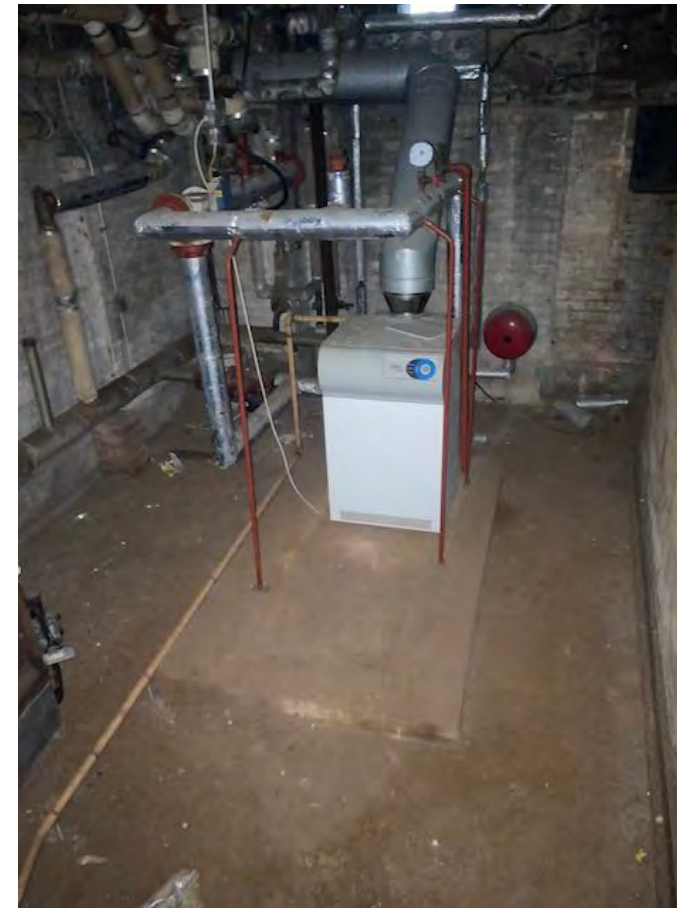
Oil (?) fired boiler in basement

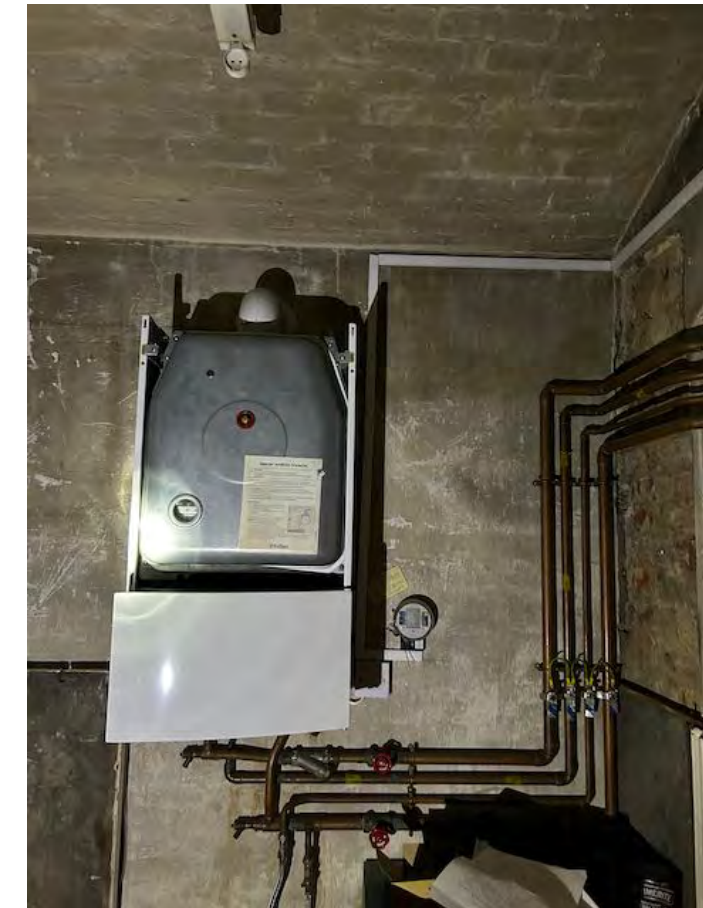
'Modern' Gas boiler to west range. Pipework fair.

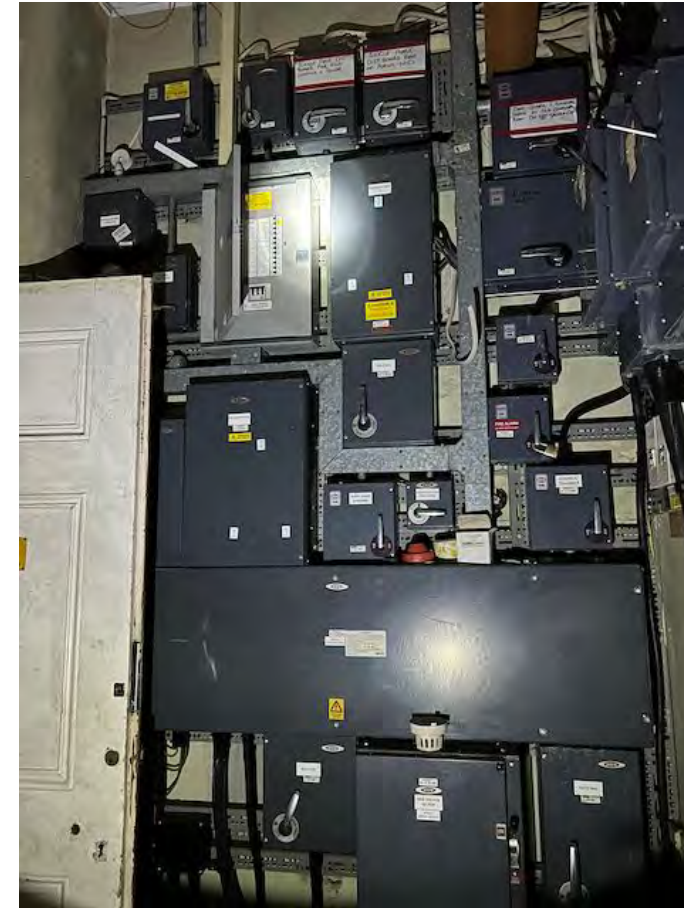
- B.8.23. A braided copper wire provides a very primitive level of lightning protection to the Clock Tower. This arrangement is very old, and it is unlikely to provide any meaningful protection to the building. The cable is draped over the roofs to the west of the building.
- B.8.24. Costs should include for a new installation to modern standards.

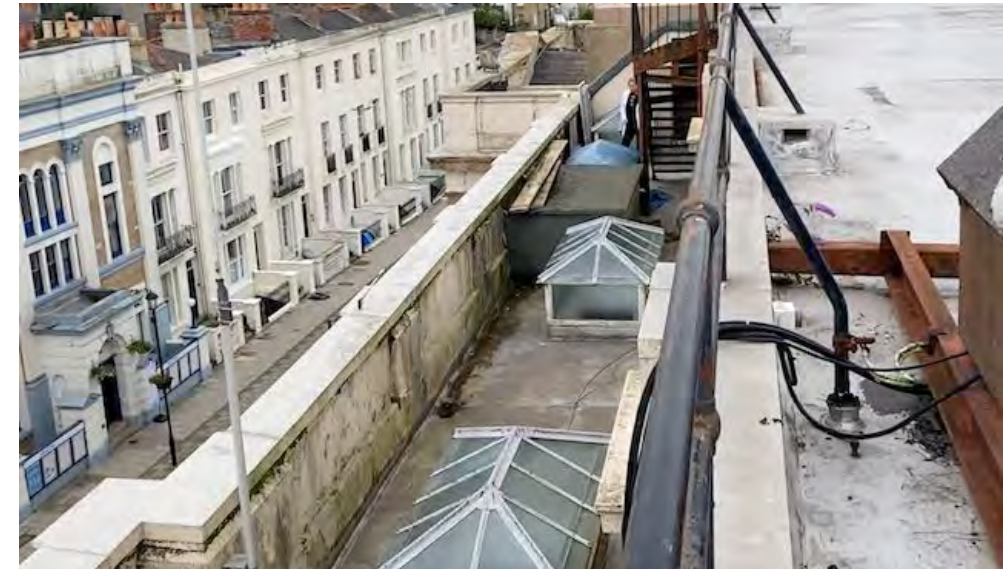
Smaller flat roof with five lanterns and the cast iron stairs

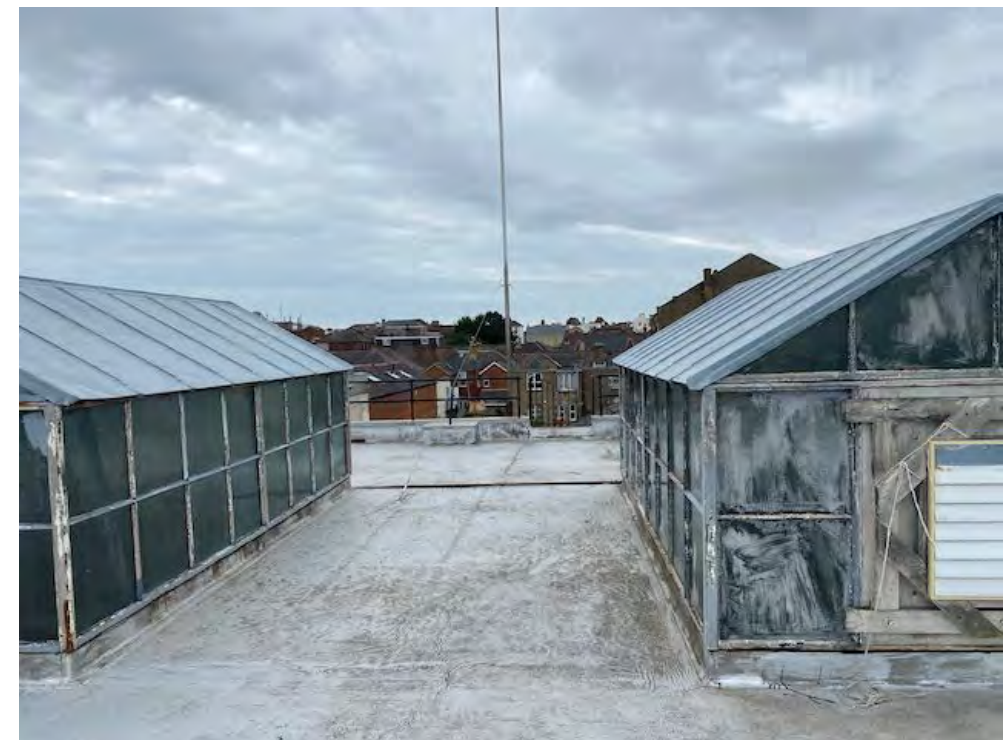
Main roof showing Georgian wired glass lanterns

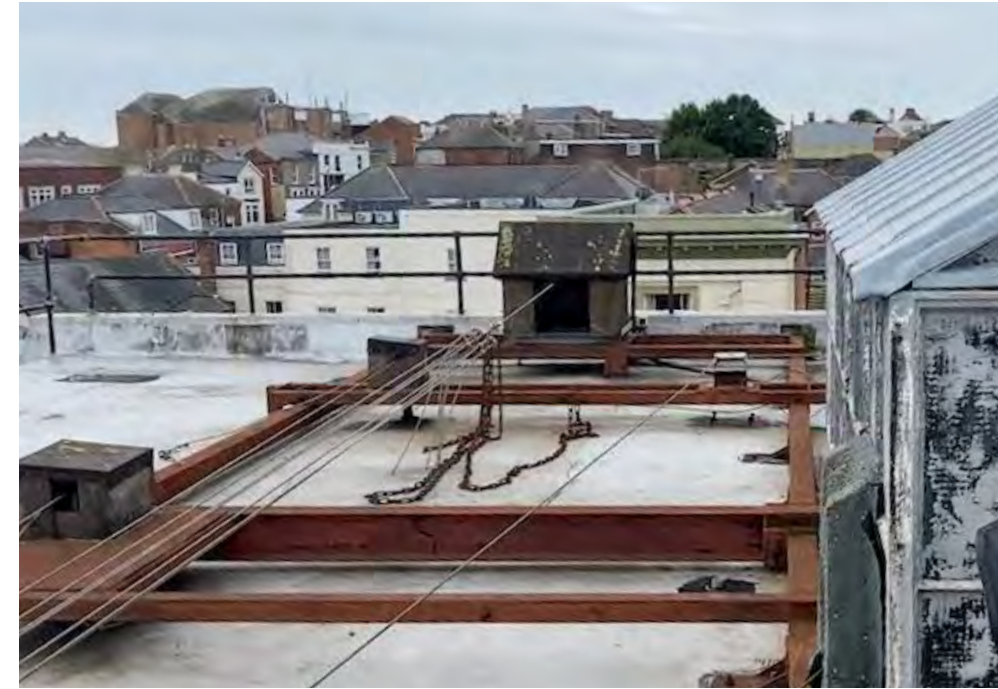
Steel frame structure for lifting scenery on the stage beneath

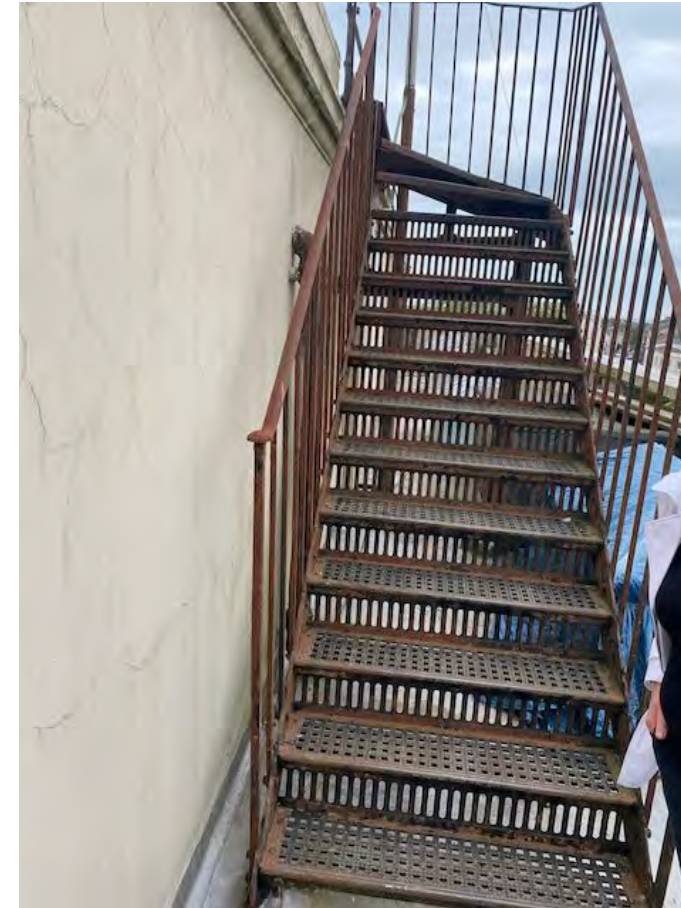
Cast iron steps to upper roof area

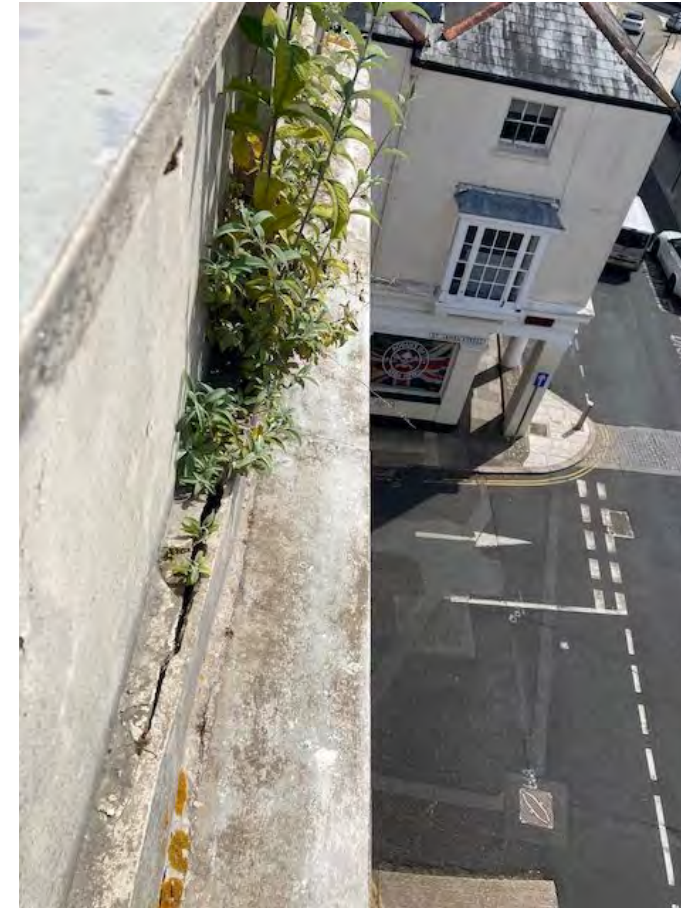
Buddleia forcing coving away from southern elevation

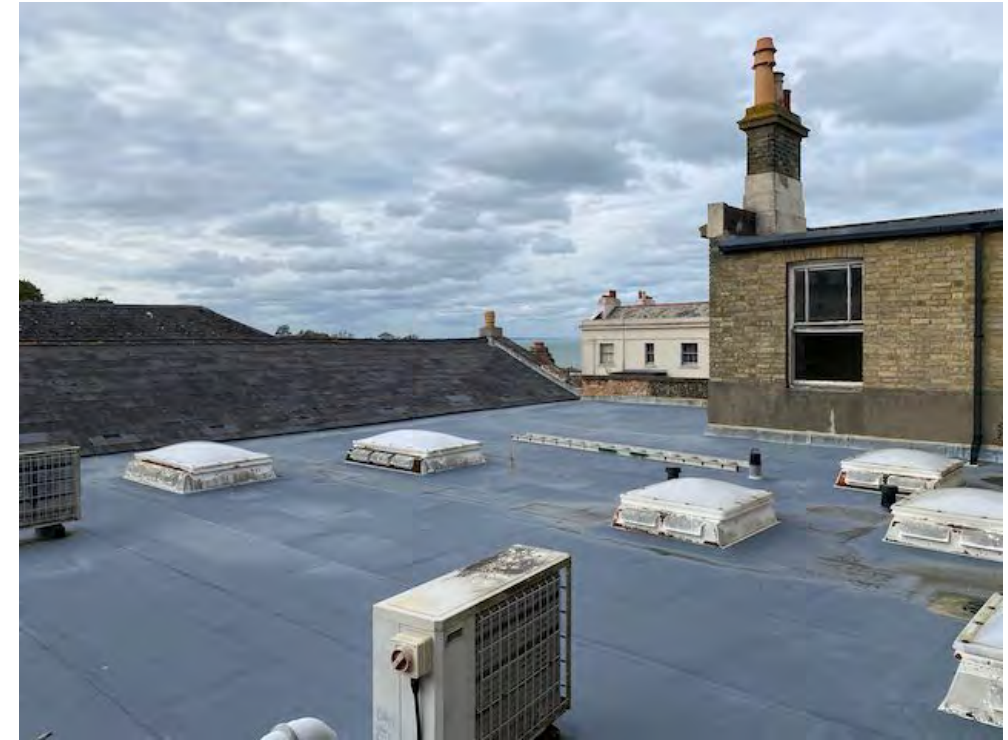
Flat roof area over western office accommodation. Flat to north.

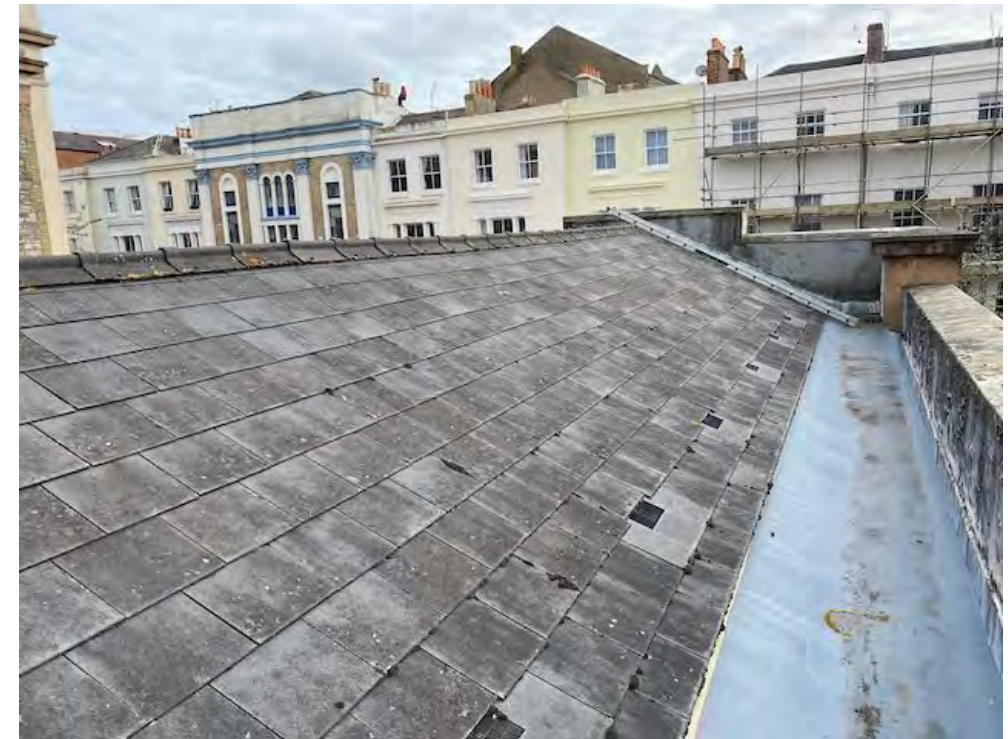
Pitched roof at the western end of the building

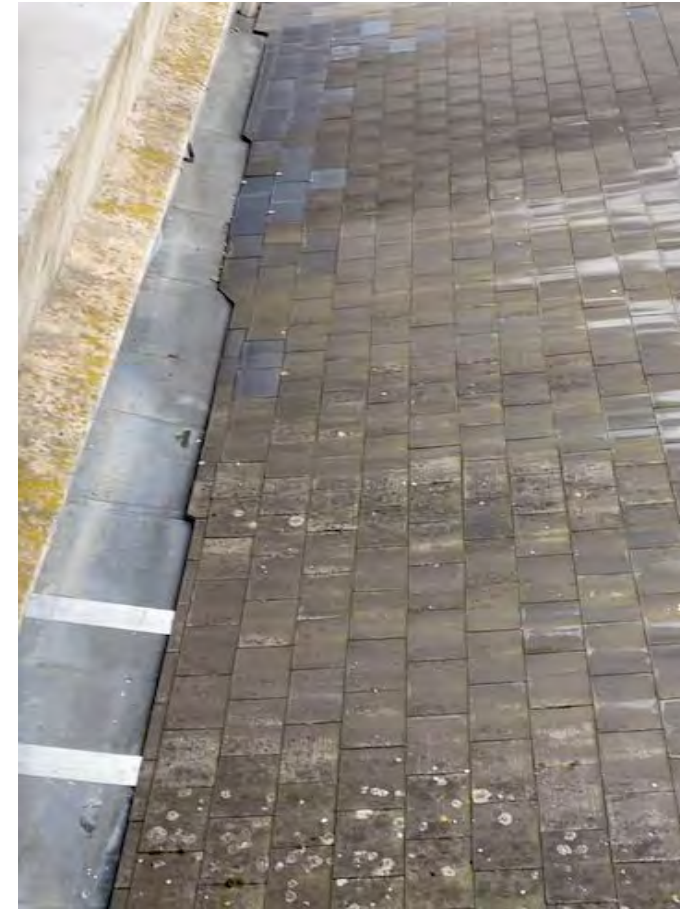
Lead lined gutter with Flashband repairs

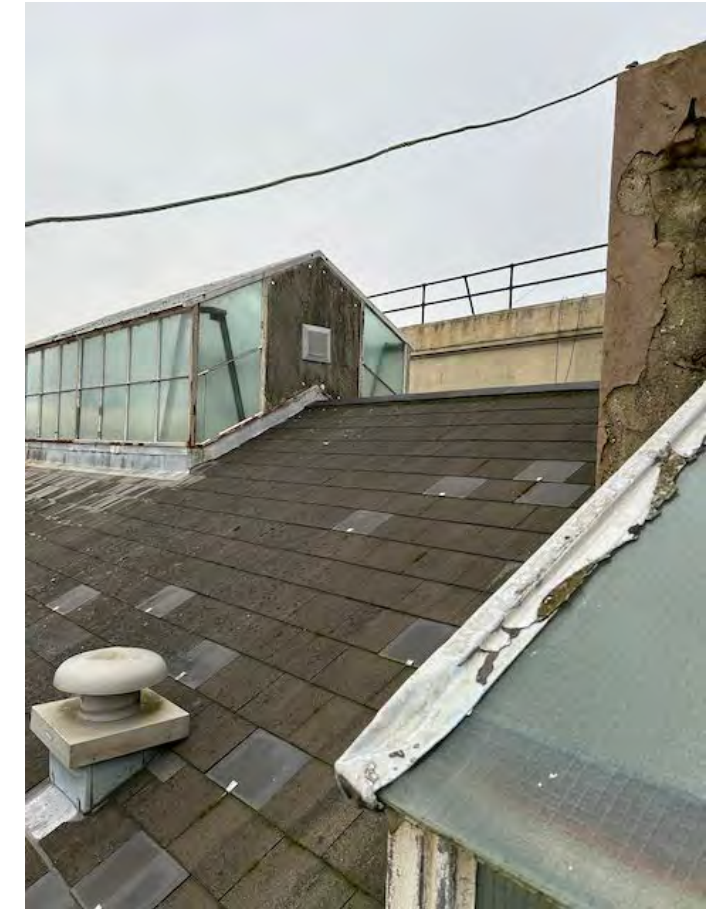
Lantern on the ridge

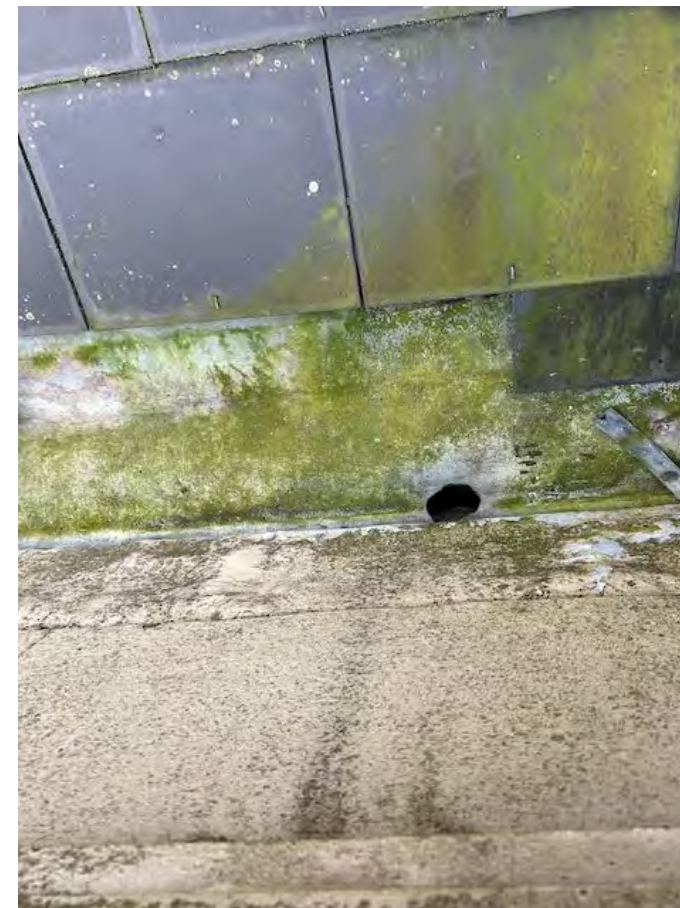
Hole in lead gutter. **Urgent** repair required

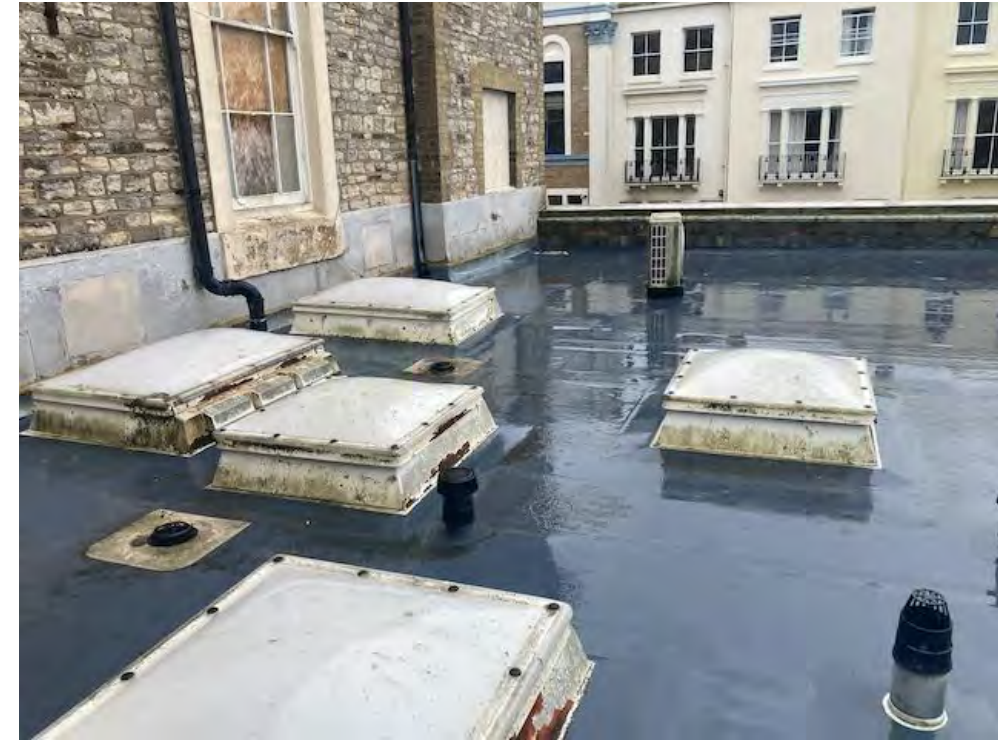
Flat roof over the western office accommodation

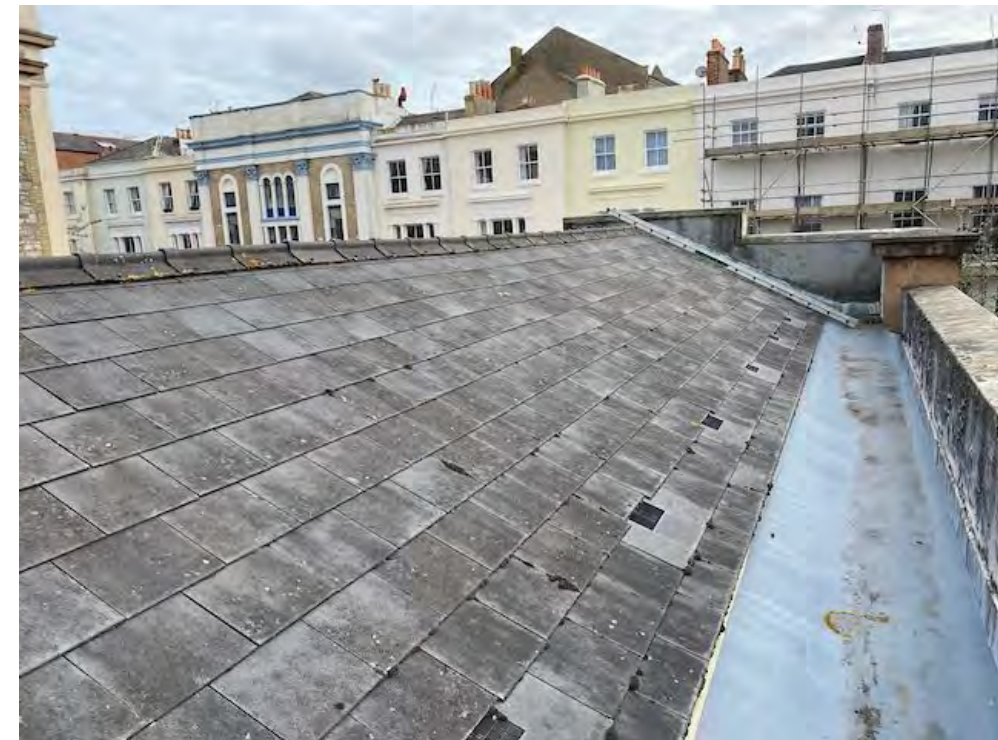
Pitched roof immediately west of the flat roof area

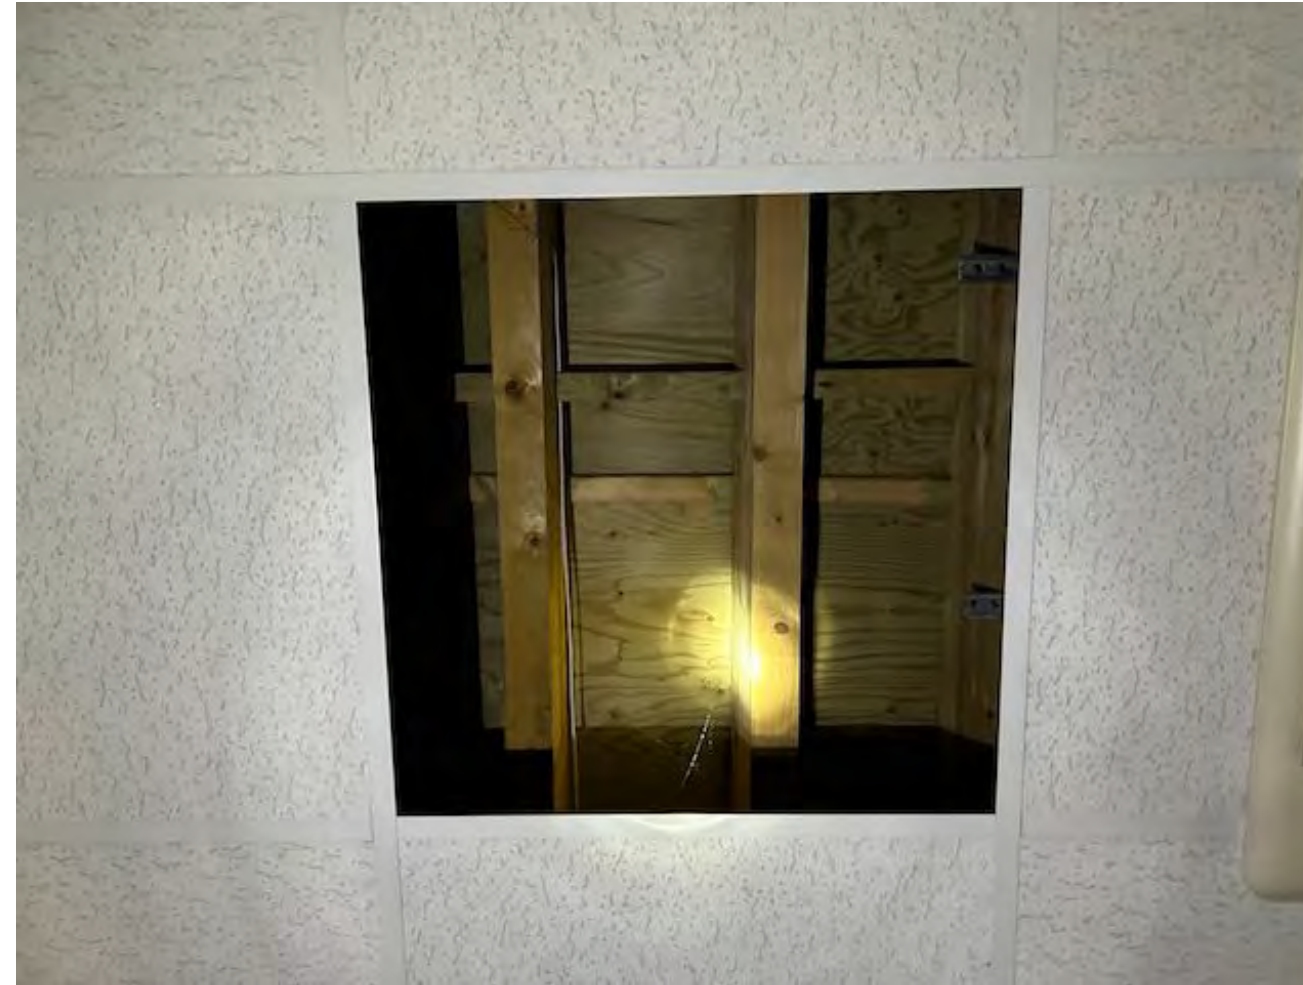
Modern roof construction beneath the West Range offices

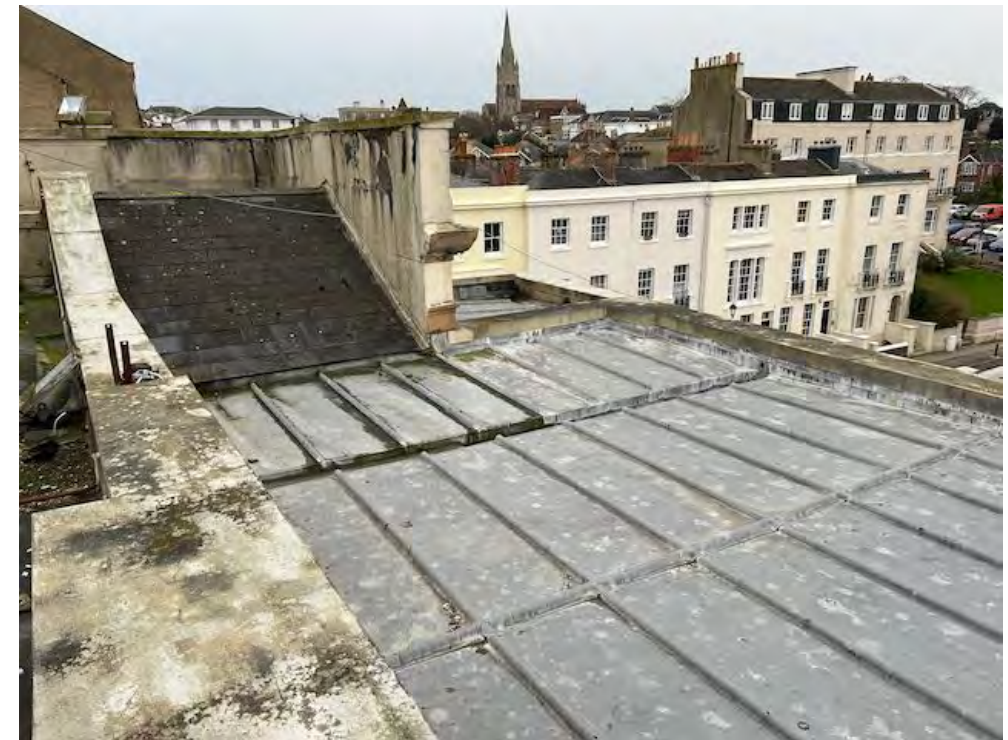
Lead roof above the Council Chamber

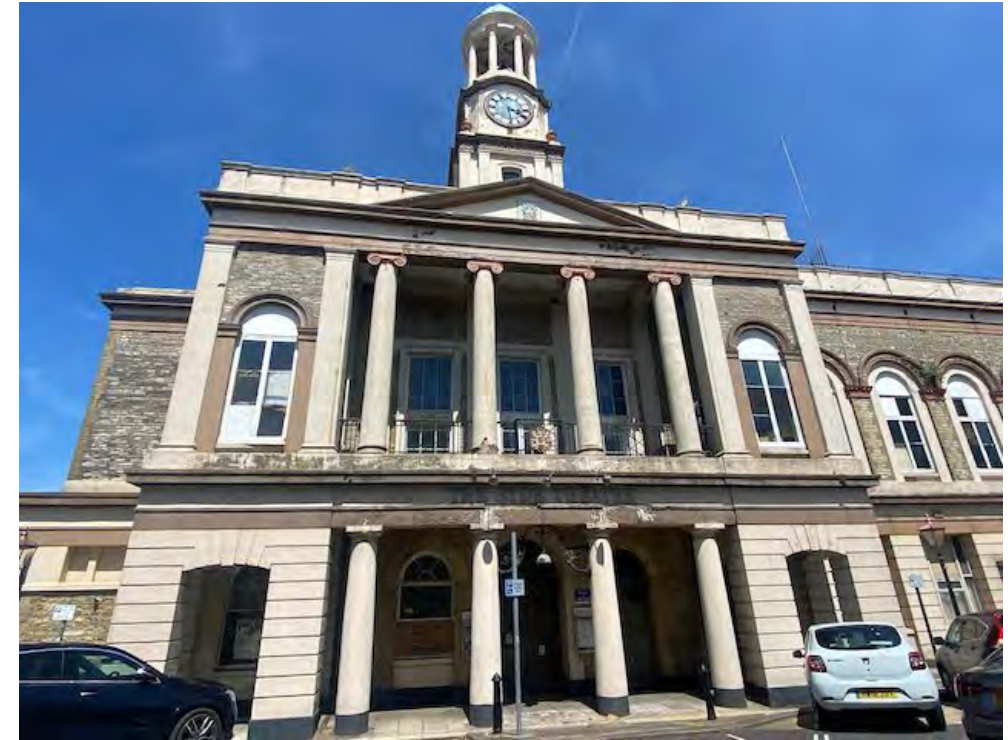
The portico which forms the main entrance of the town hall

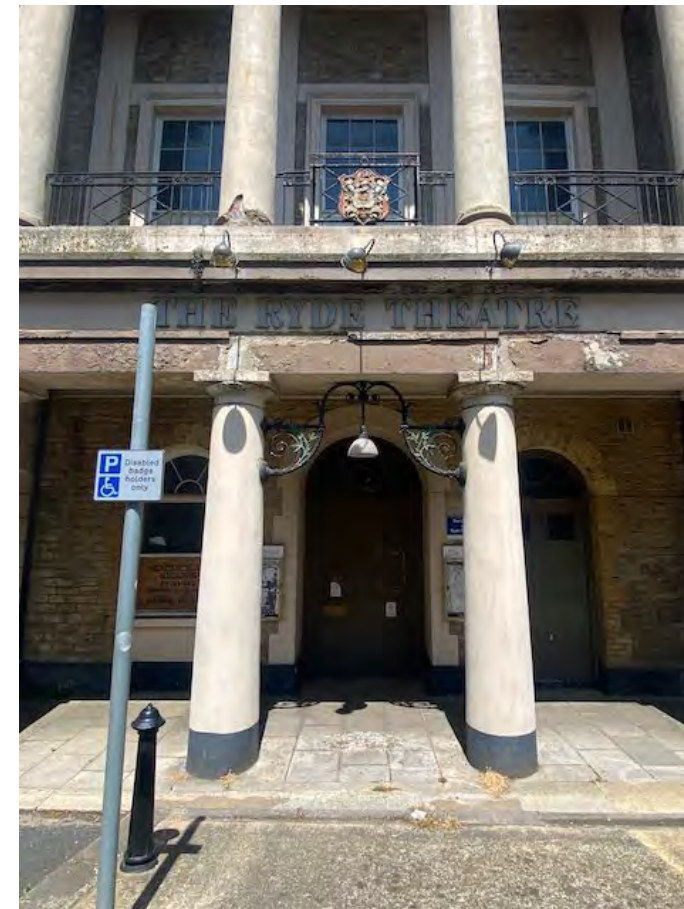
Stone lintel above the lower columns exhibiting blistered paint

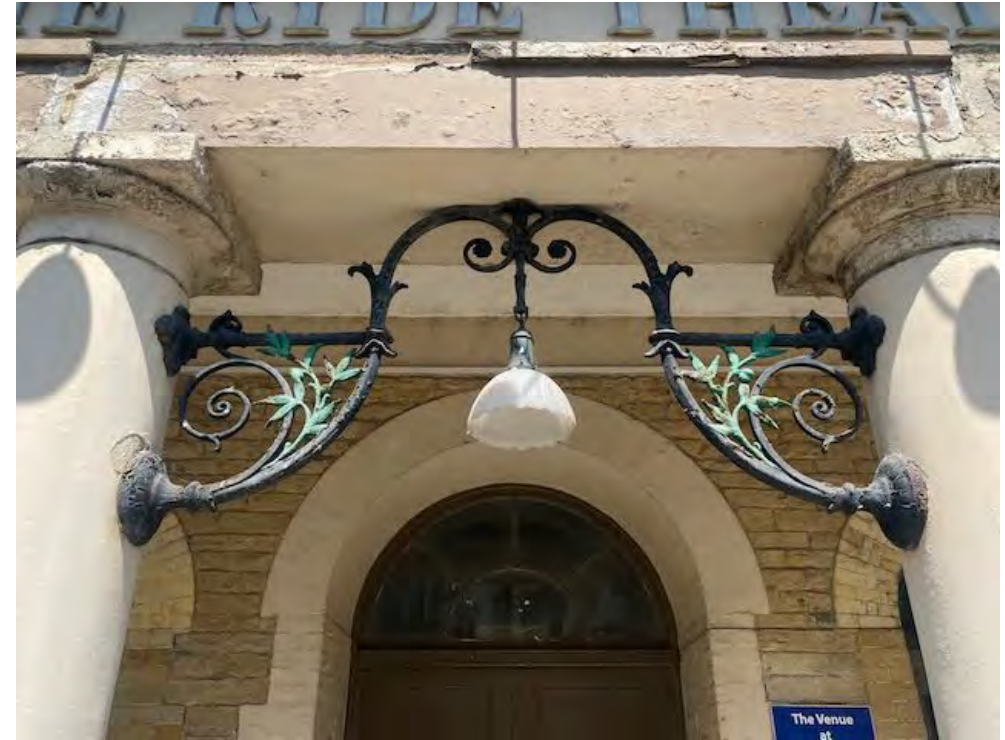
Decorative wrought iron light fitting

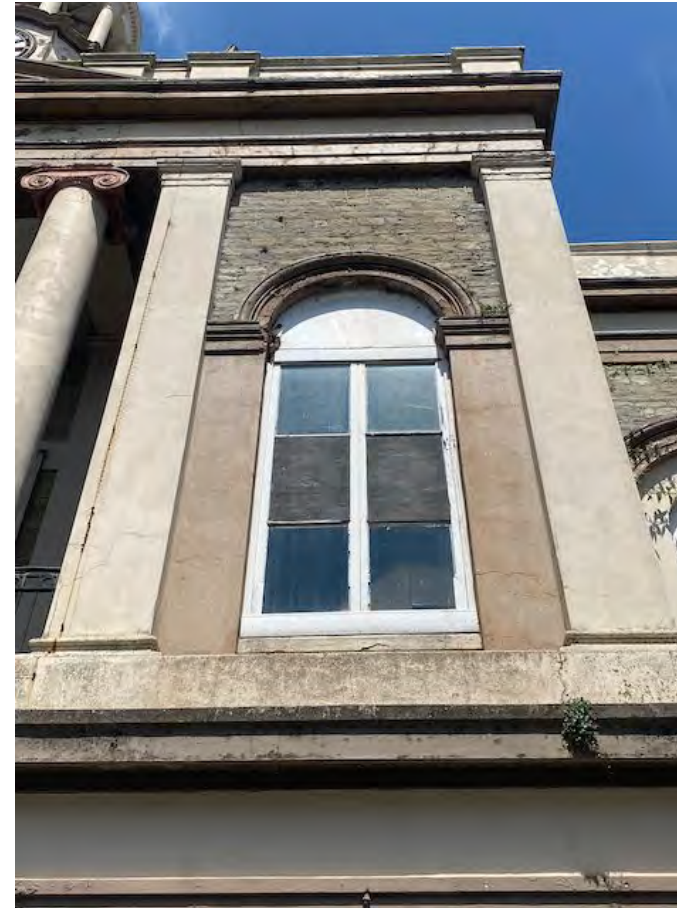
Horizontal cracks through the render of the eastern pilasters

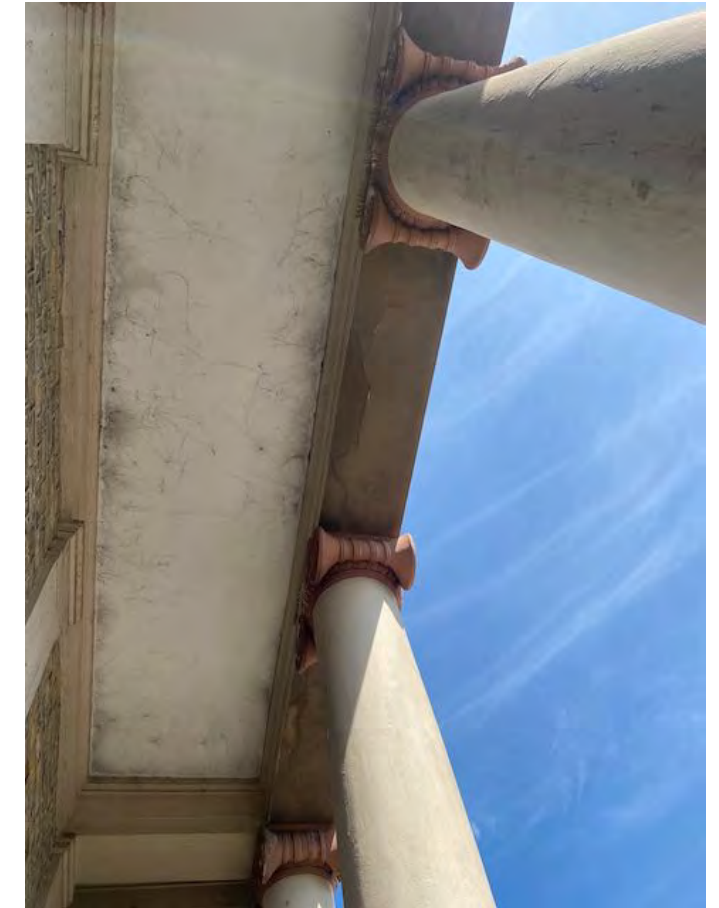
The column capitals with the painted volutes. Note cracking to underside. Corrosion to steelwork above

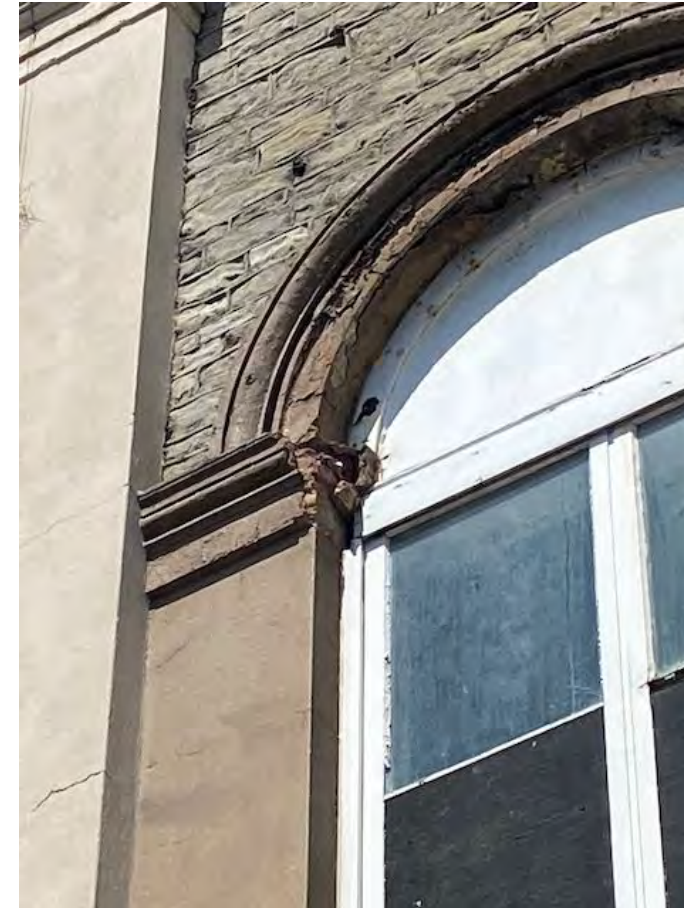
Significant decay to the run moulded cornice

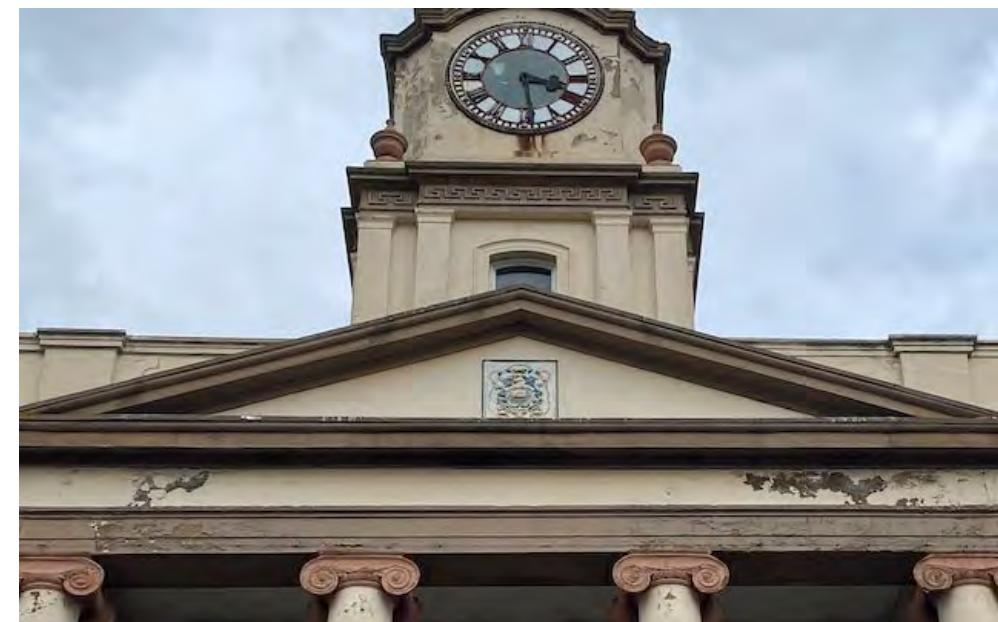
Rendered tympanum with the Ryde Borough Council crest

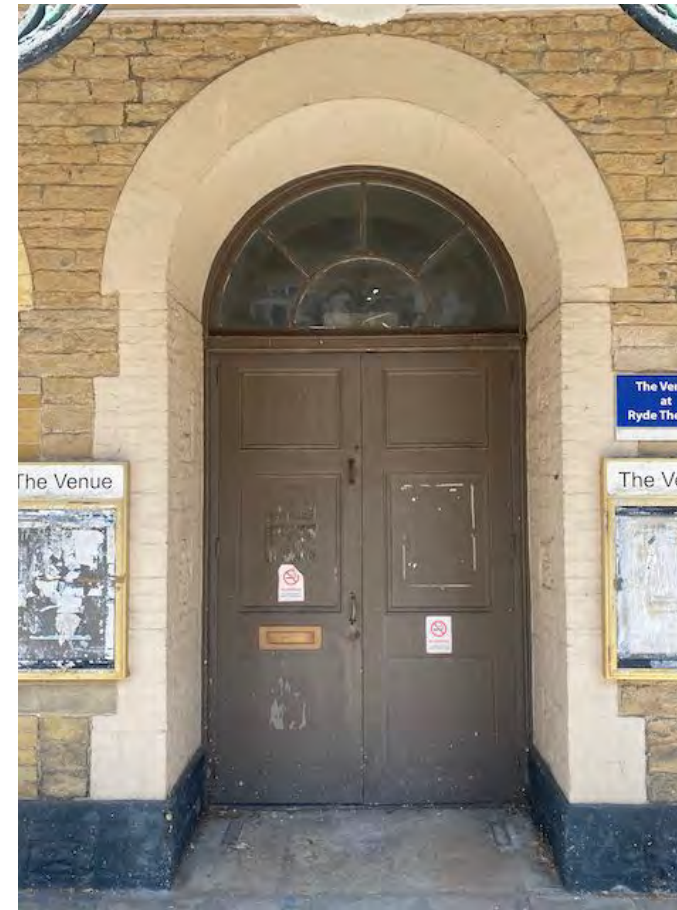
- C.2.68. A vent exists above the line of the door and this has been covered using an aluminium louvred cover. This also needs to be removed.
- C.2.69. There are sections where previous brackets, possibly designed to hold modern signs, also remain in the joints. We would recommend that these are removed.

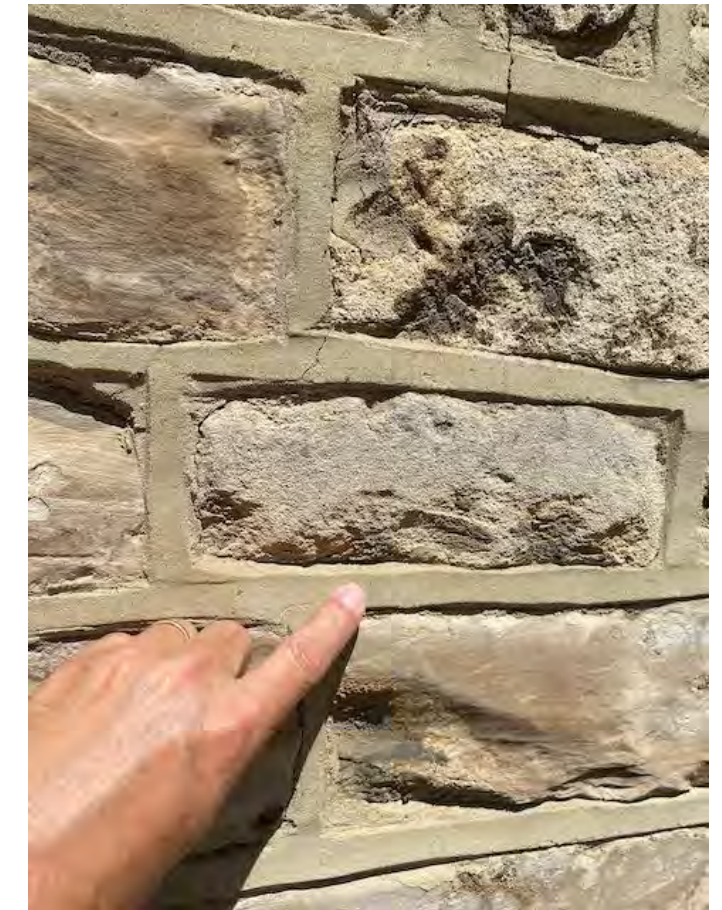
Cementitious Ribbon pointing

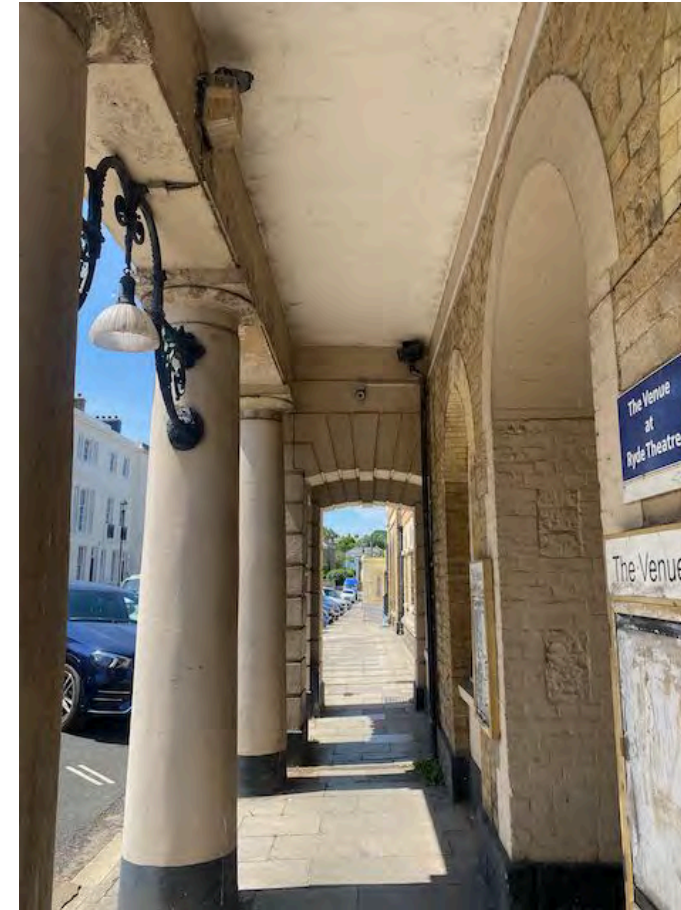
The underside of the balcony showing the display boards and the suspected asbestos soffit

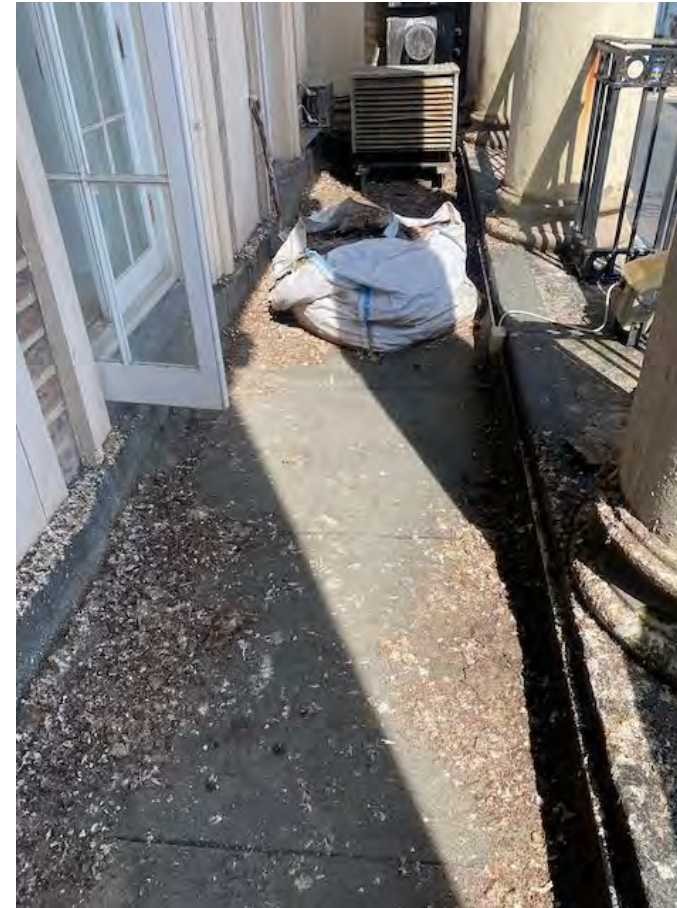
Note the pronounced bow in the line of the central panel
