Condition Report

Ryde Town Hall

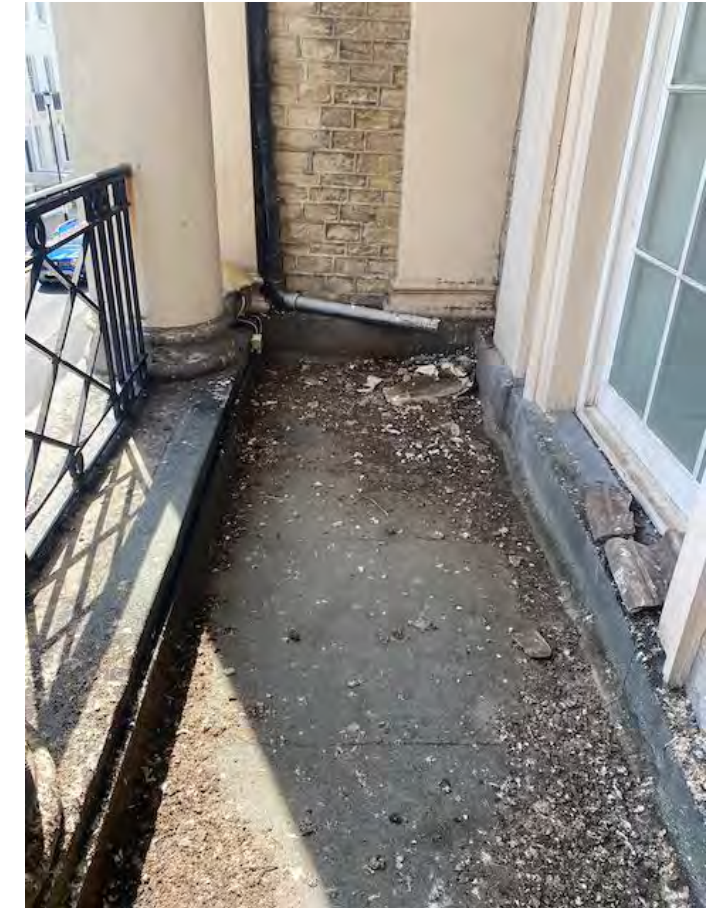
Balcony surface showing pigeon droppings

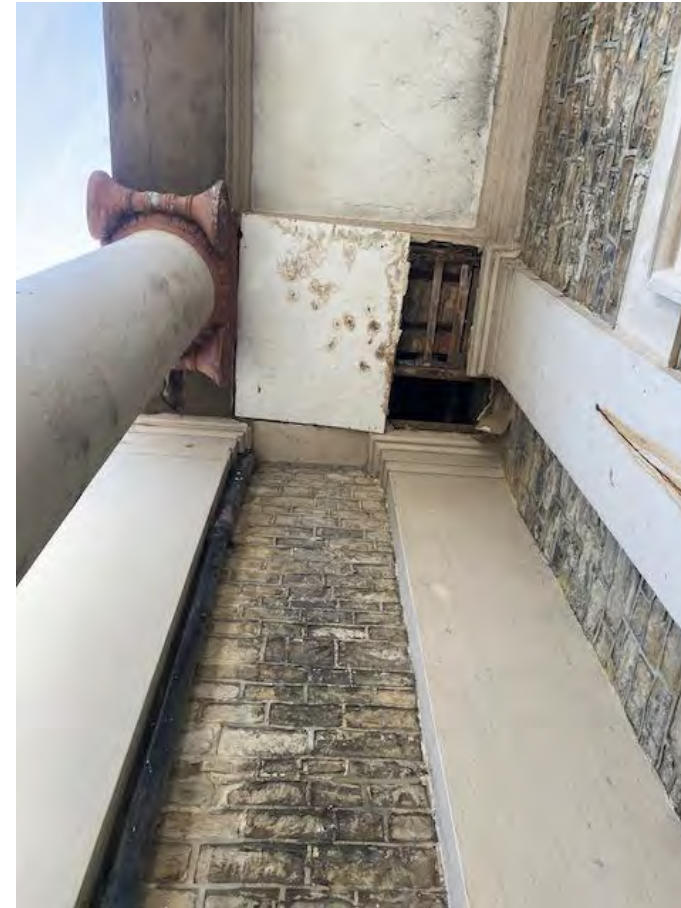
Section of failed ceiling exposing timber joists. Note wrought iron spanning between column and south elevation of building

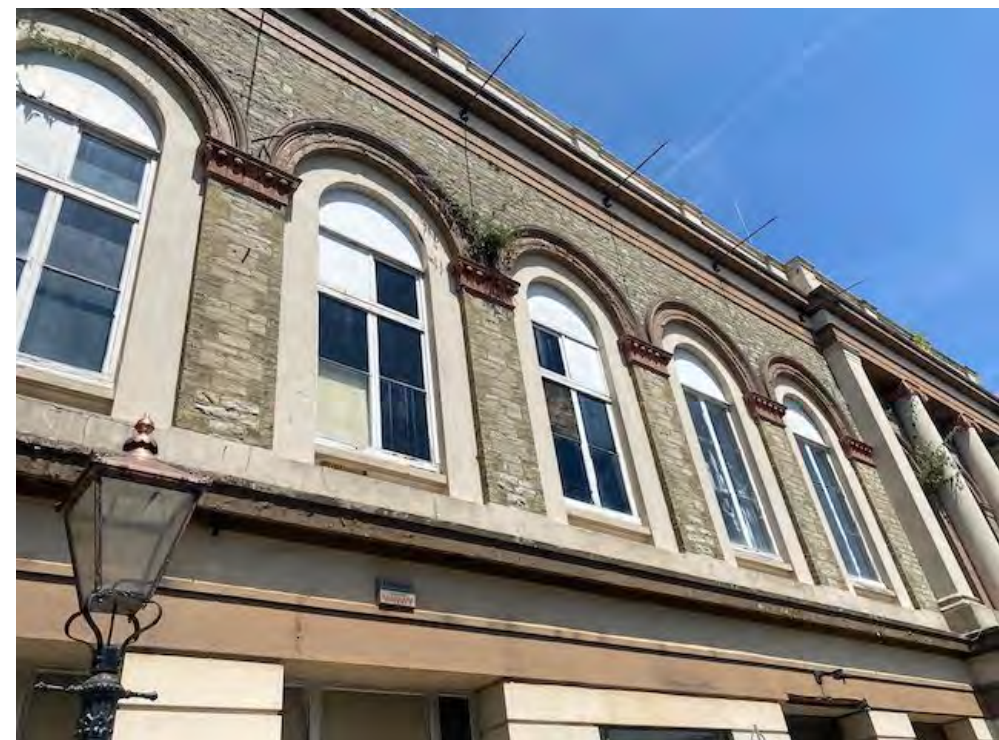
The first floor windows showing moulded acanthus leaf capitals

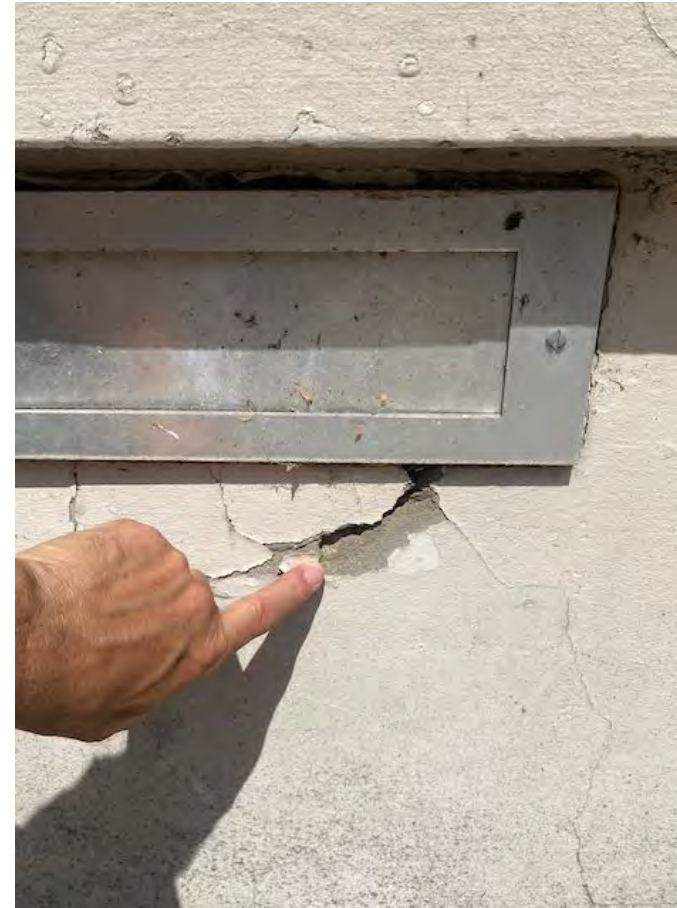
Impact damage around letter box

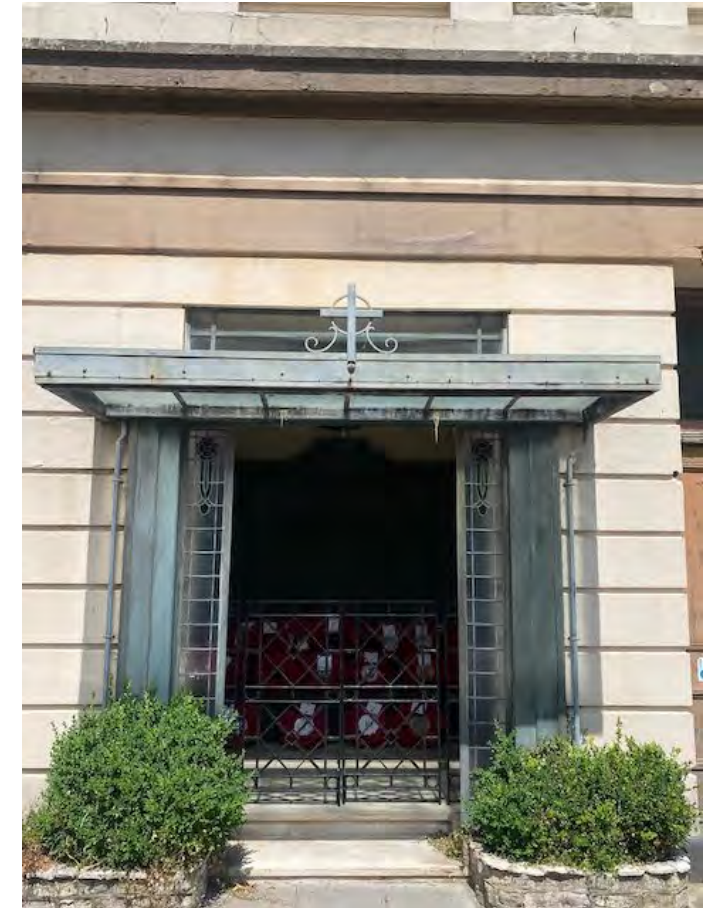
Vertical cracks in render above the war memorial.

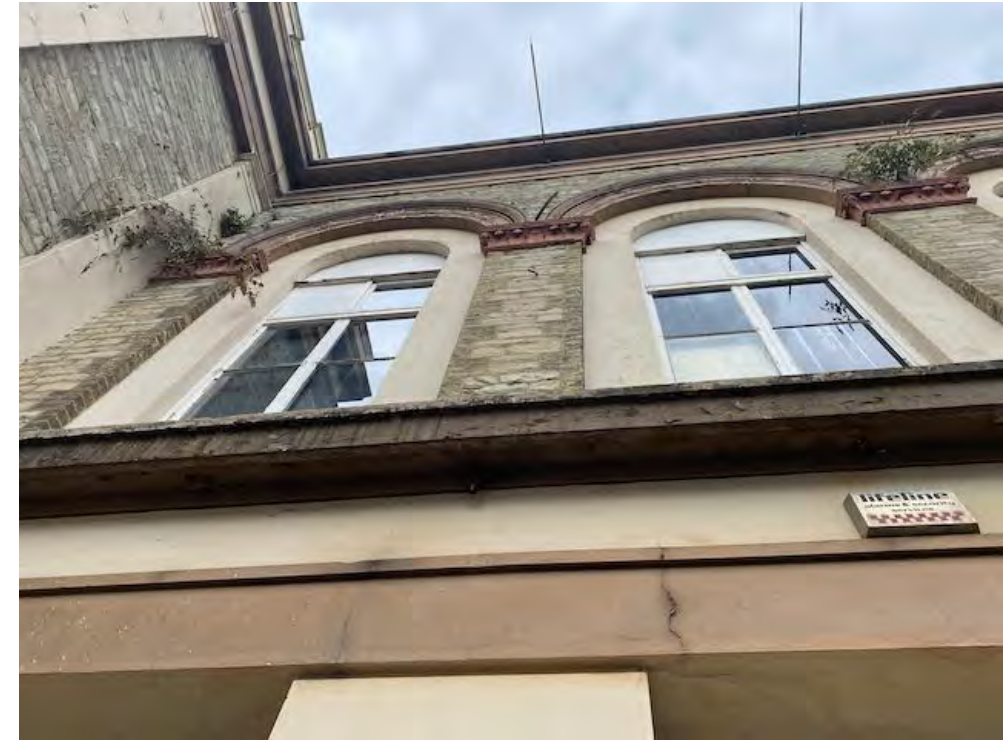
First floor windows with semicircular arched windows

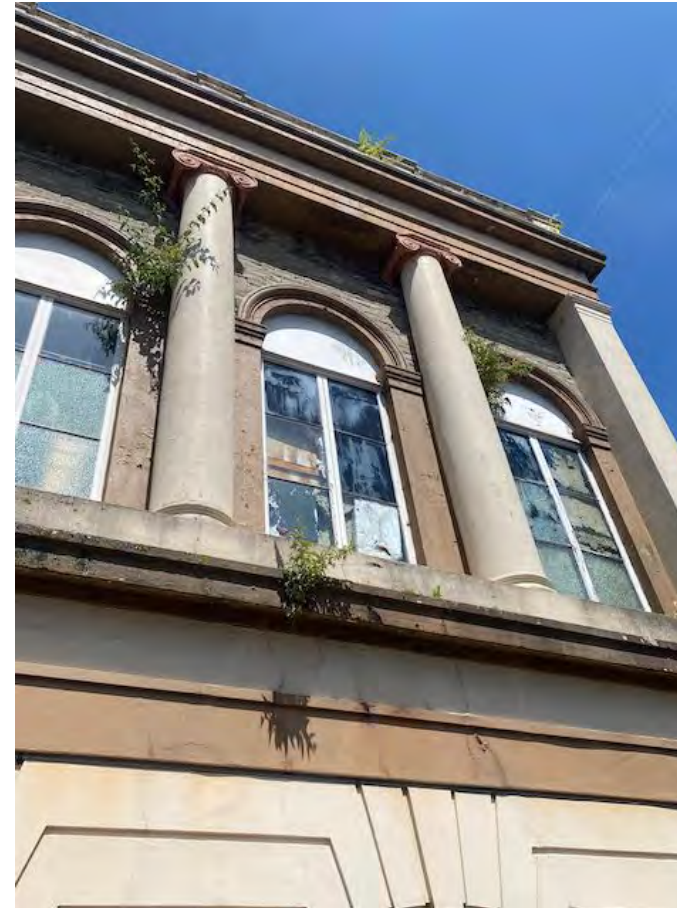
Areas of established Buddleia on the eastern pavilion

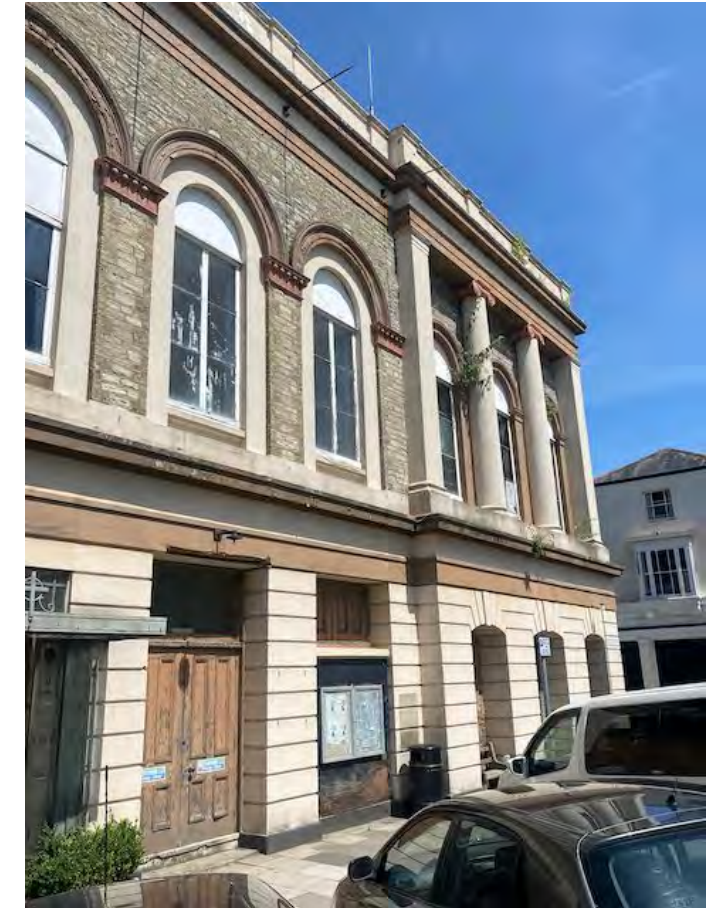
The Eastern Pavilion

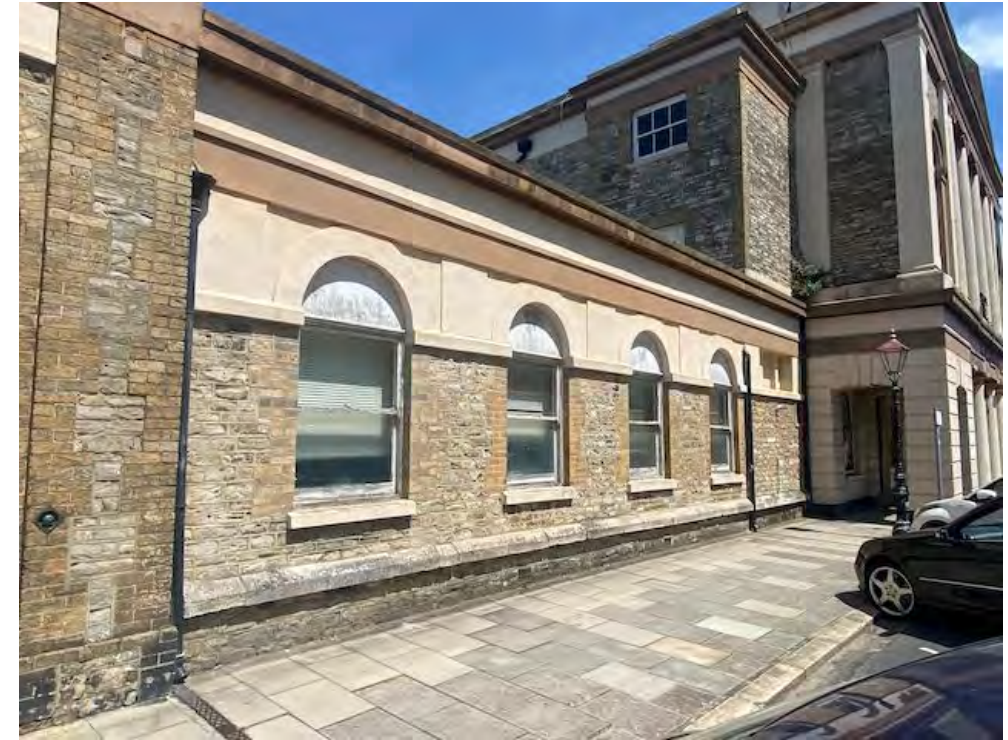
- C.2.147. All the joints between the stones require re-pointing. This should be carried out using a fine lime mix.
- C.2.148. Some of the stones show some deterioration to the face, however this is more of a characteristic of the stone and they can remain. No work is needed.

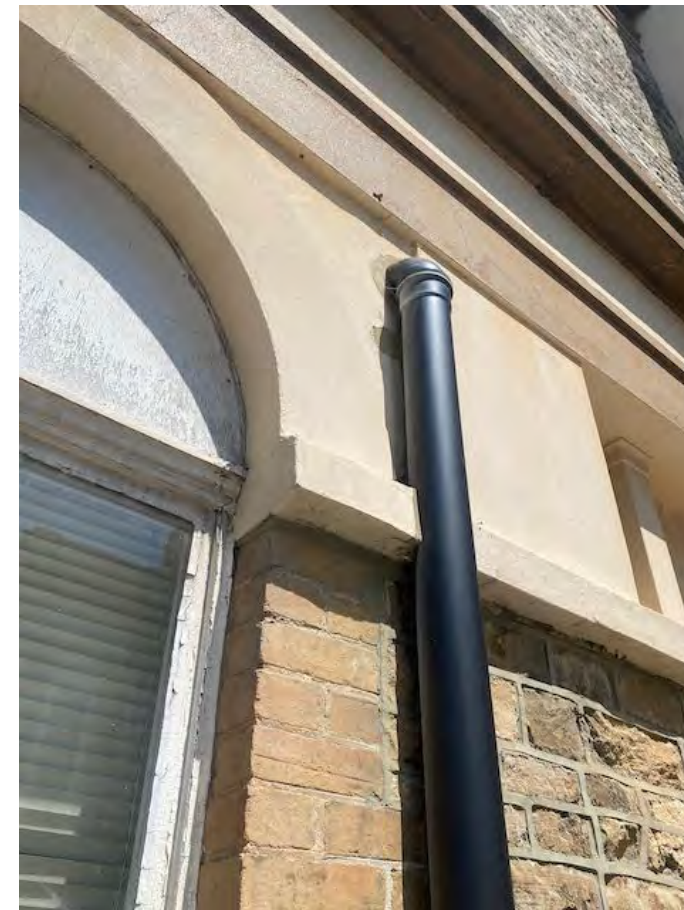
Plastic rainwater pipe penetrating the wall.

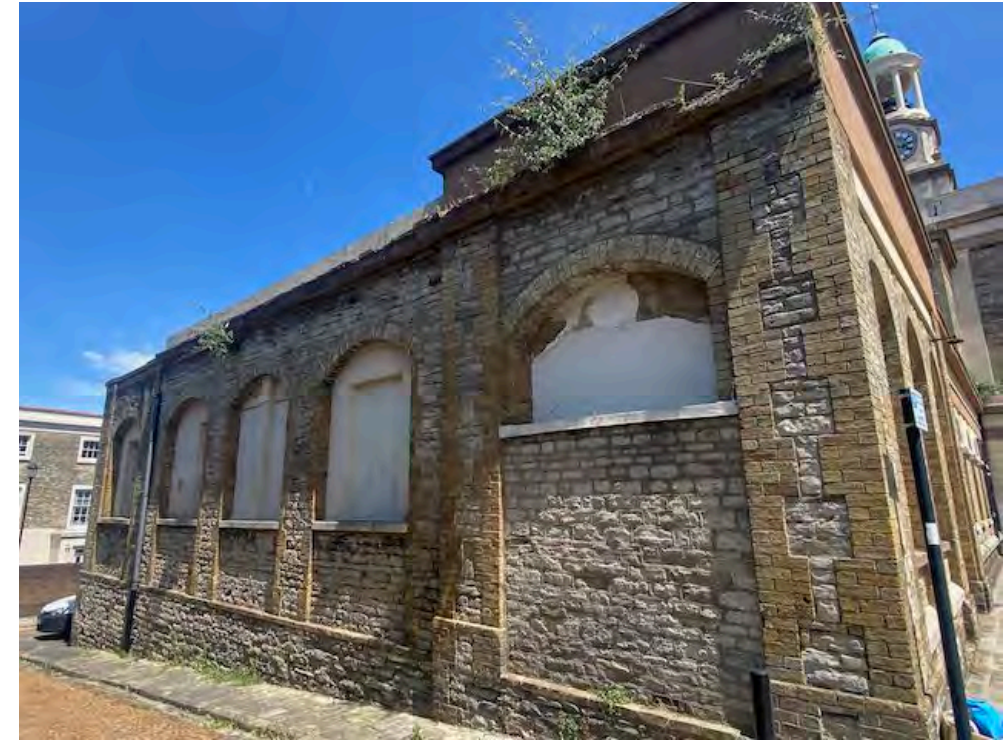
- C.2.160. There is a cream coloured brick quoin which marks the corner between the south and west elevations. This is all in a very good condition.

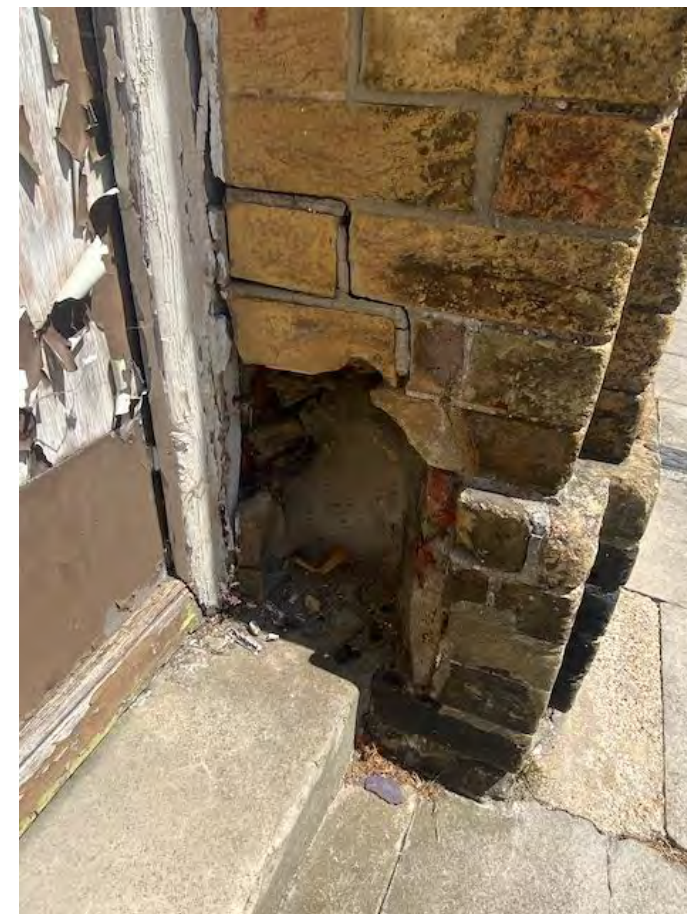
Area of damage next to door on the western pavilion

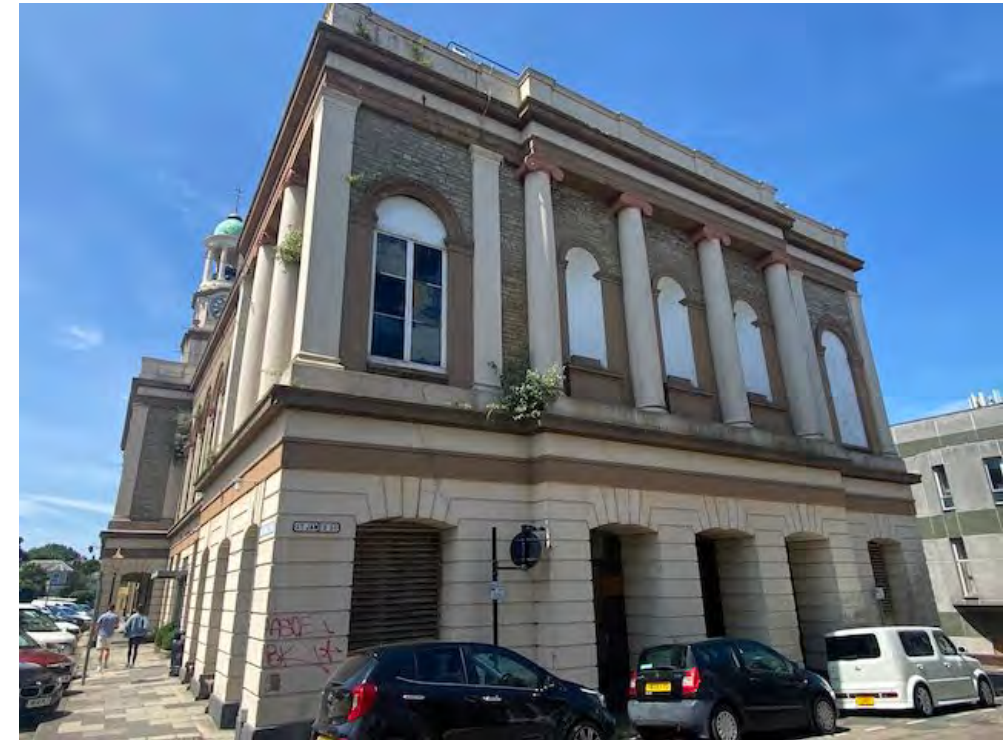
Eastern elevation showing the partially open arcade at ground level

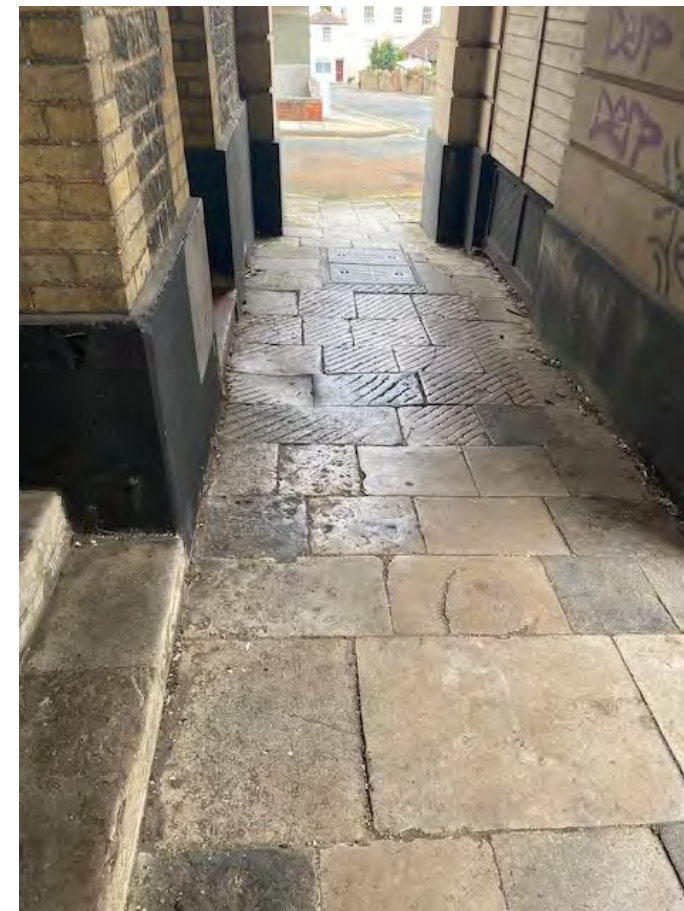
Purbeck stone slabs thought to be original

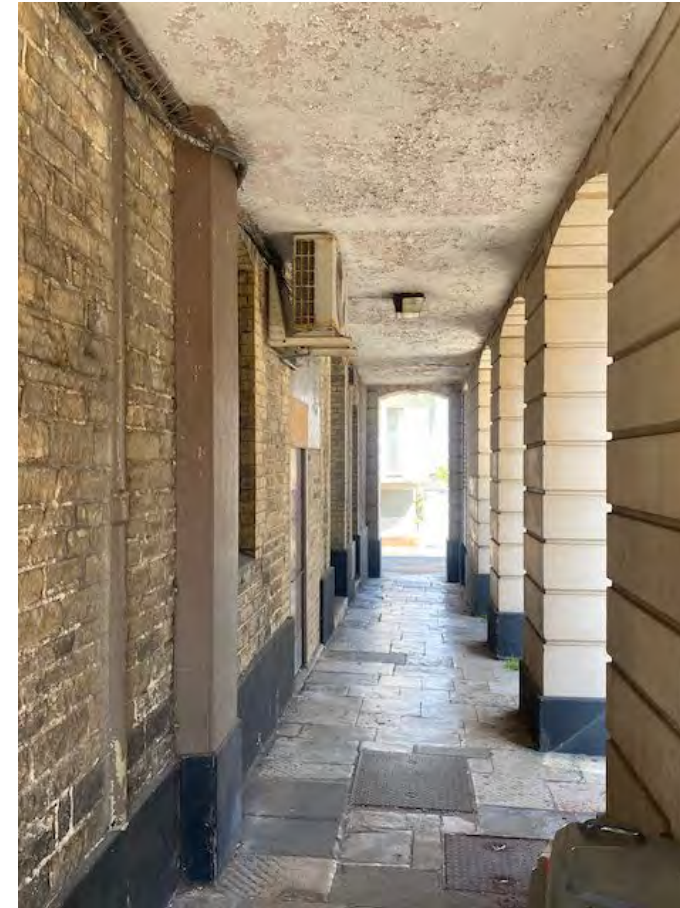
Inner wall of the eastern arcade

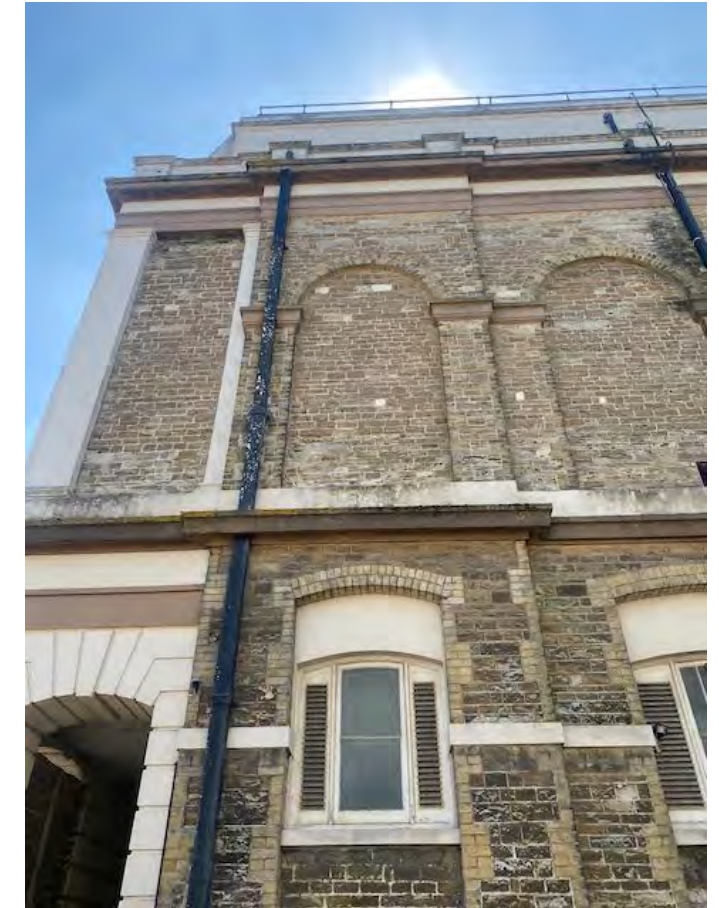
East end of the North elevation showing the string course Rainwater pipes from flat roof above.

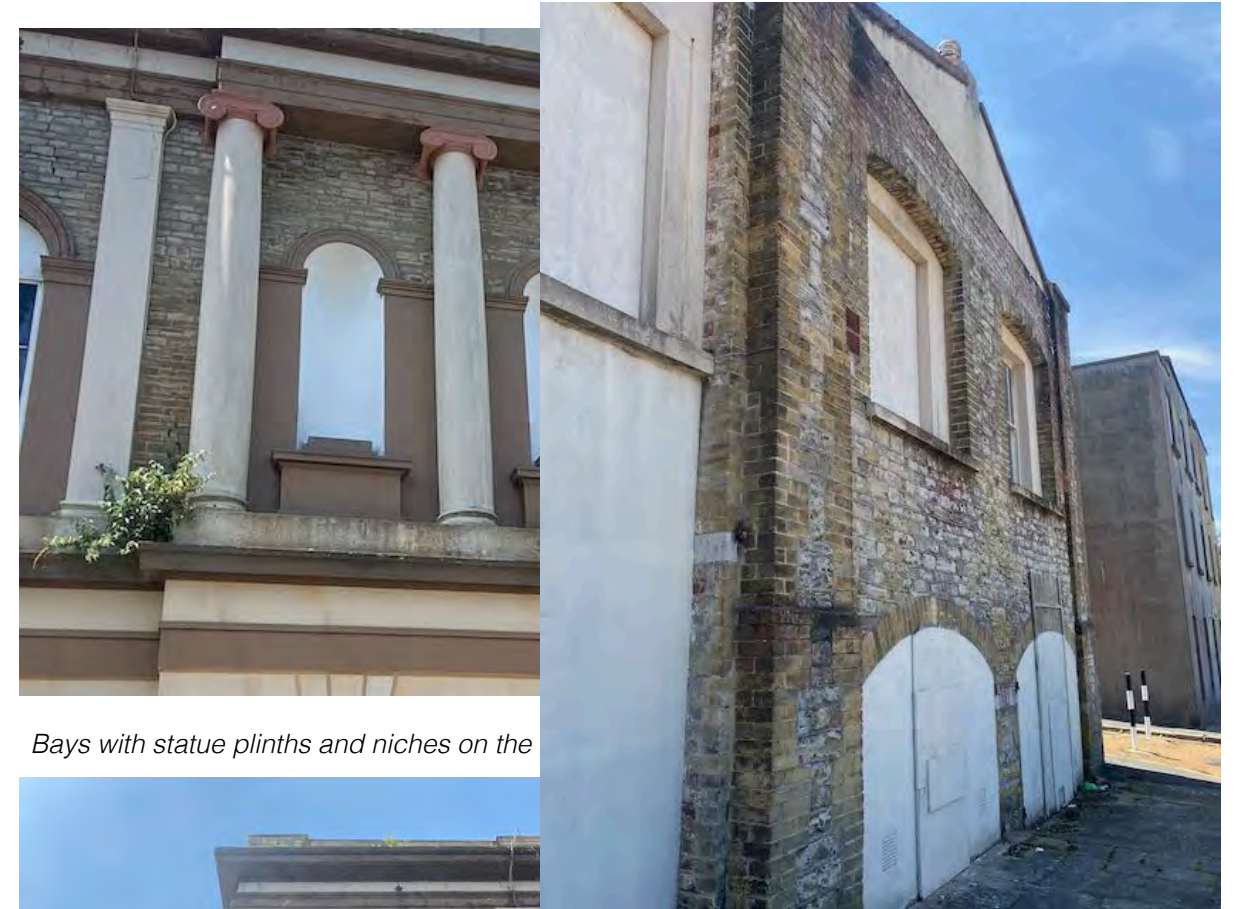
Bays with statue plinths and niches on the

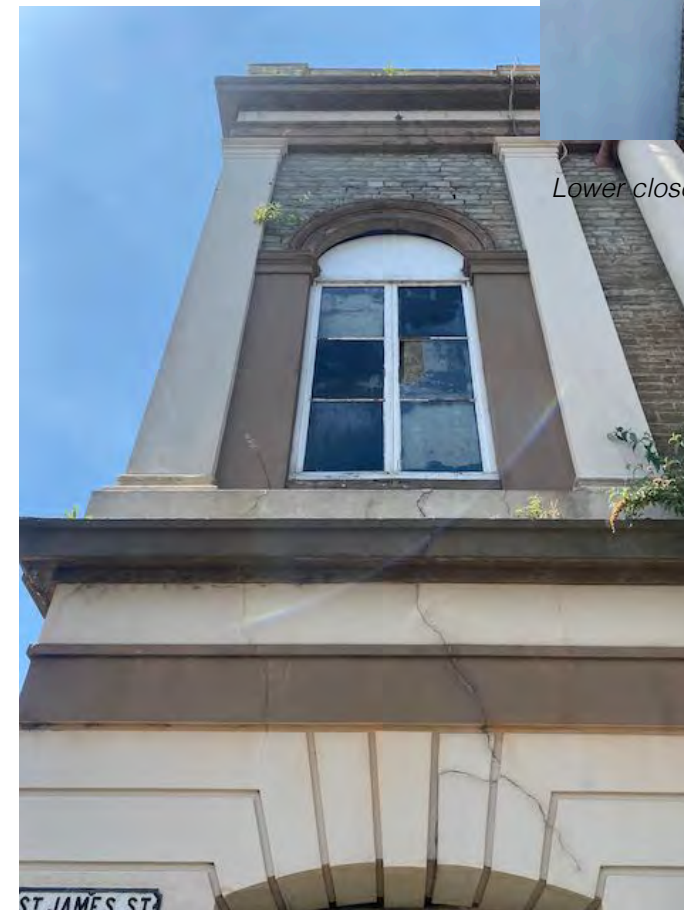
Lower closed openings

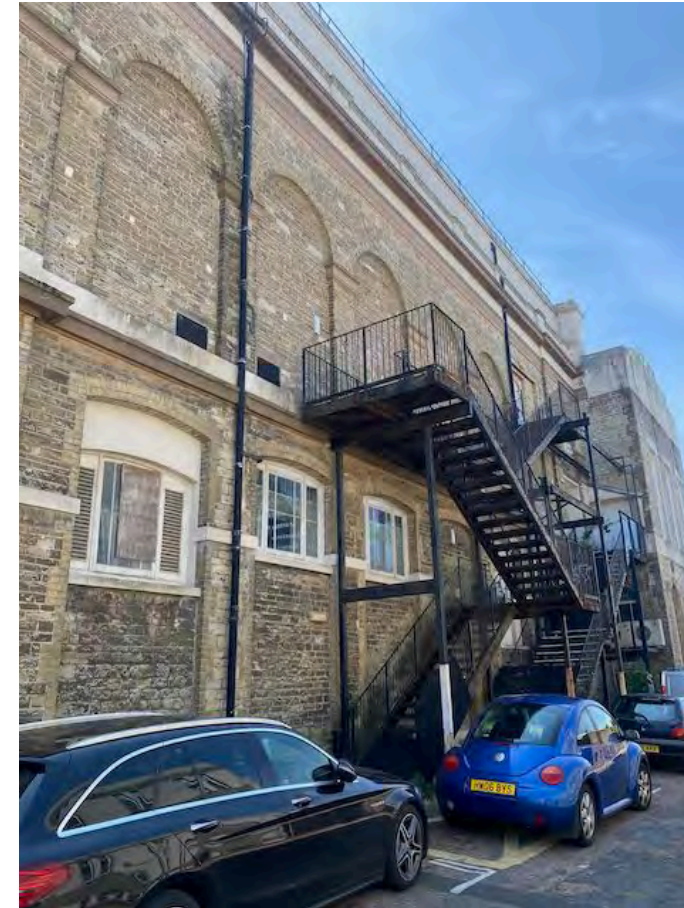
- C.2.216. The wall in this location is generally in a good condition where it is more sheltered from the prevailing wind and rain. The surface has become scarred in the past with the introduction of new services for electrics and coolers for heat recovery and chiller units, although it would potentially be possible for these to be improved in appearance.

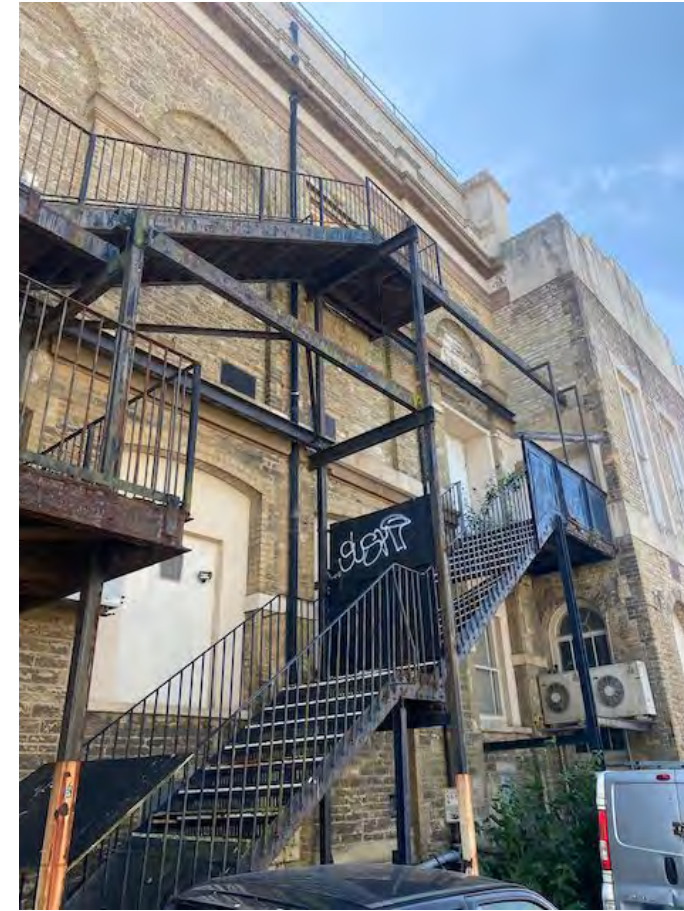
Fire escape on the north elevation. Urgent works required.

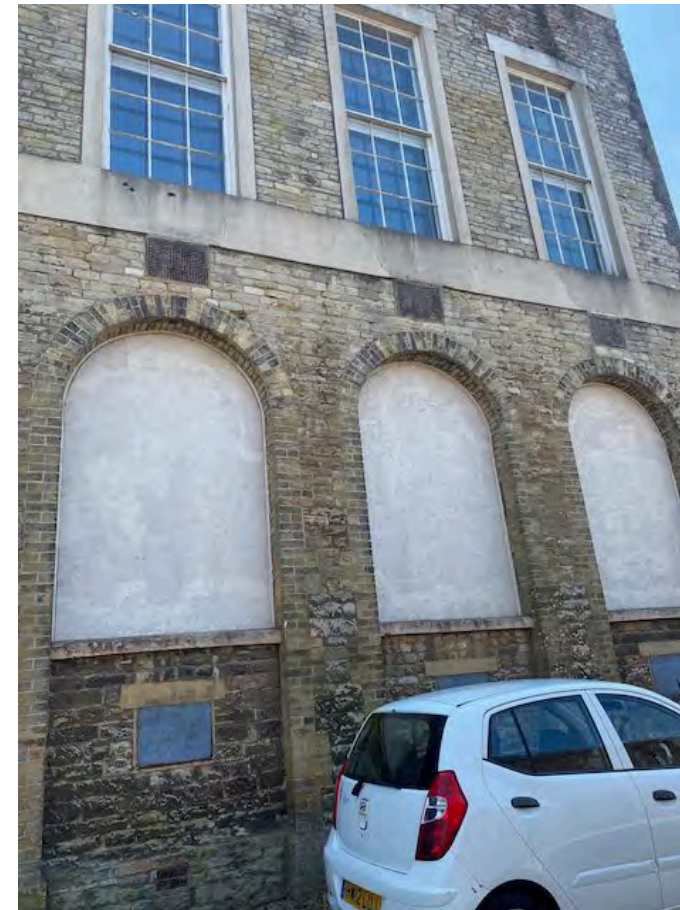
The projecting bay showing the three large openings

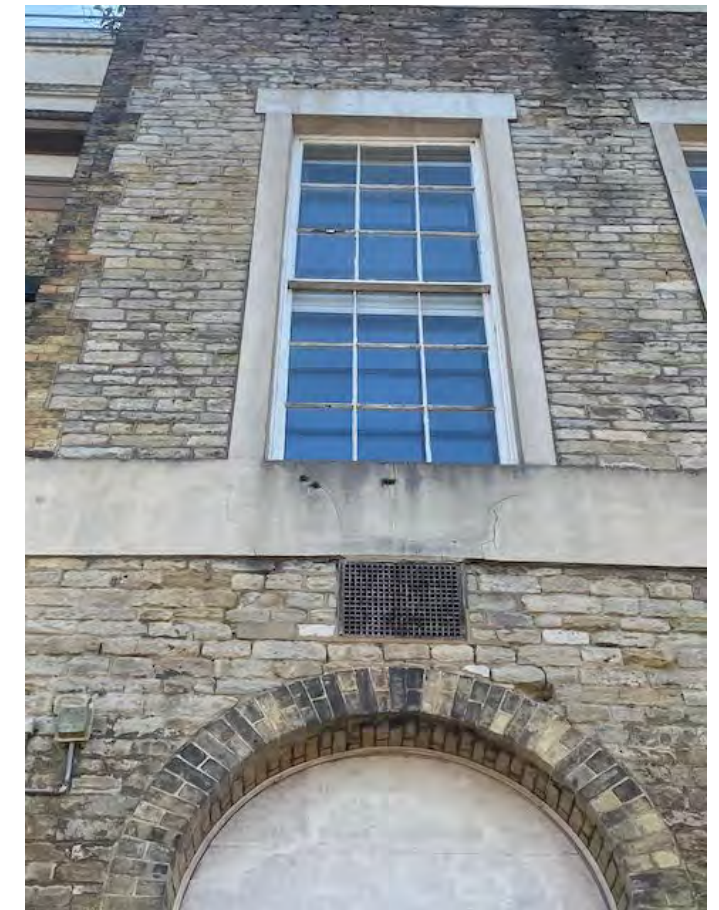
The rendered string course and one of the metal vents

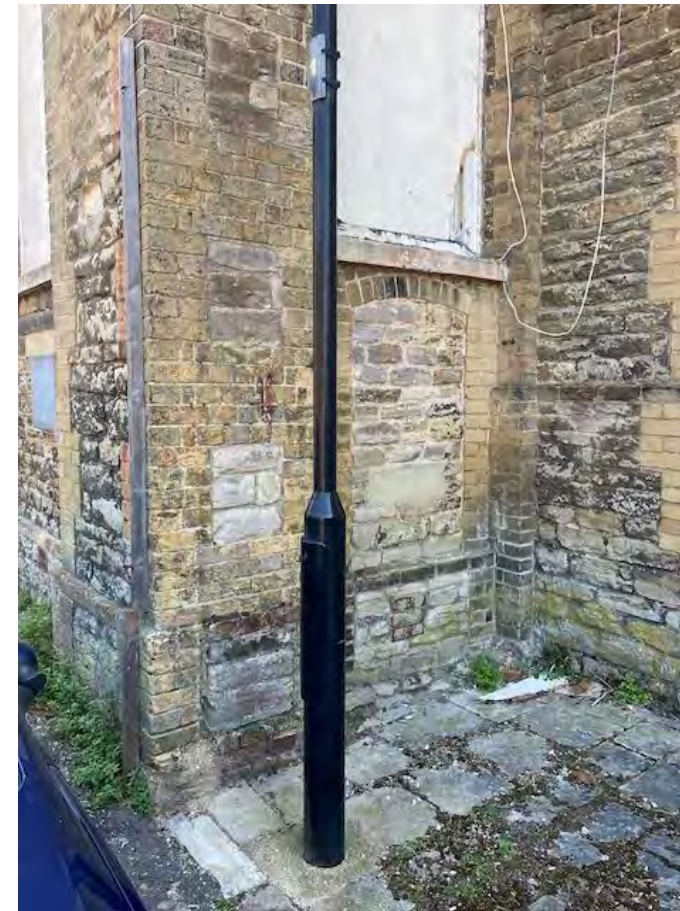
Blocked up former doorway

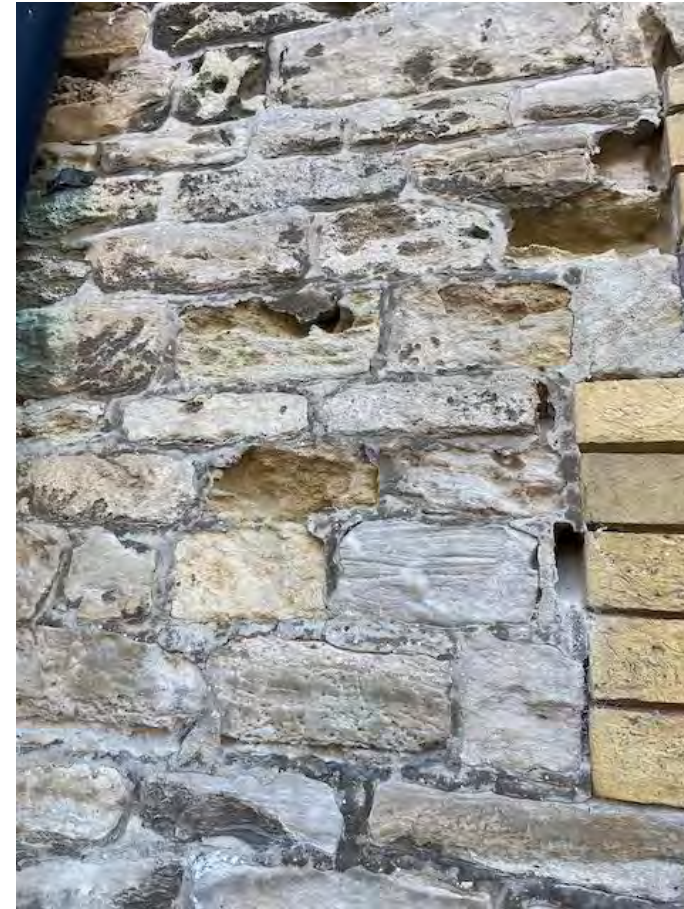
Badly eroded stone as a result of masonry bee attack

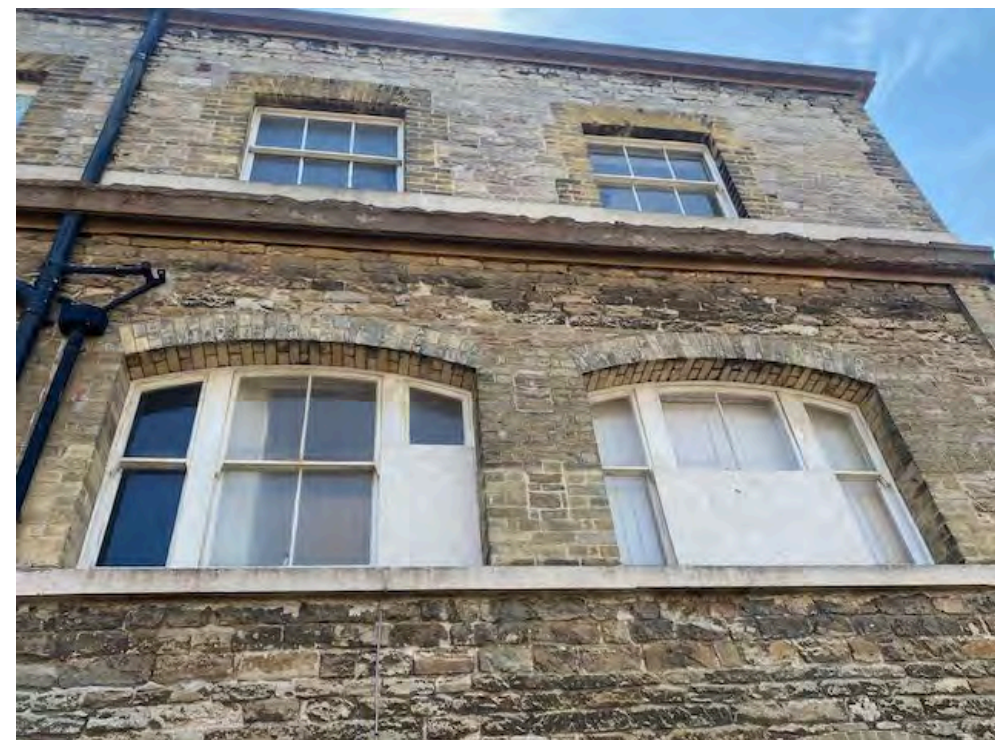
Damaged string course. Note change of masonry 3 courses below rendered string course. Lower sections original, with extension above.

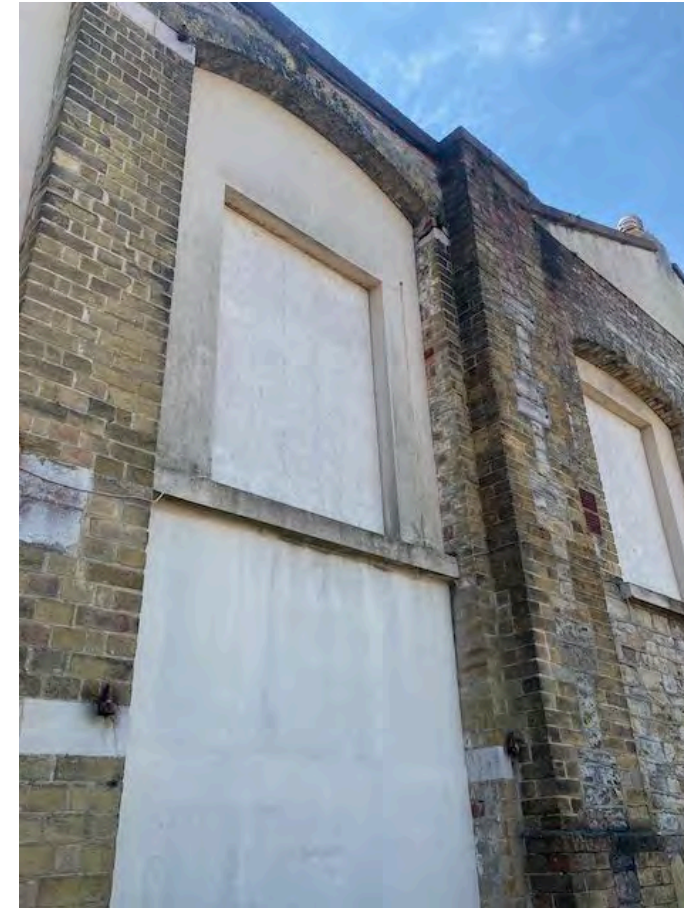
Closed openings with iron pintels

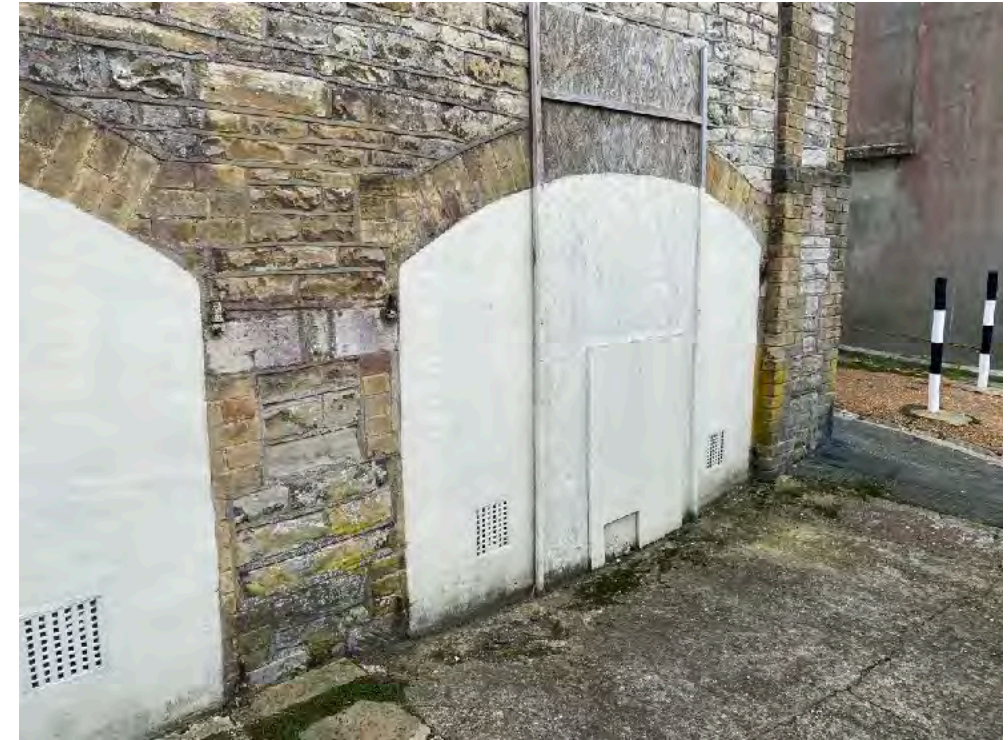
Rendered panels that may have previously contained doors to an undercroft.

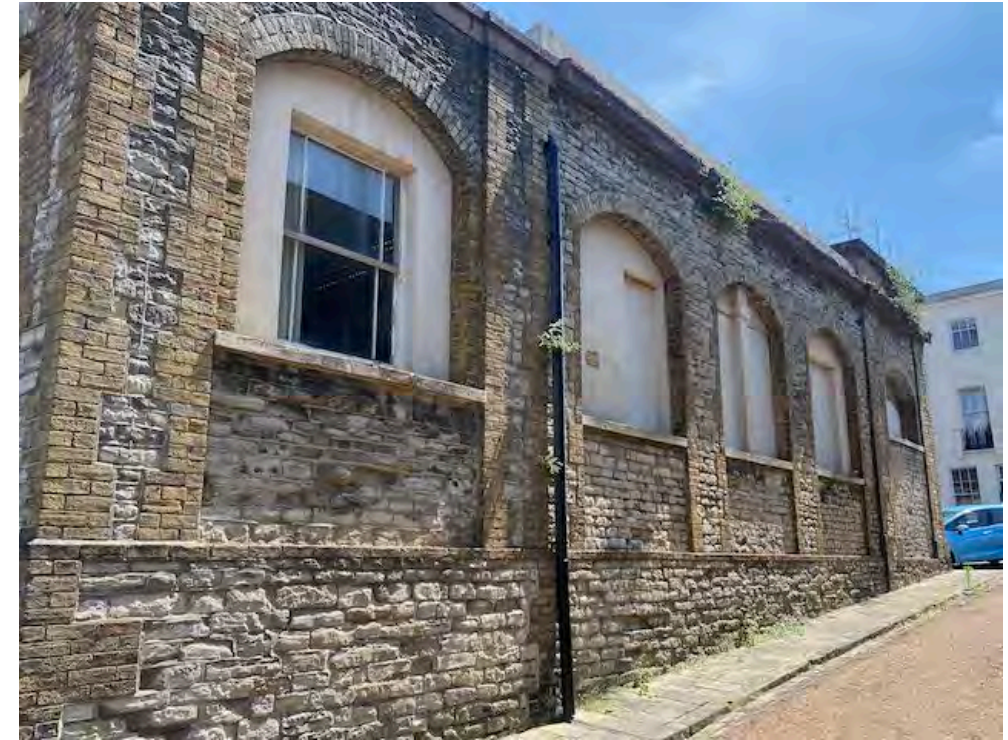
- C.2.287. The render above the flat roof is cracked and in a poor condition. It is expected that this was added to provide a 'barrier' against damp, although in all probability it may be making matters worse. We would recommend that this is removed, albeit that the stone behind may have been damaged at the time the cement was applied. This will need further review once removed. In the short term it can remain.

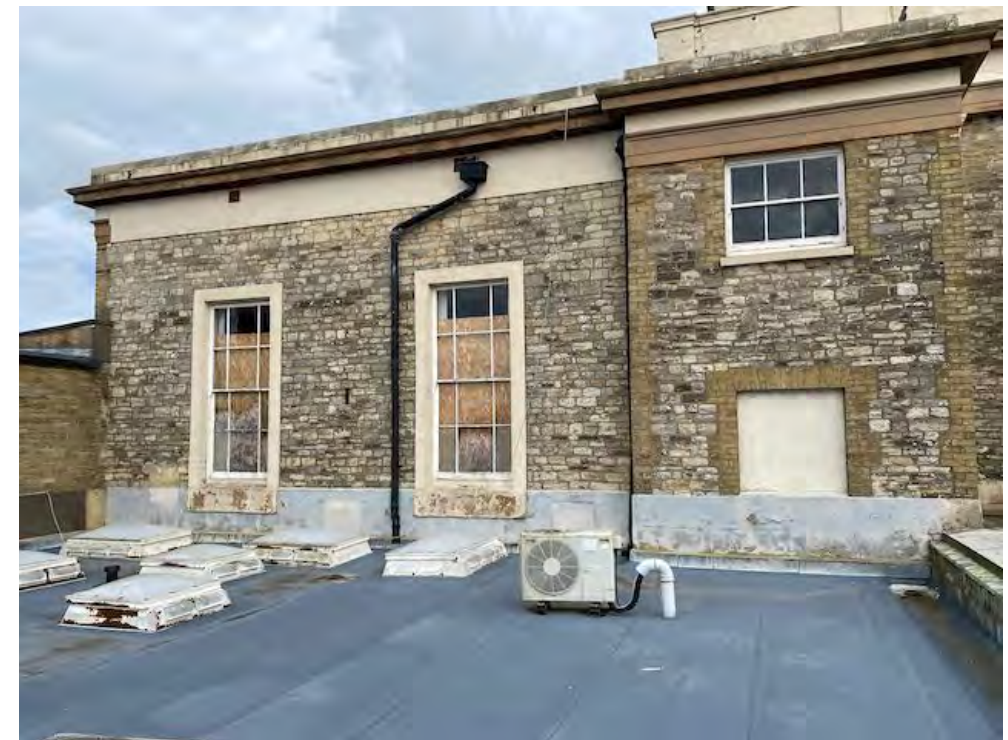
Walls of the west facing elevation of the Council Chamber

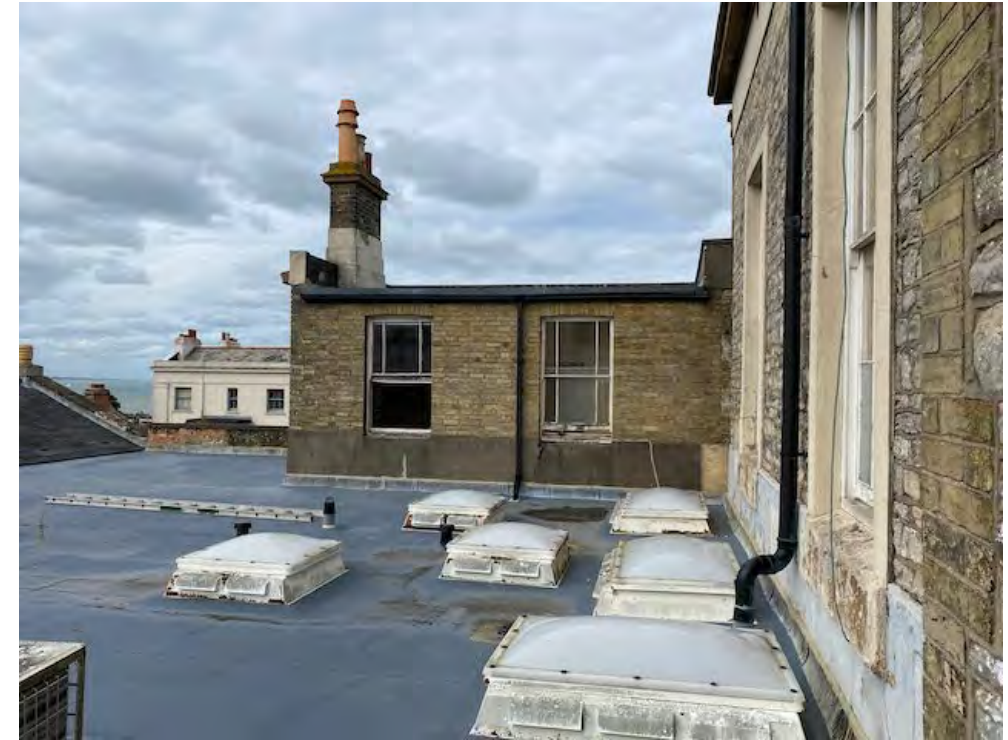
Flat roof generally in a good condition, with serviceable rooflights.

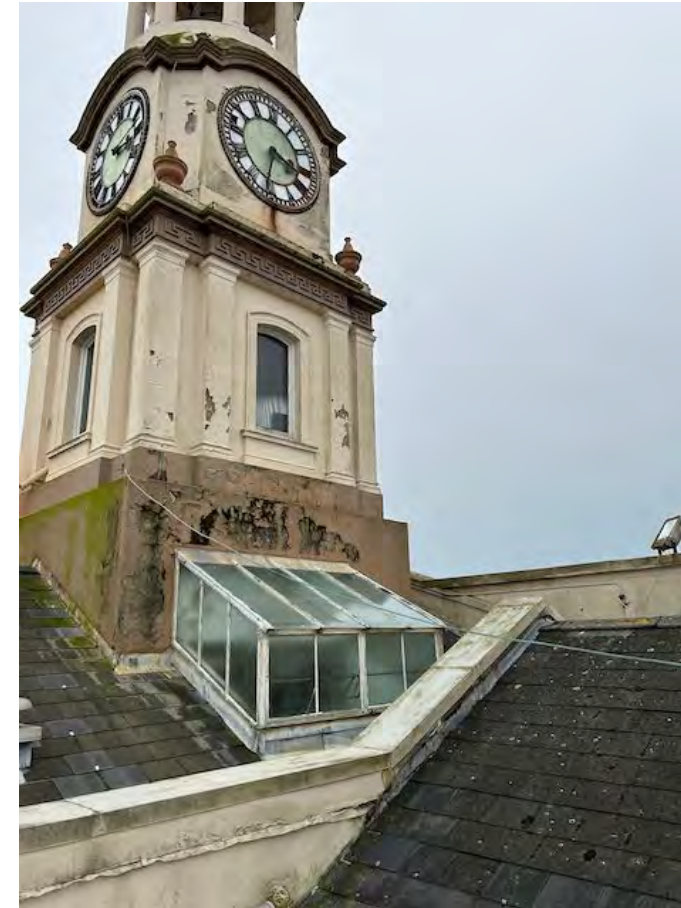
The Clocktower from the North west. Extensive cement repairs

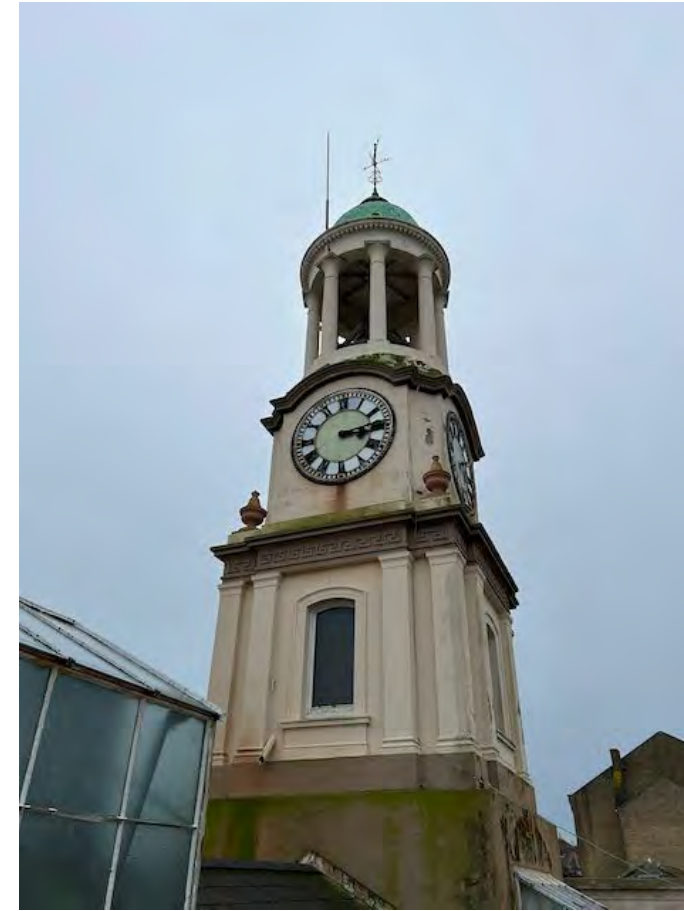
The clocktower from the North

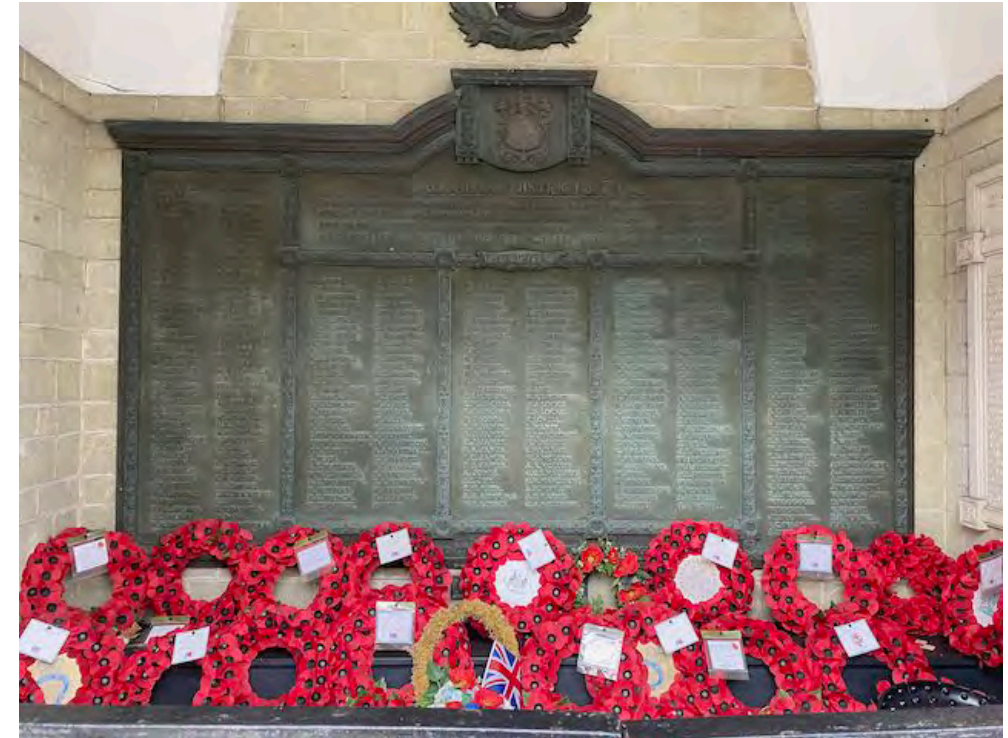
The inside of the war memorial
