Condition Report

Ryde Town Hall

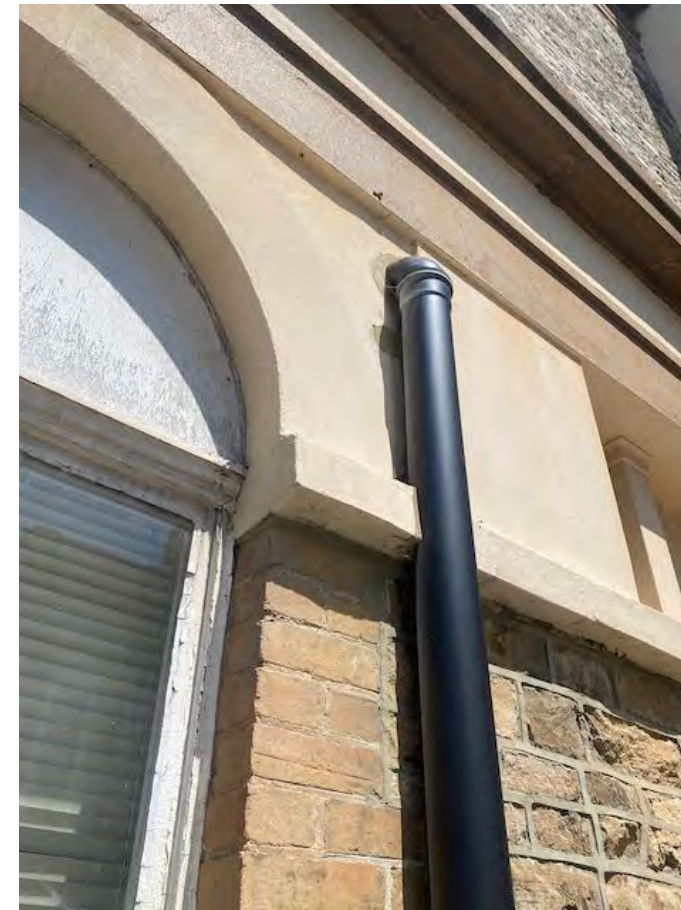
Rainwater pipe serving flat roof to west of main hall.

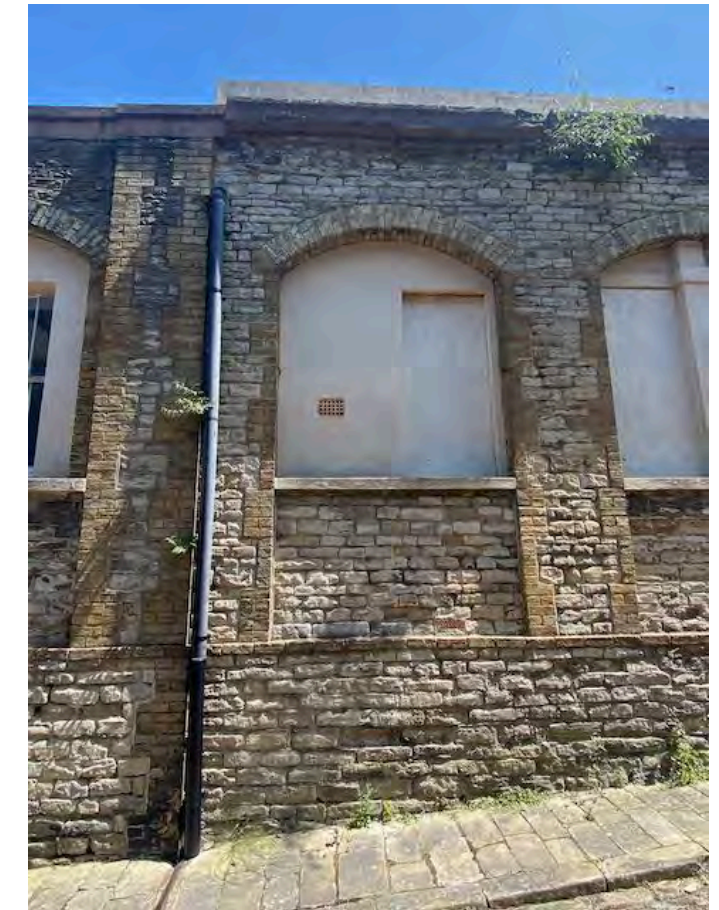
Single downpipe on the western elevation

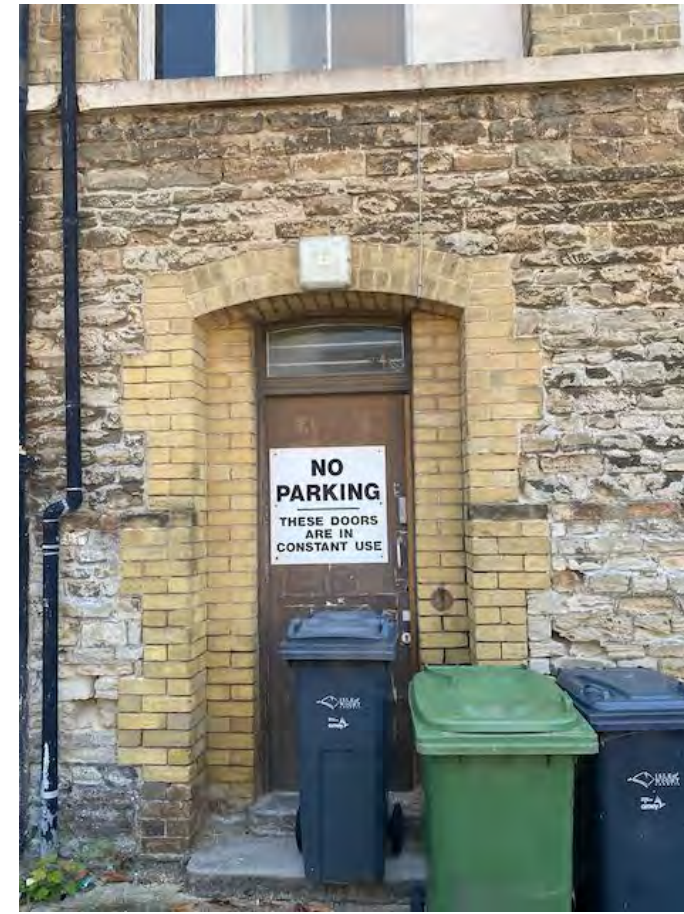
Downpipe on the northern elevation.

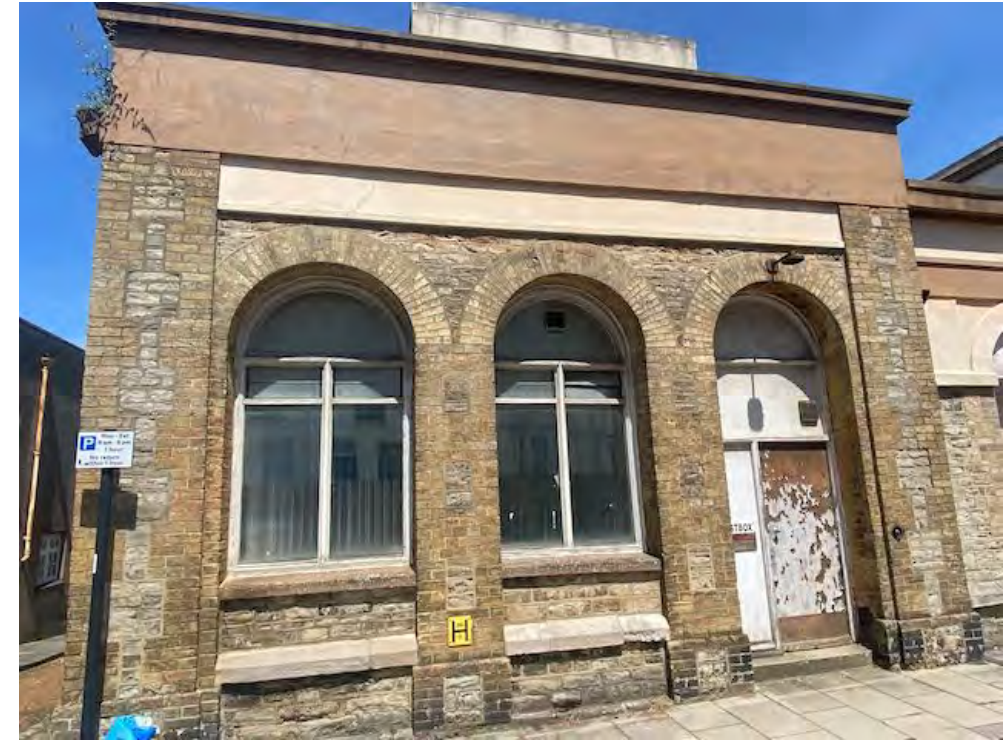
Windows at the eastern end of the southern elevation

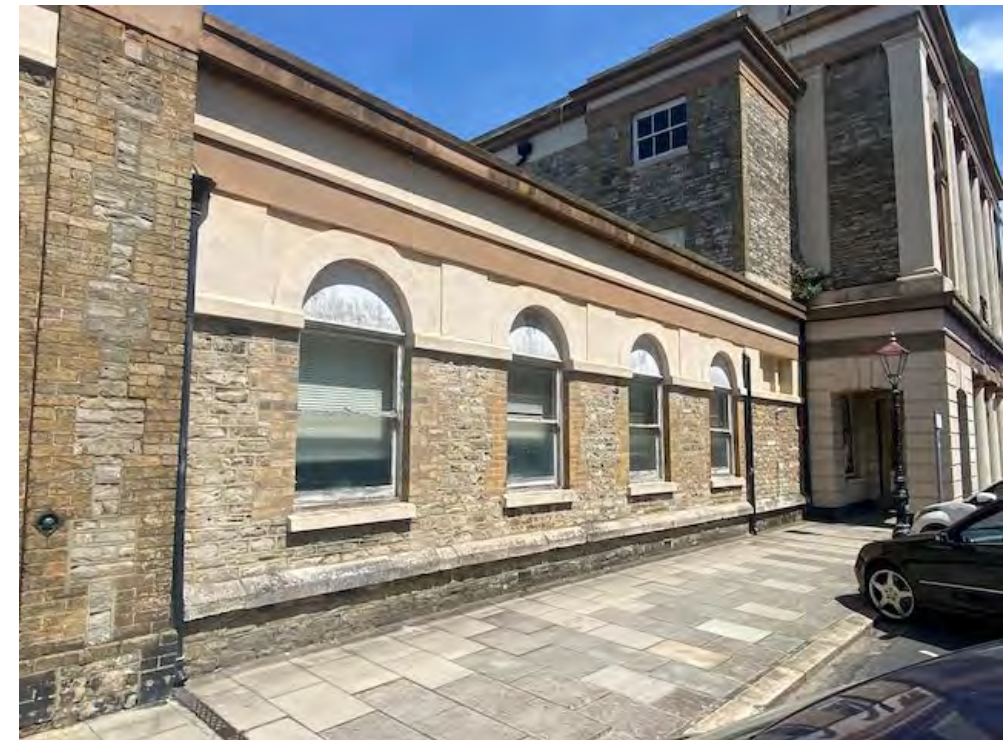
Windows on the link section

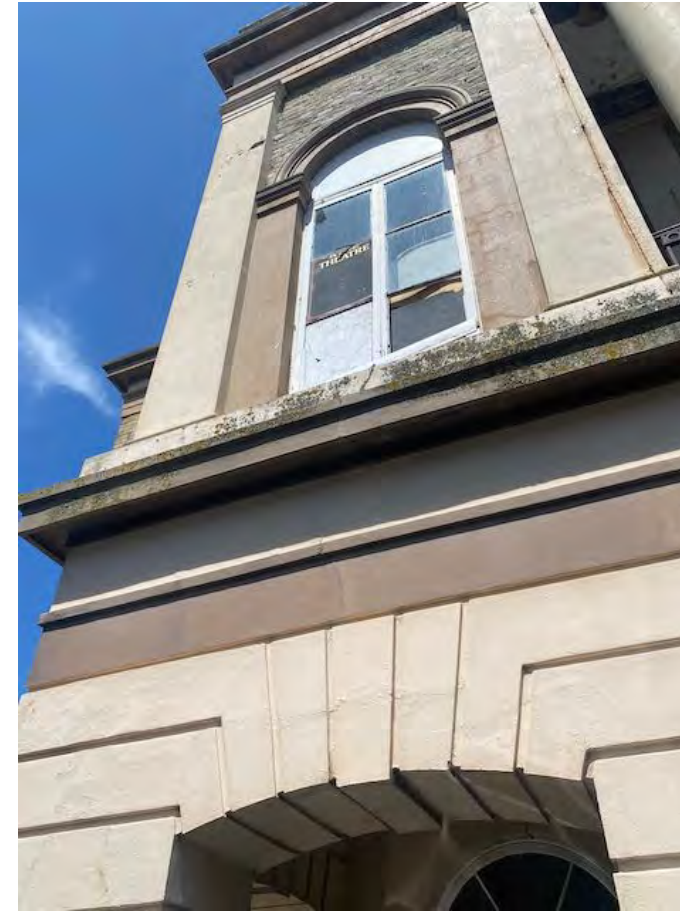
Window to the west of the balcony with bottom rail on the point of falling

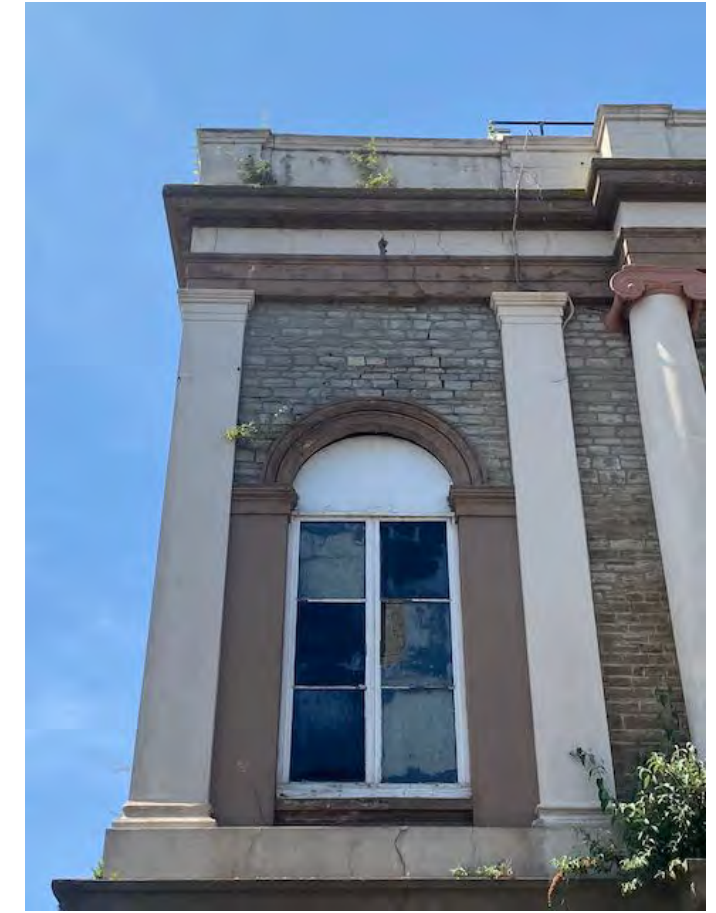
Cracking to SE corner

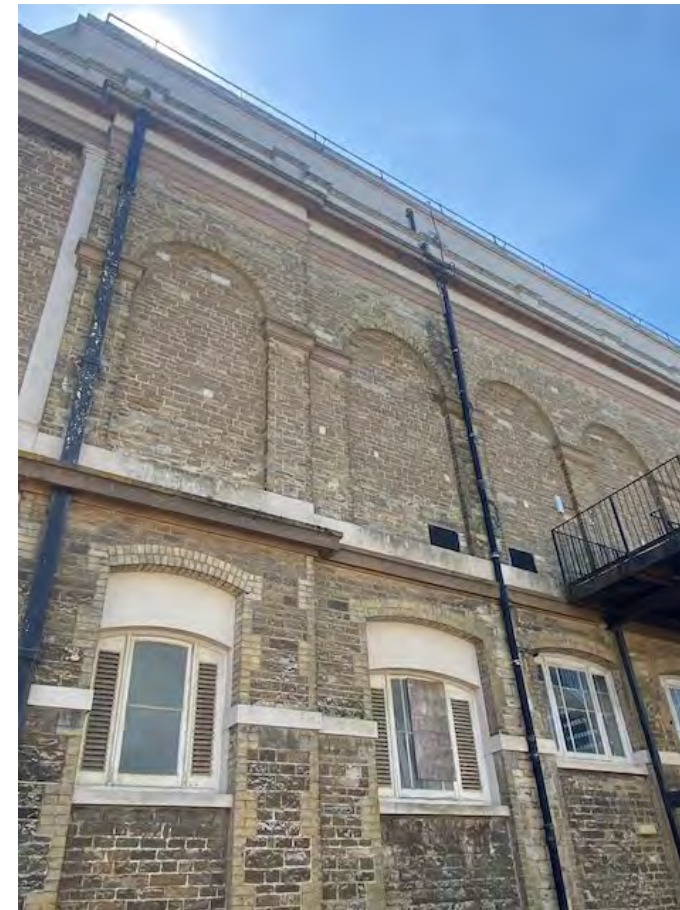
Louvered windows on the north elevation

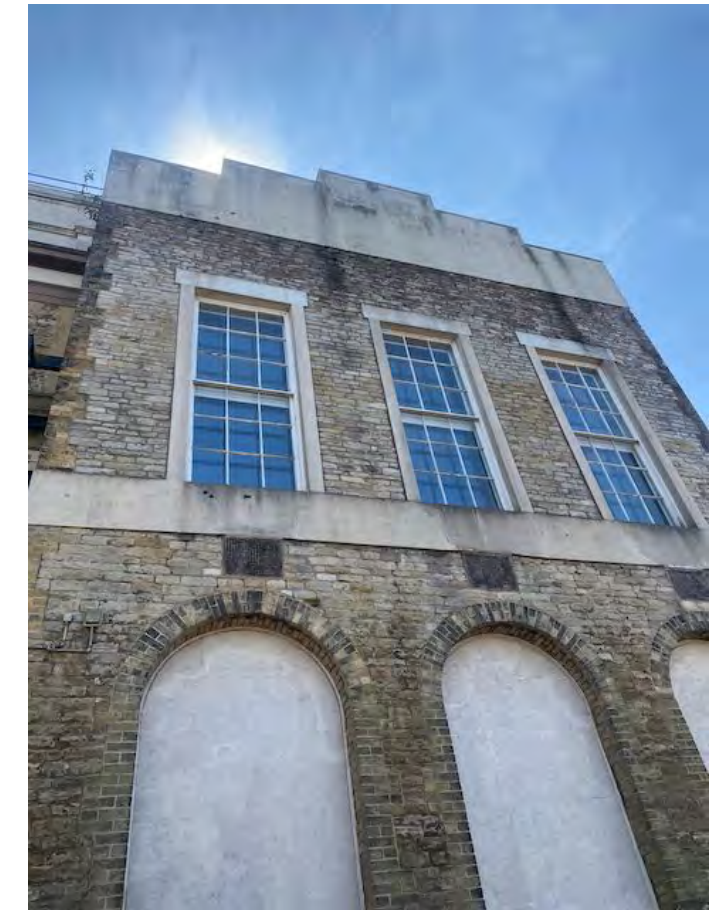
Large first floor windows on the first floor of the town hall.

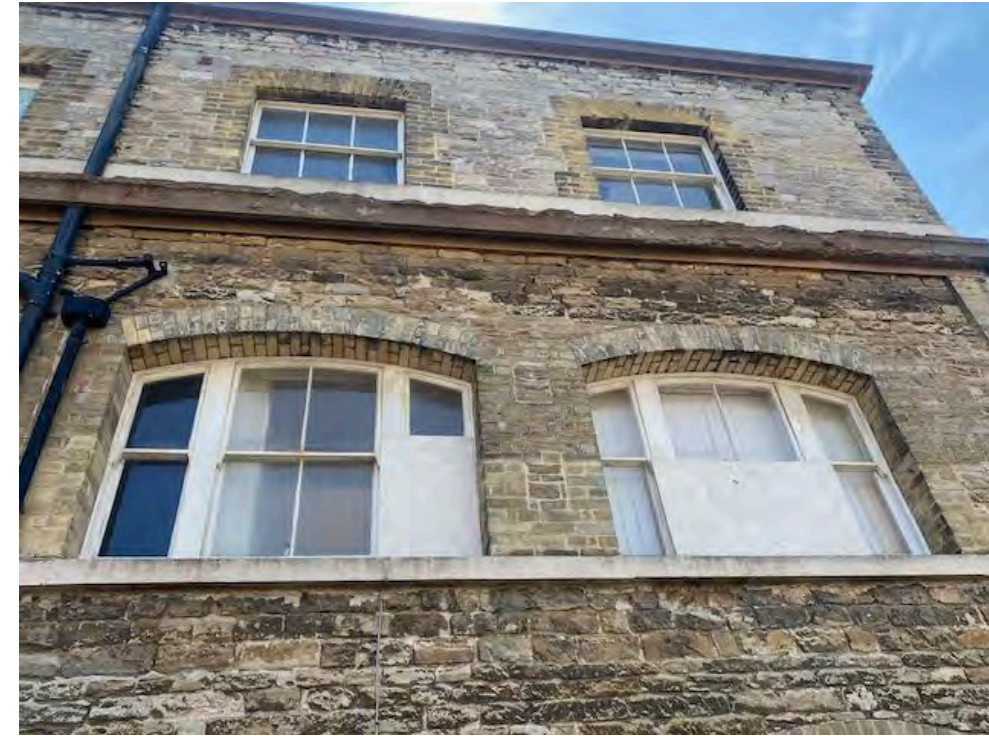
Windows on the market street elevation.

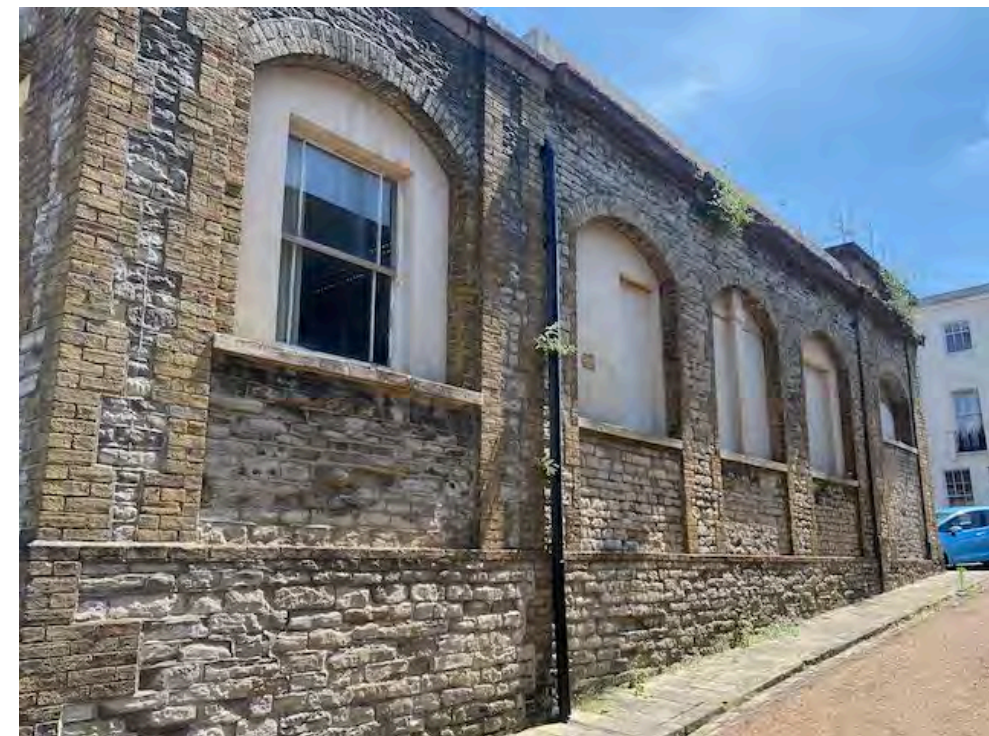
West elevation windows

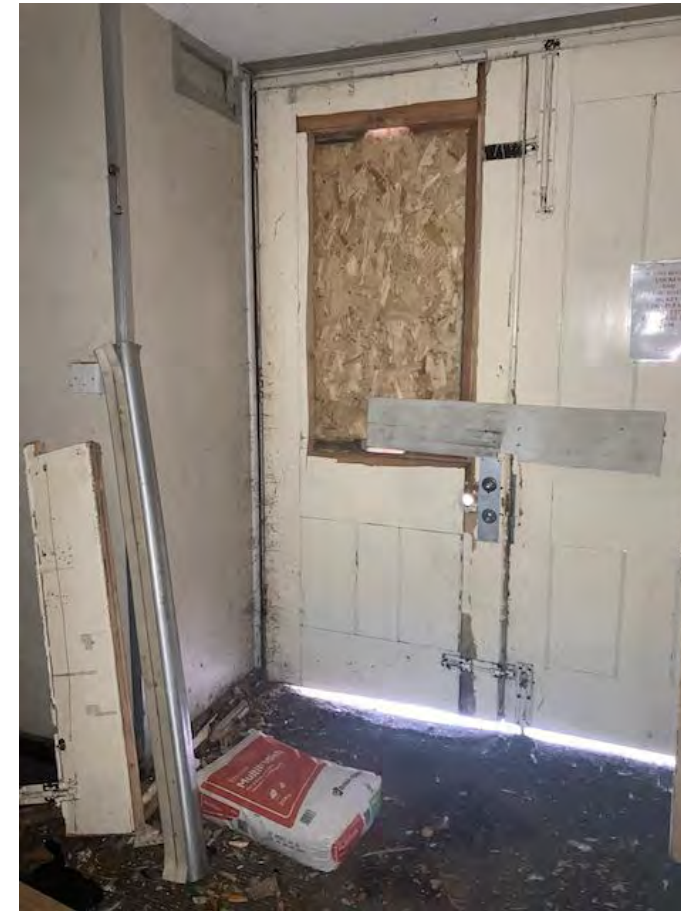
Previous entrance door to the lobby

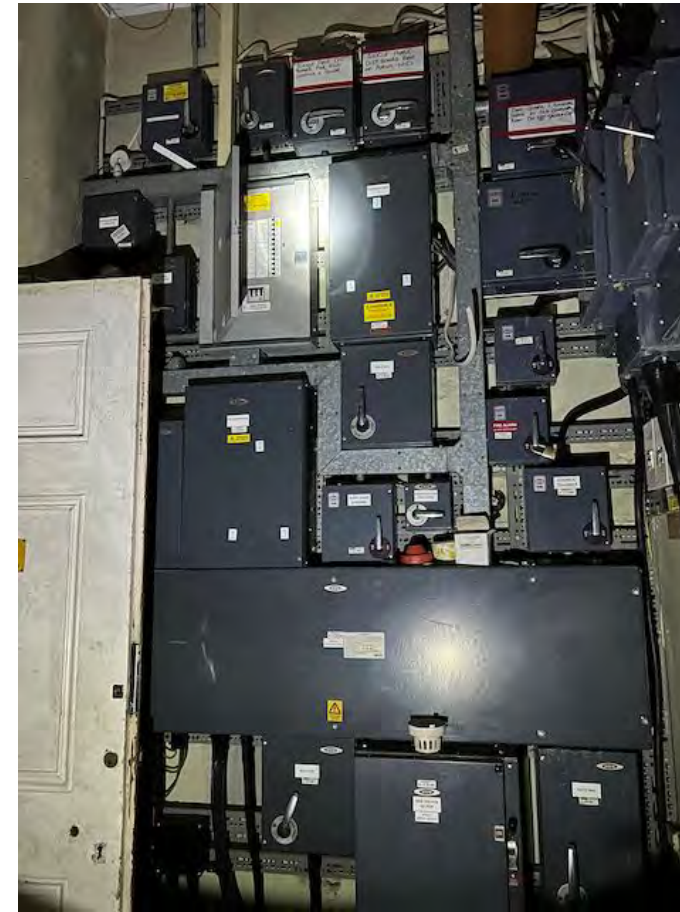
Electrical plant room

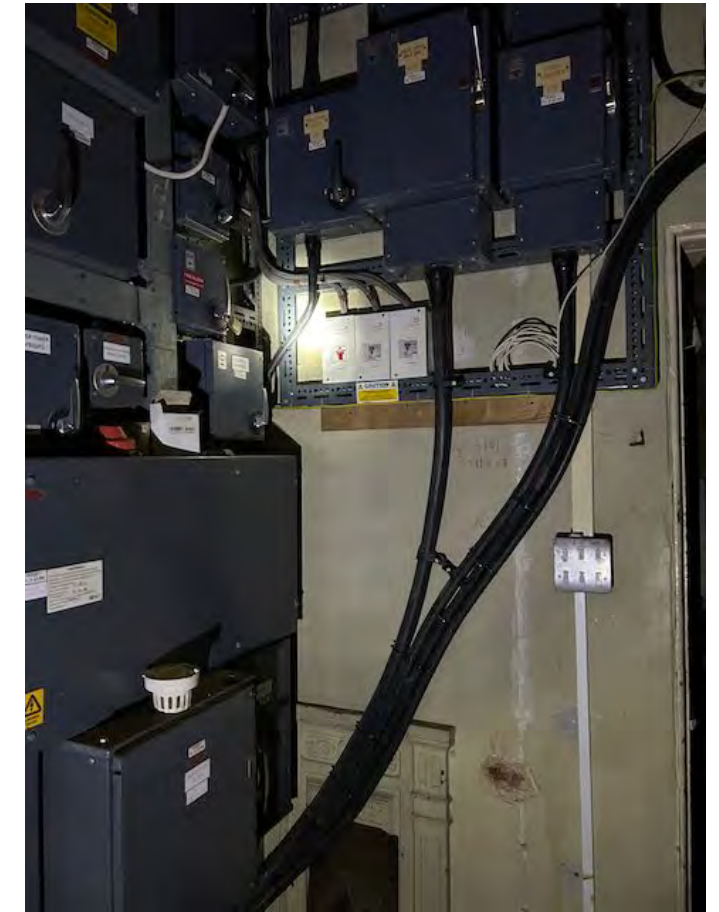
Note historic fire surround below

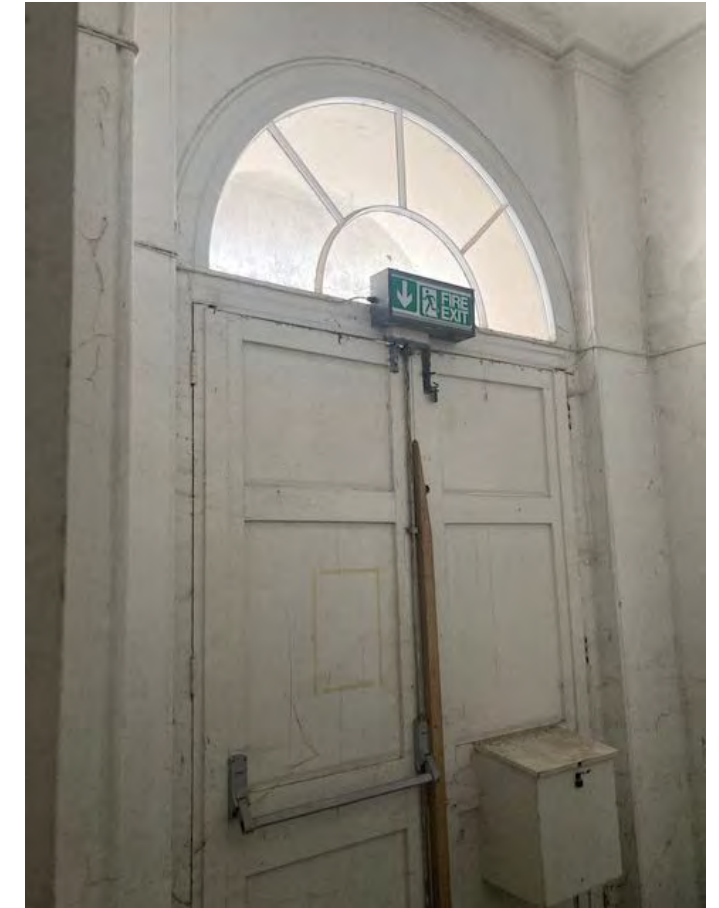
Central ground floor lobby area

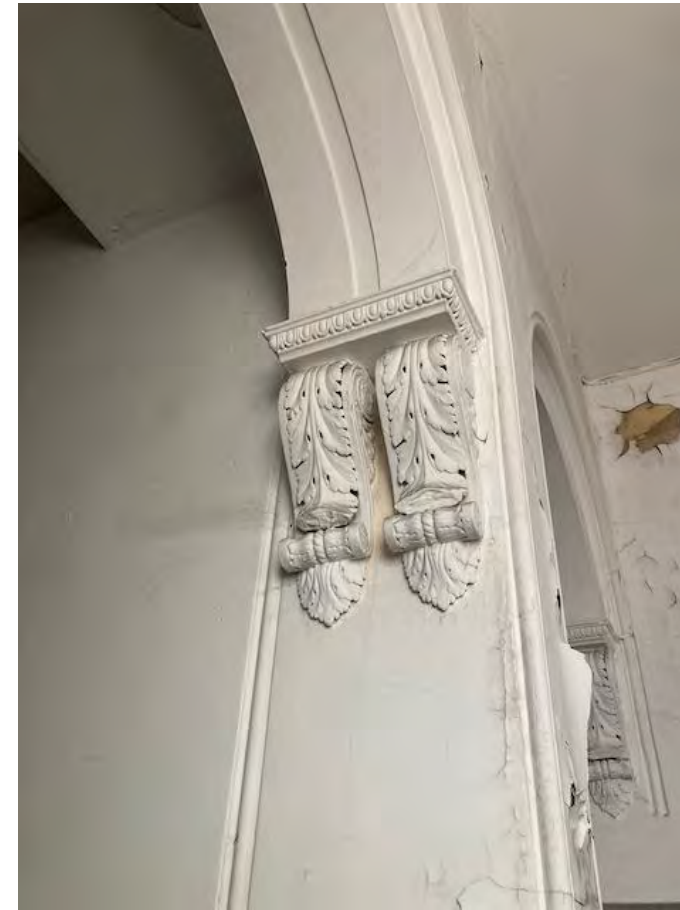
Decoration at base of stair

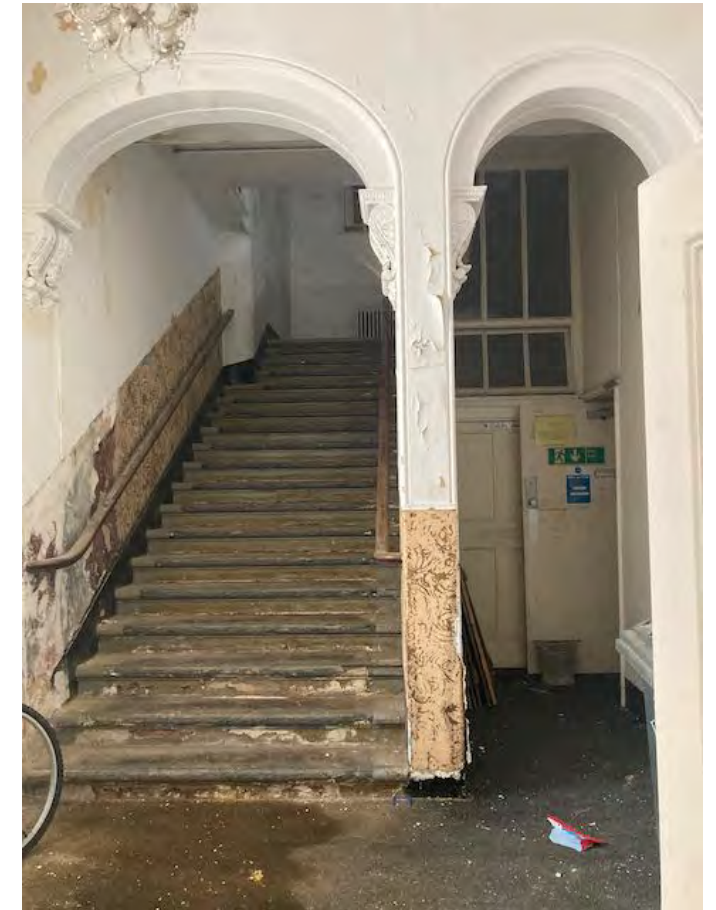
Main staircase to First floor

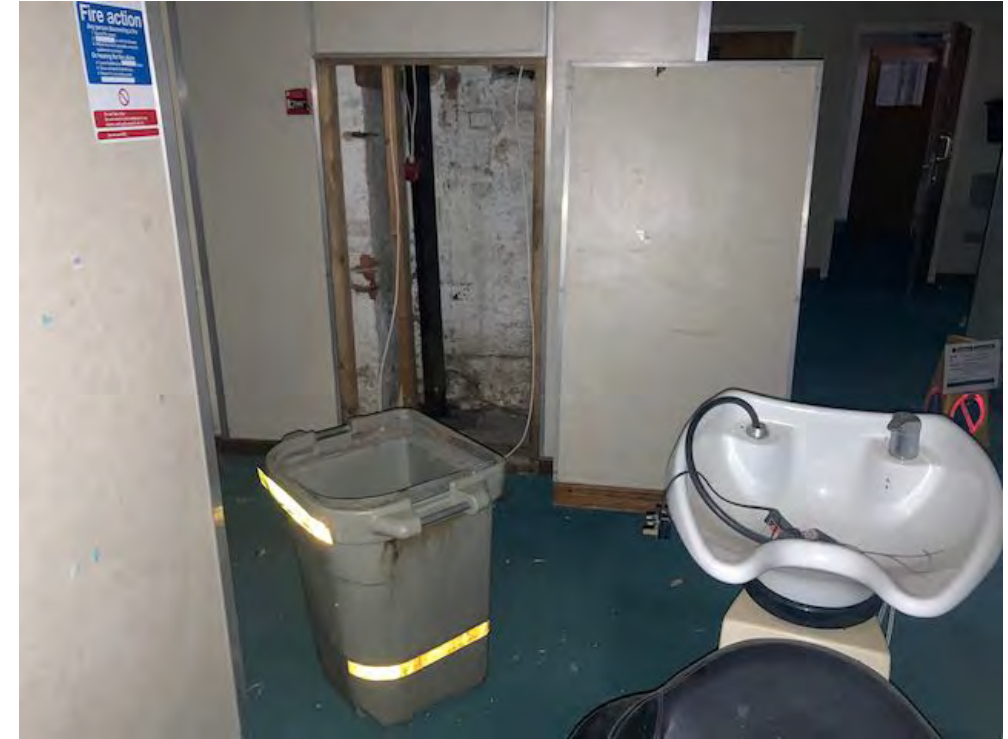
Area to the rear of the former entrance lobby

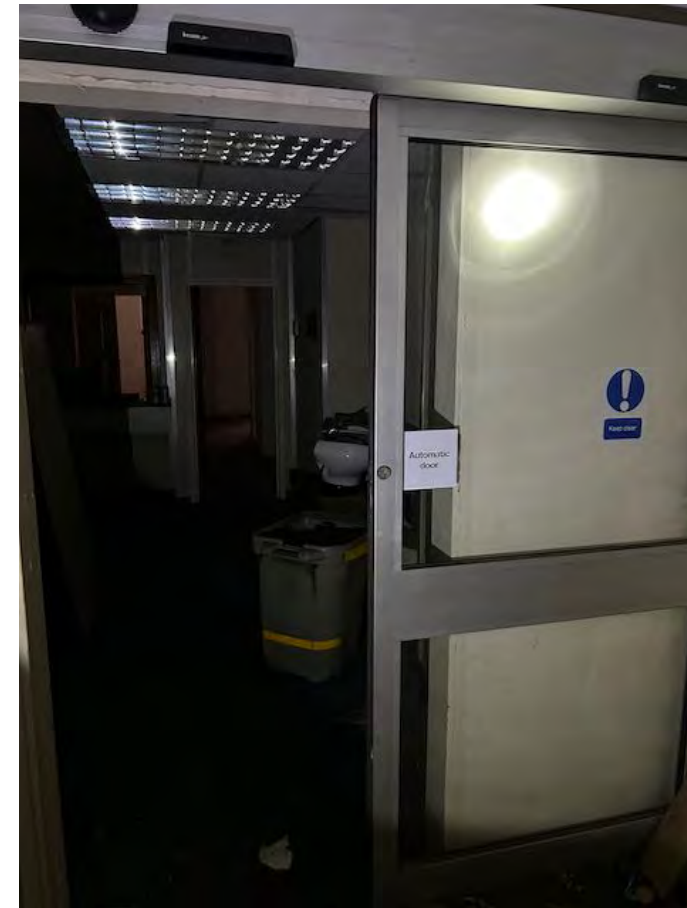
Entrance doors to former Social Services Office
(Opened December 1997)

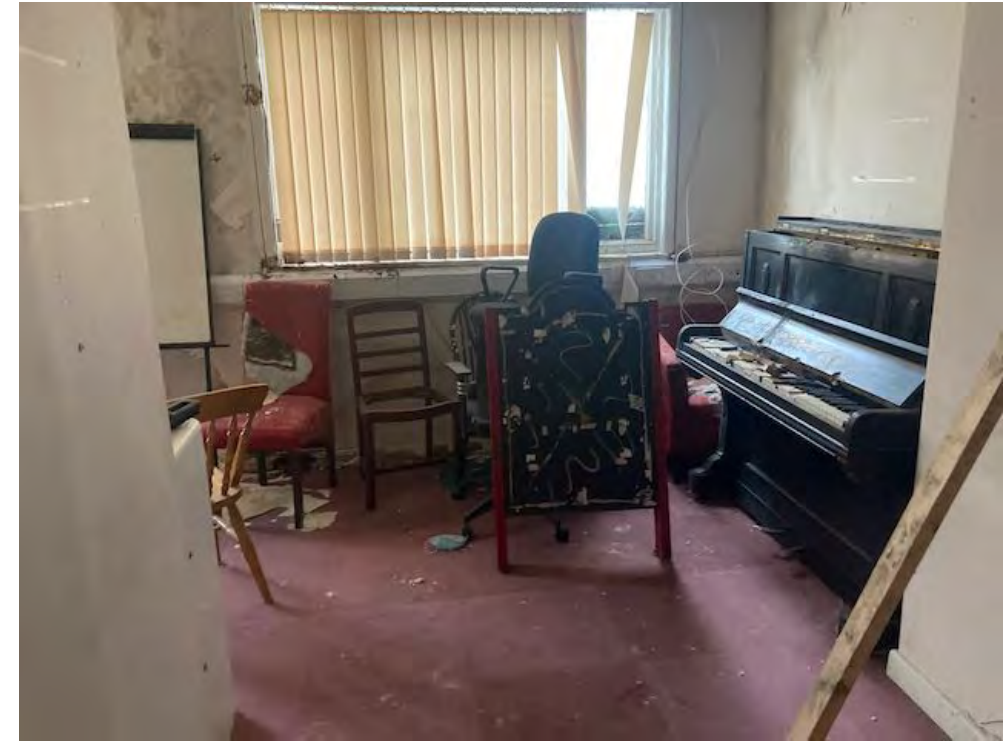
Office immediately to the west of the war memorial

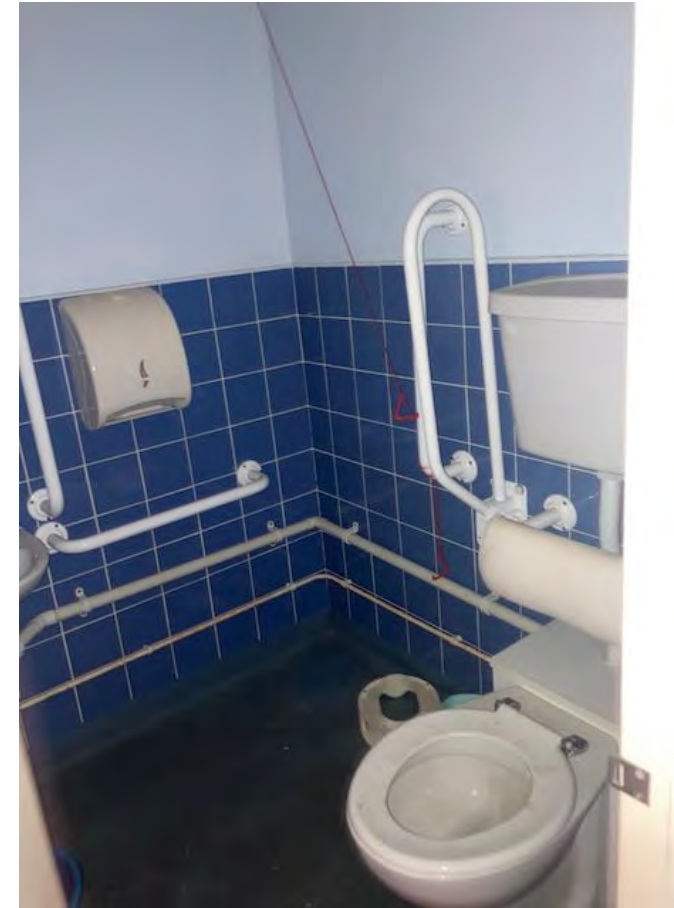
- D.7.1. The accessible WC is in a very worn condition.
- D.7.2. The ceiling is of modern plasterboard, with the walls tiled at their base to a height of approximately 1m.
- D.7.3. Modern vinyl floor coverings forming an up-stand to approximately 100mm at the base of the walls. The vinyl sheeting should be removed to allow an inspection of the floor surface beneath.
- D.7.4. All now considered redundant with removal recommended in due course.

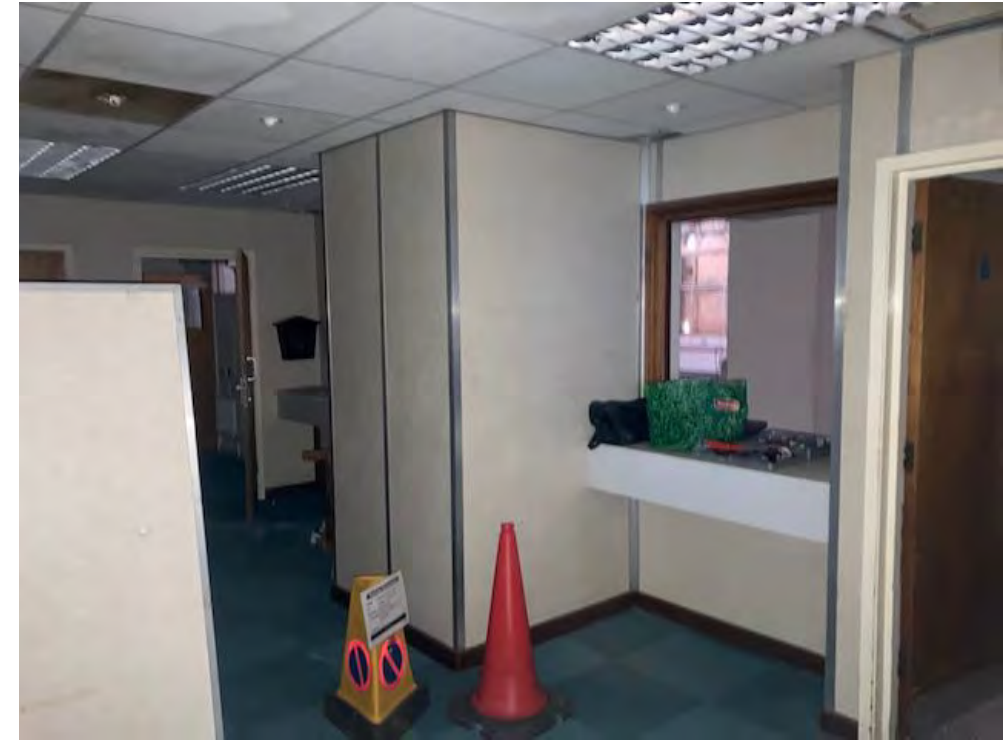
Internal ground floor office accommodation (Social Services)

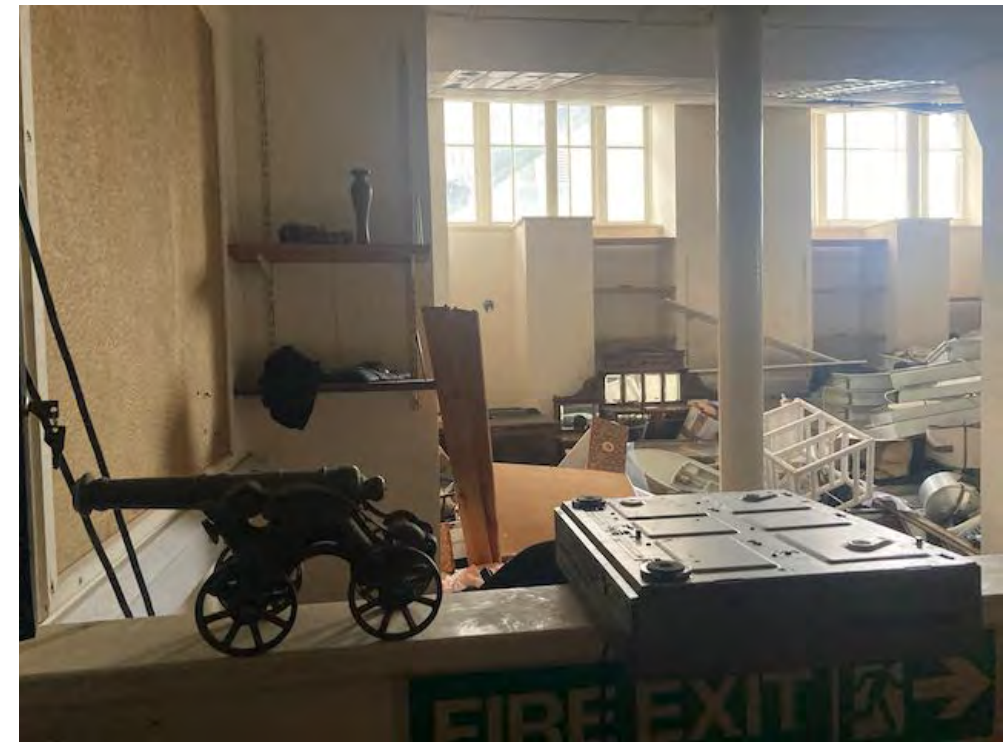
Cast iron columns providing support to the floors above. Columns shown on 1860 town plan, as subdivisions to market stalls.

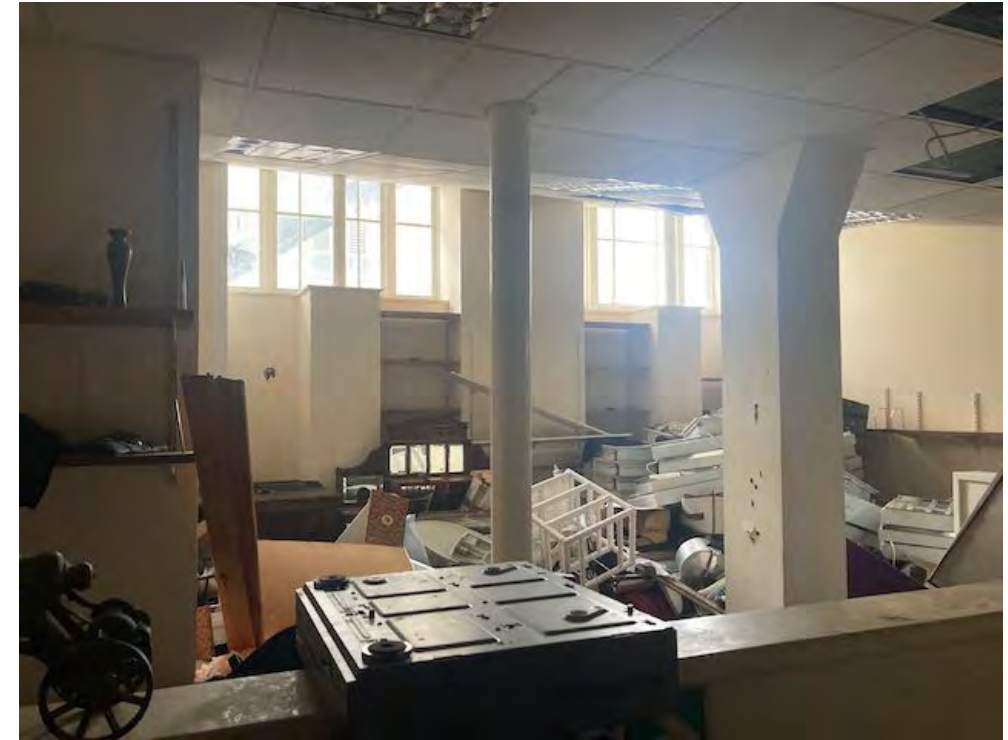
Modern debris to be removed

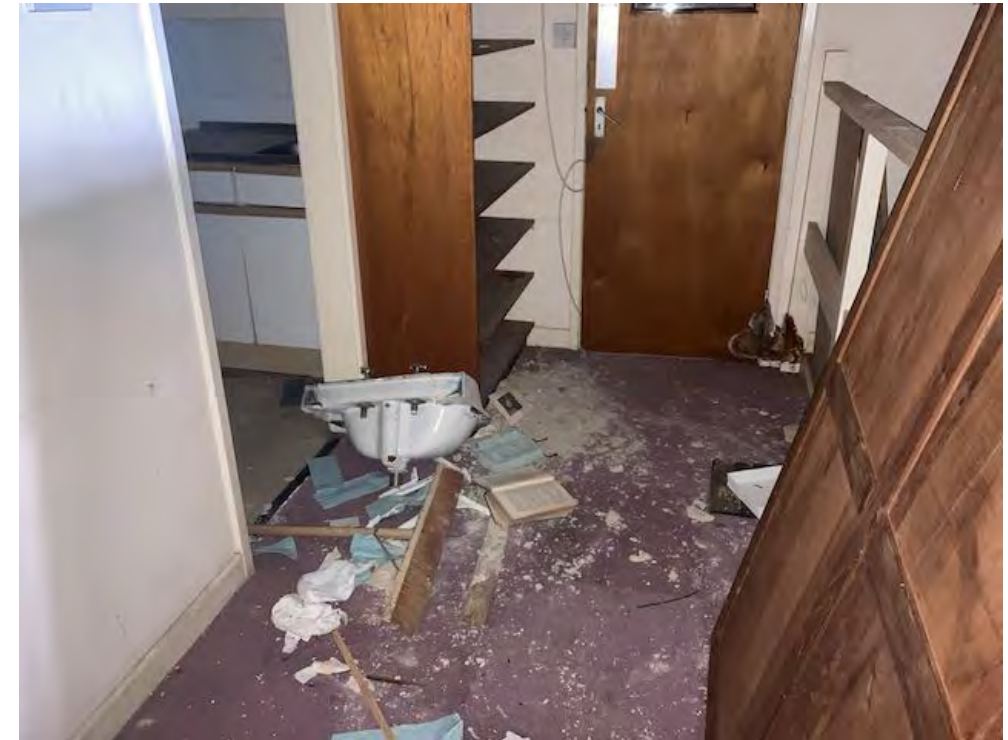
Dry rot fungus visible at bottom right of door. Vandalism.

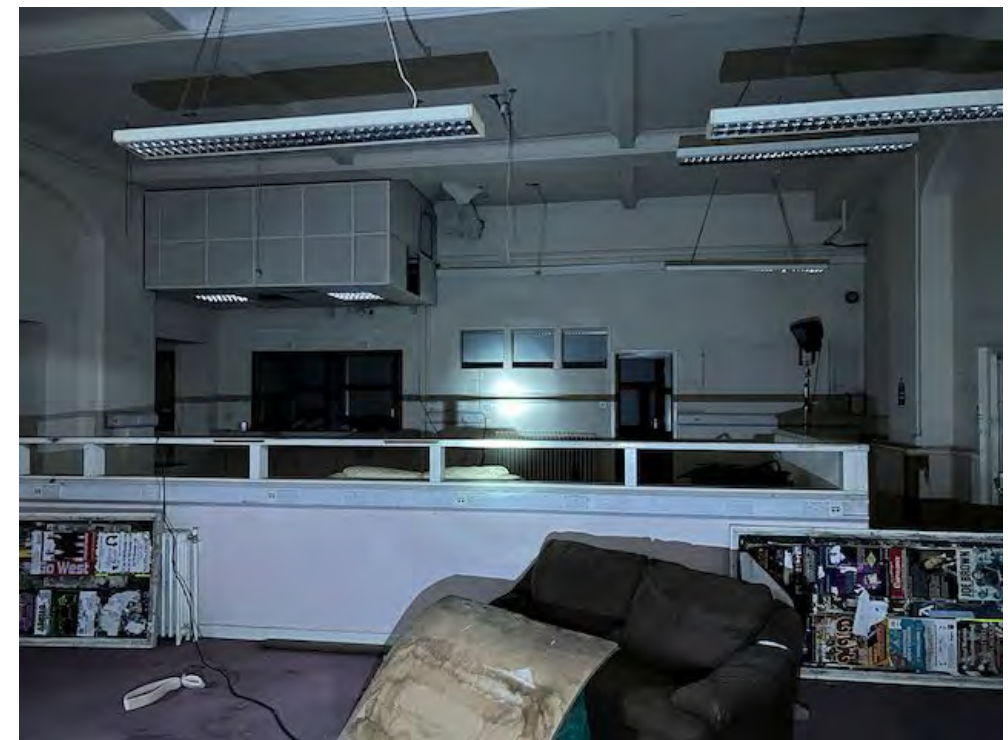
Lower main hall looking south

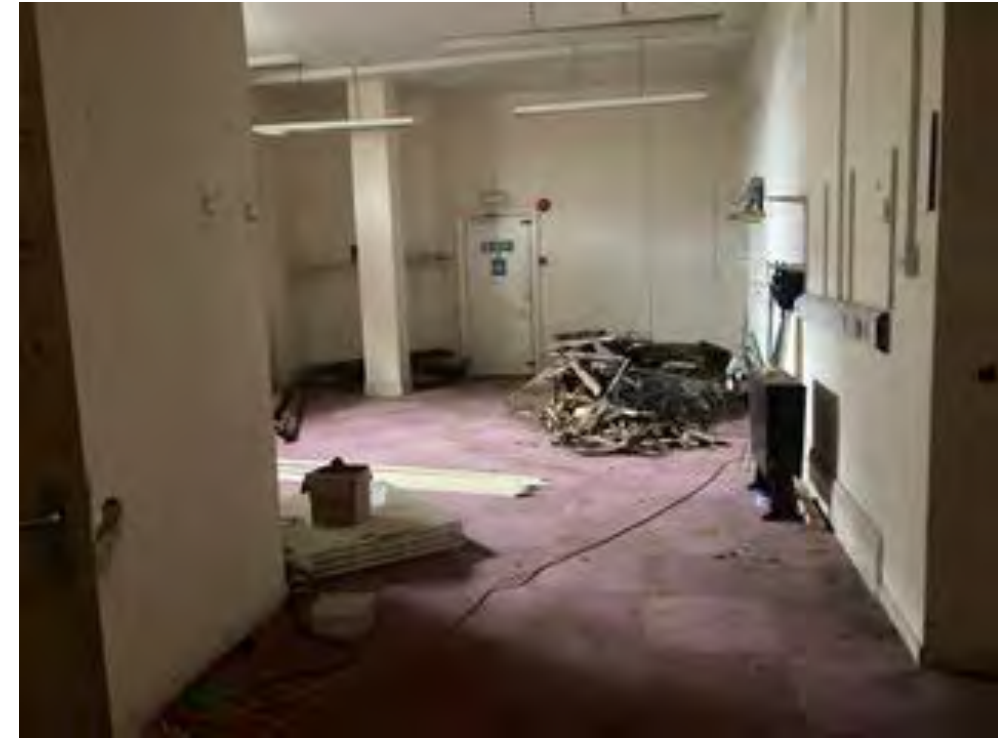
The room seen looking east

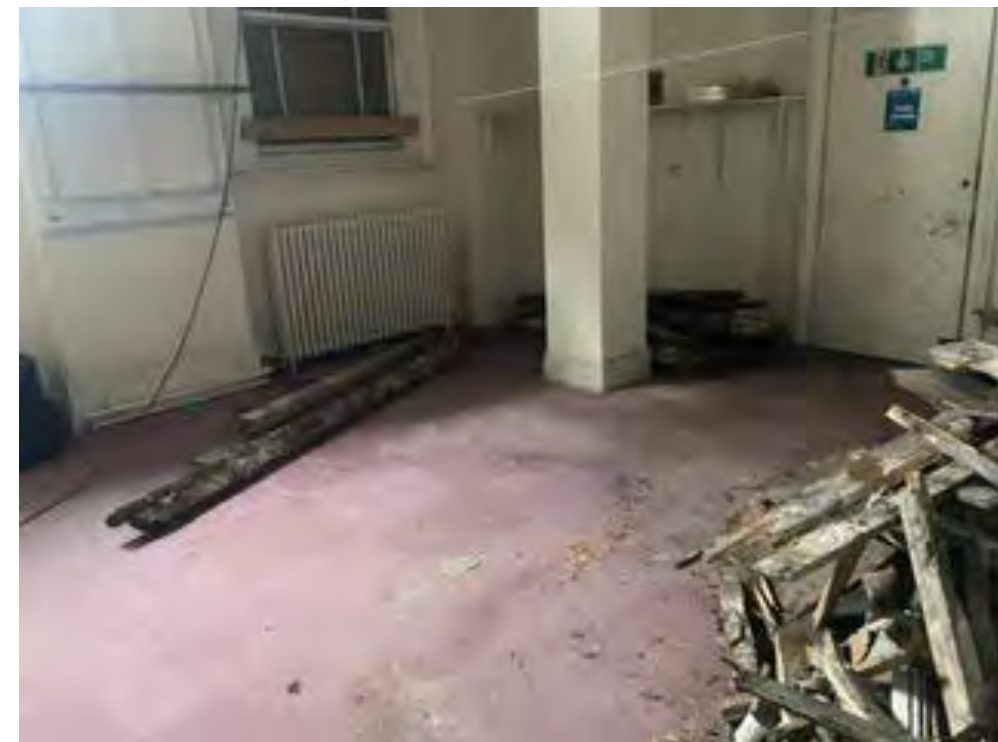
Infected timber and fire escape door

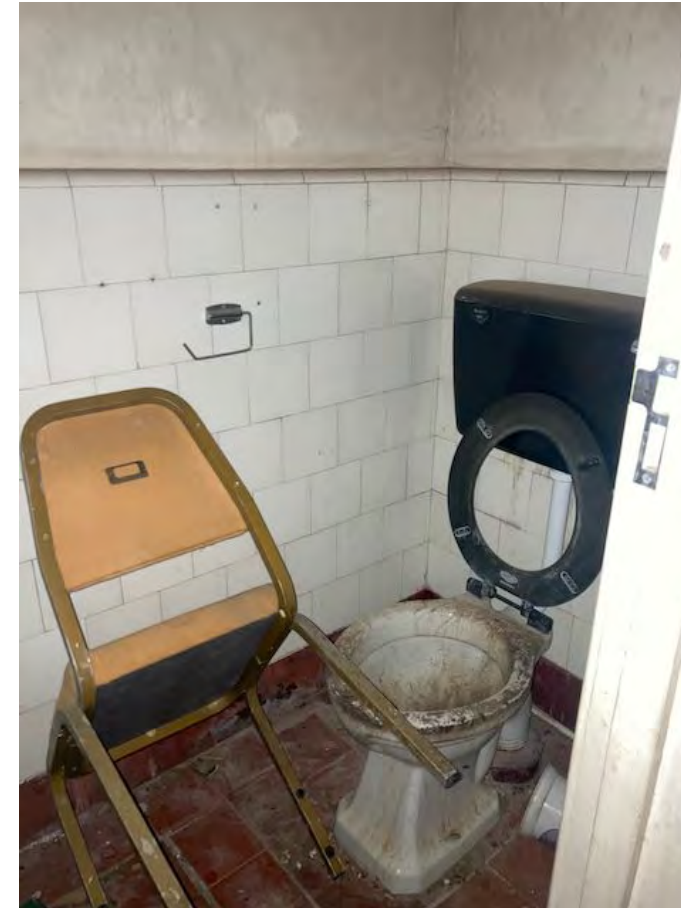
The small WC accessed from the north south corridor

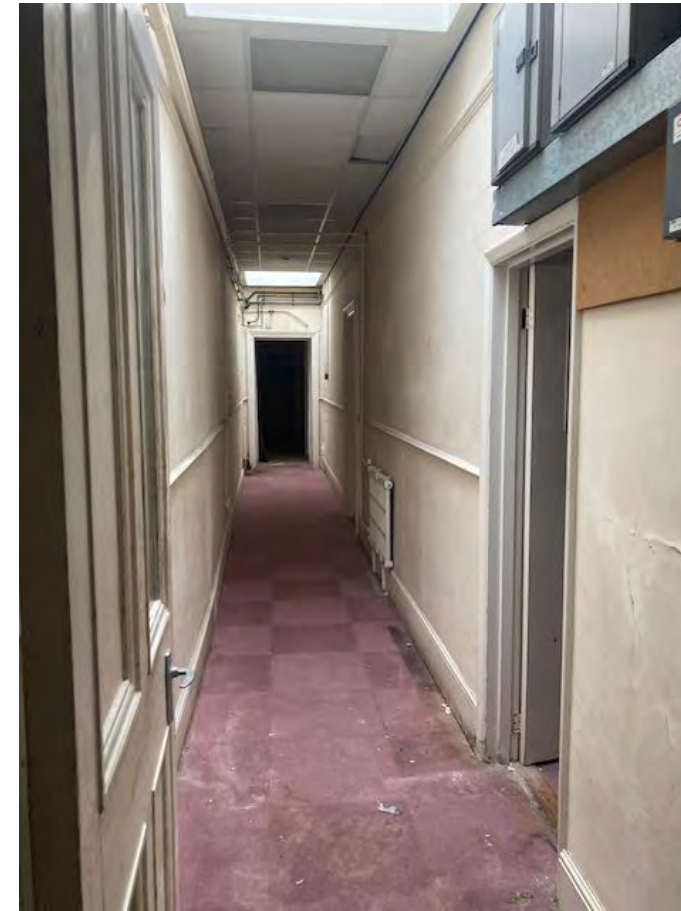
*Corridor in western single storey accommodation.
Modern suspended ceiling*

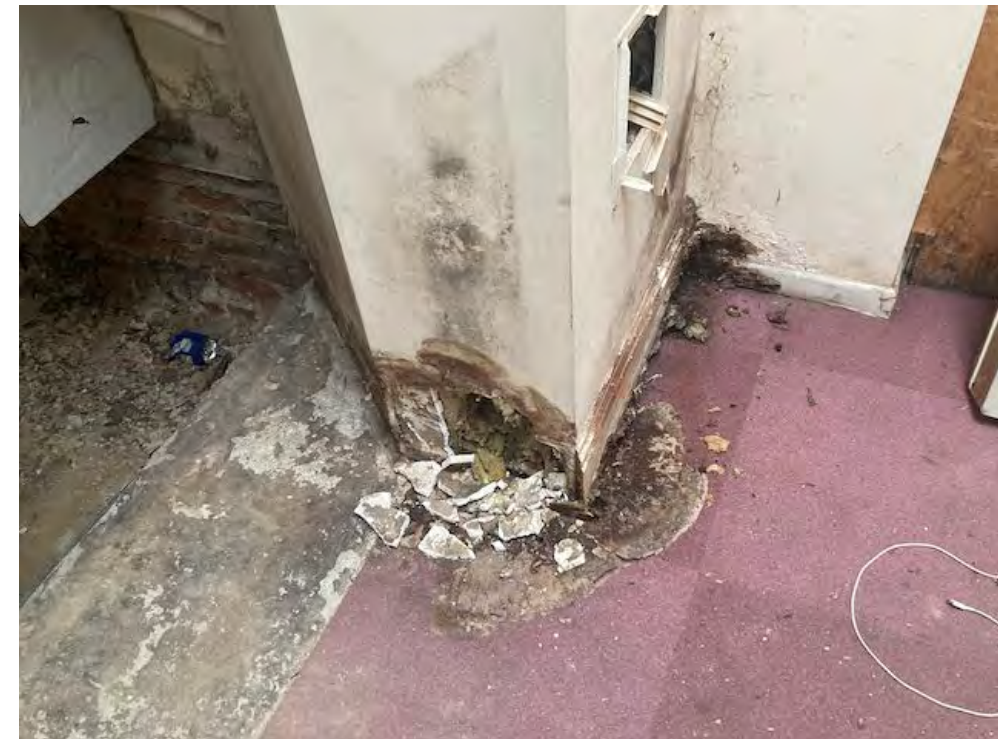
Damaged drainage chamber and dry rot fungus

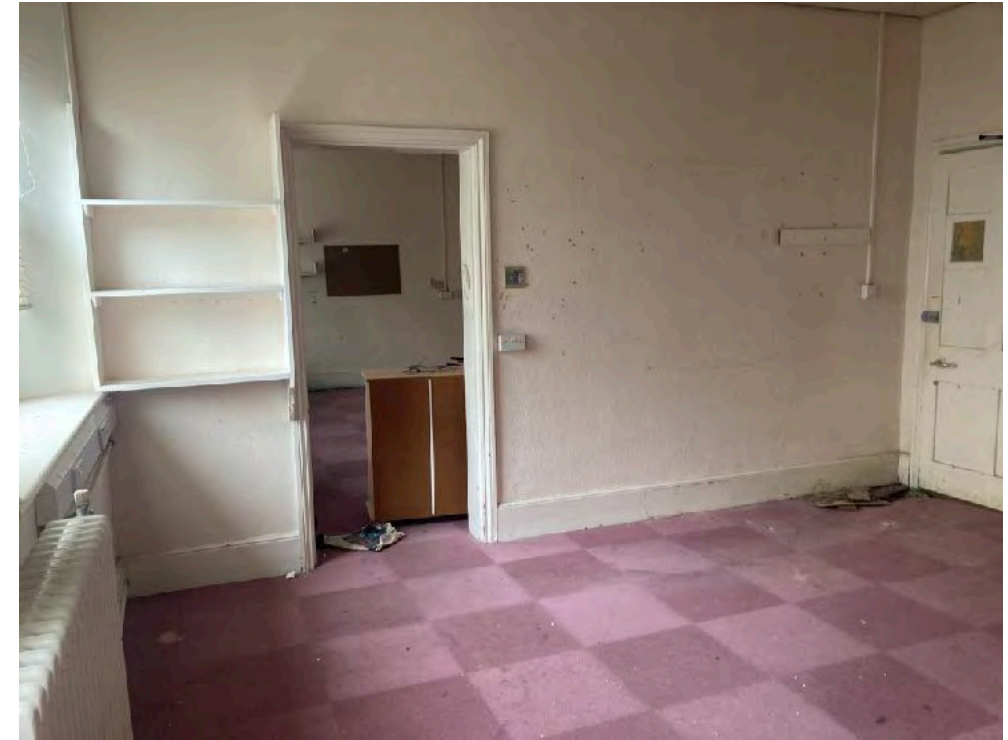
- D.16.9. The office to the west (G8) can be accessed via a shared doorway between the two offices or via a separate doorway to the corridor.

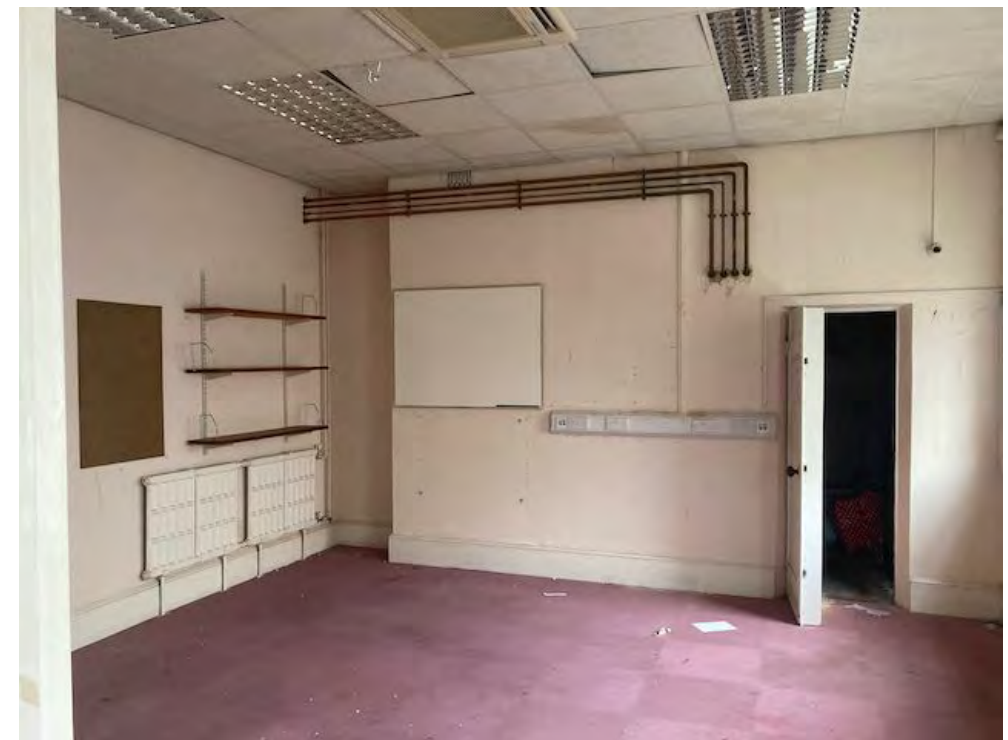
G18: Strong room door to East wall.
