Condition Report

Ryde Town Hall

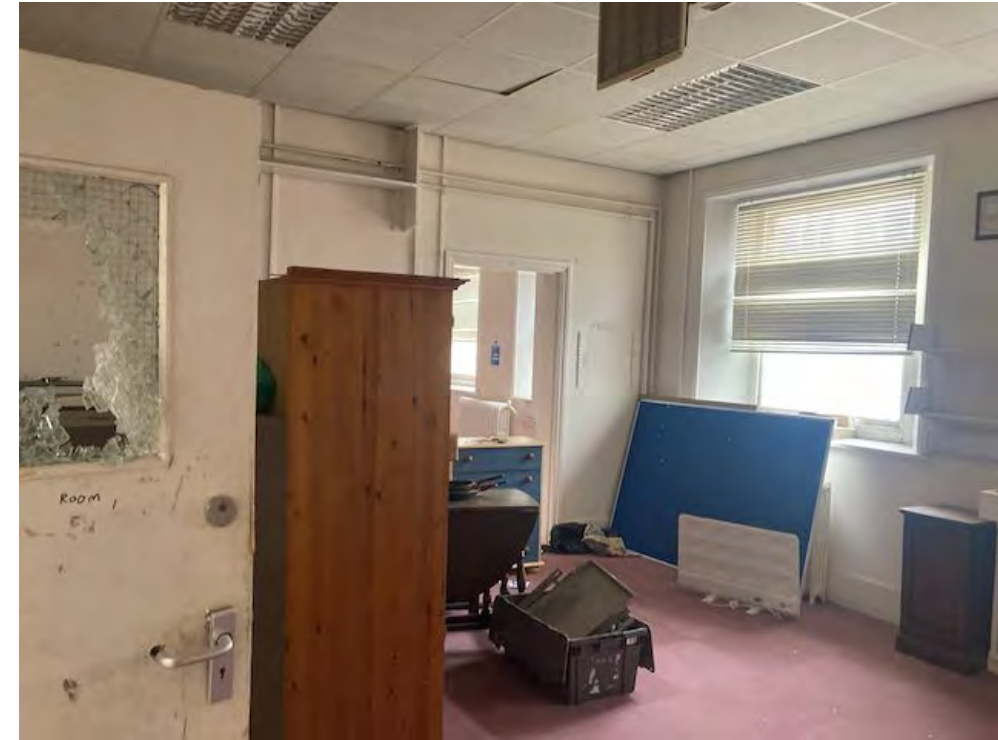
Office to west in the south elevation of the west wing

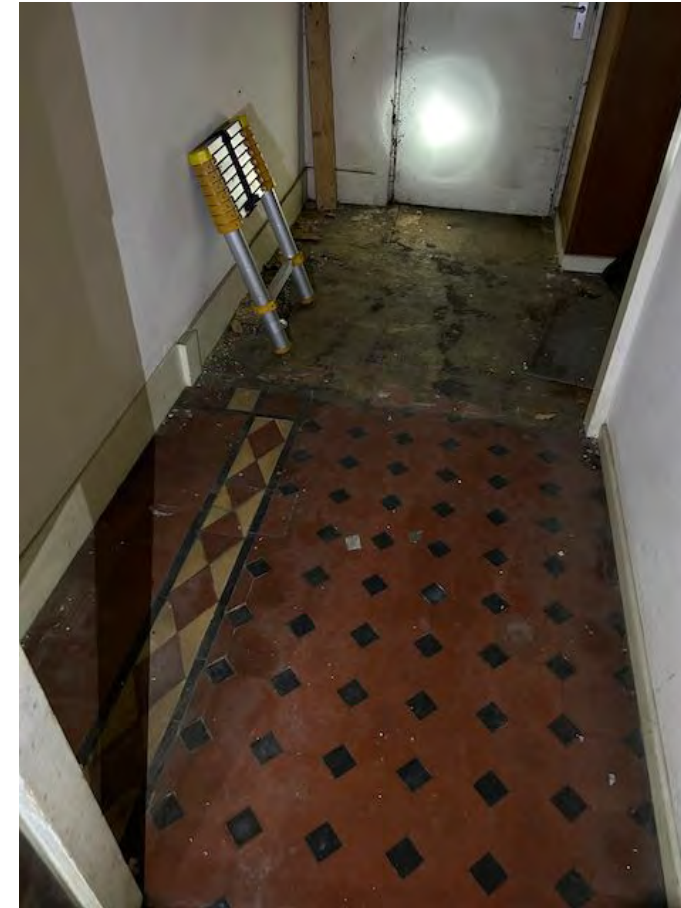
Entrance hall with the decorative tile finish

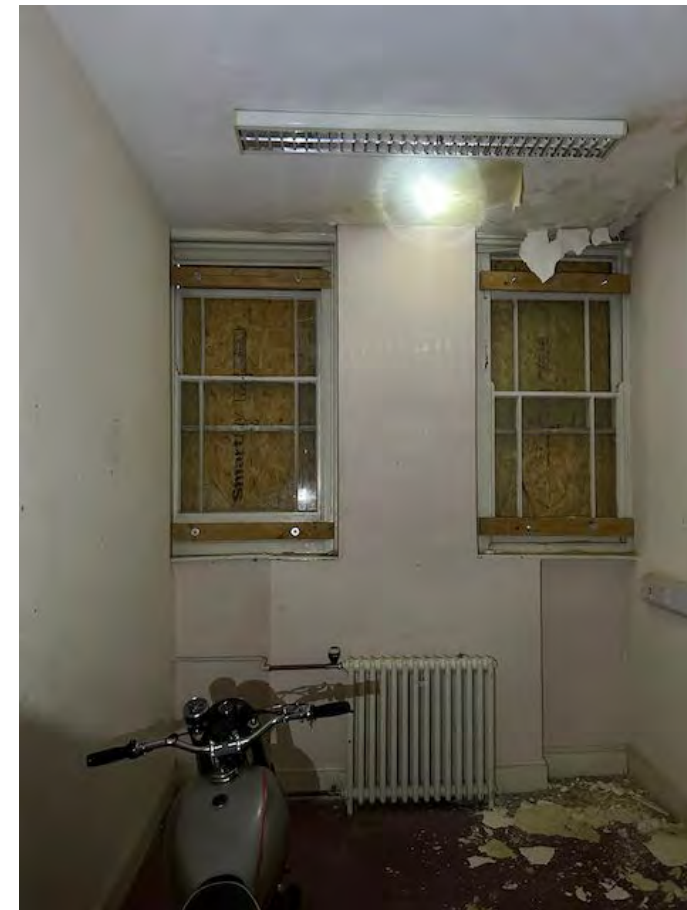
Office at the west end of the building

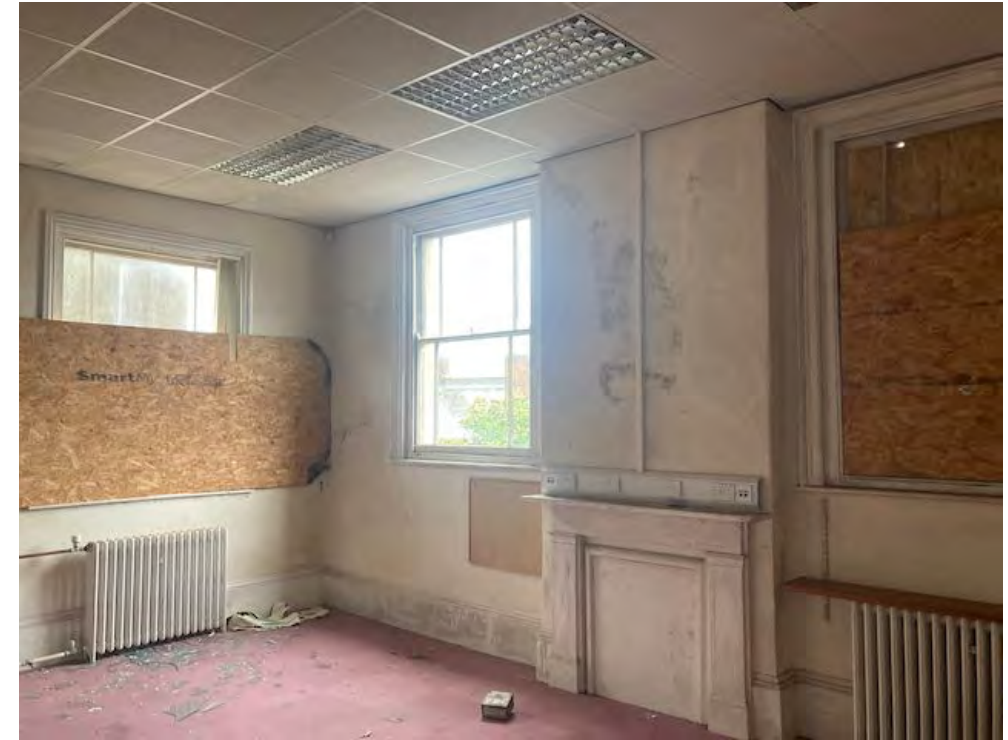
Sash windows on the north western corner

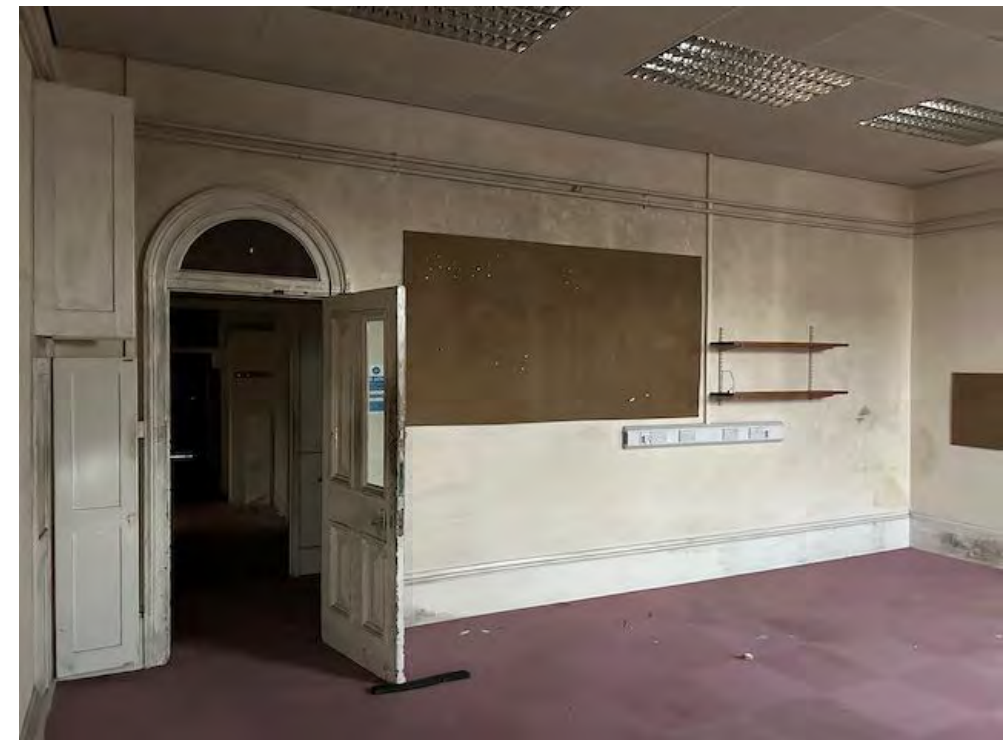
Office in the north west corner of the building

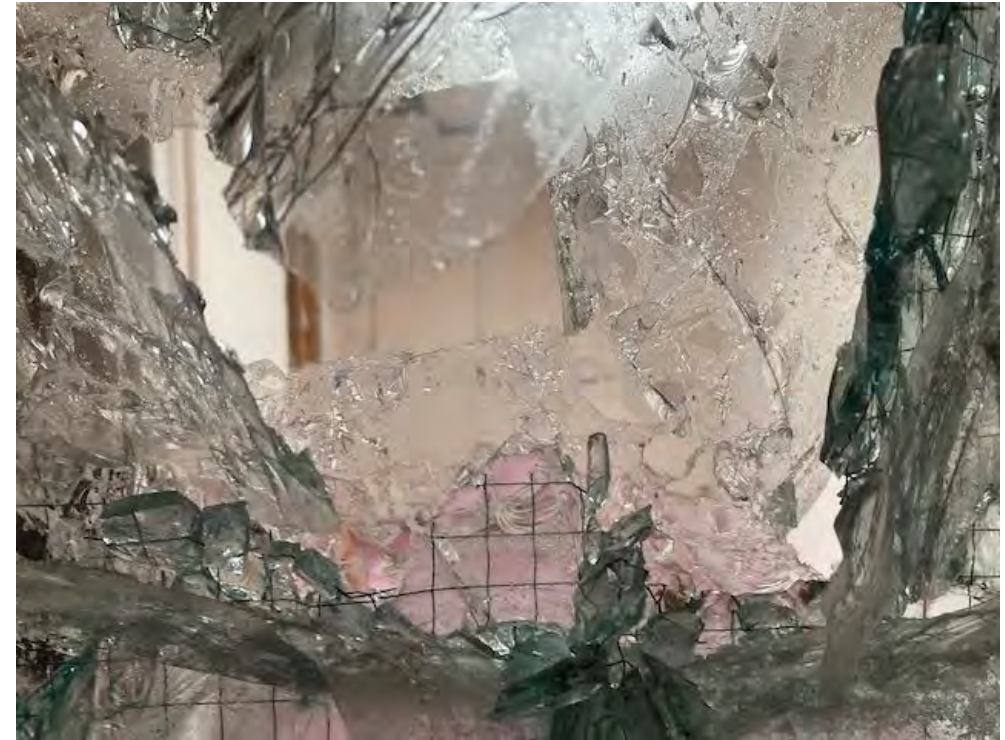
Broken door glass between office spaces in this area

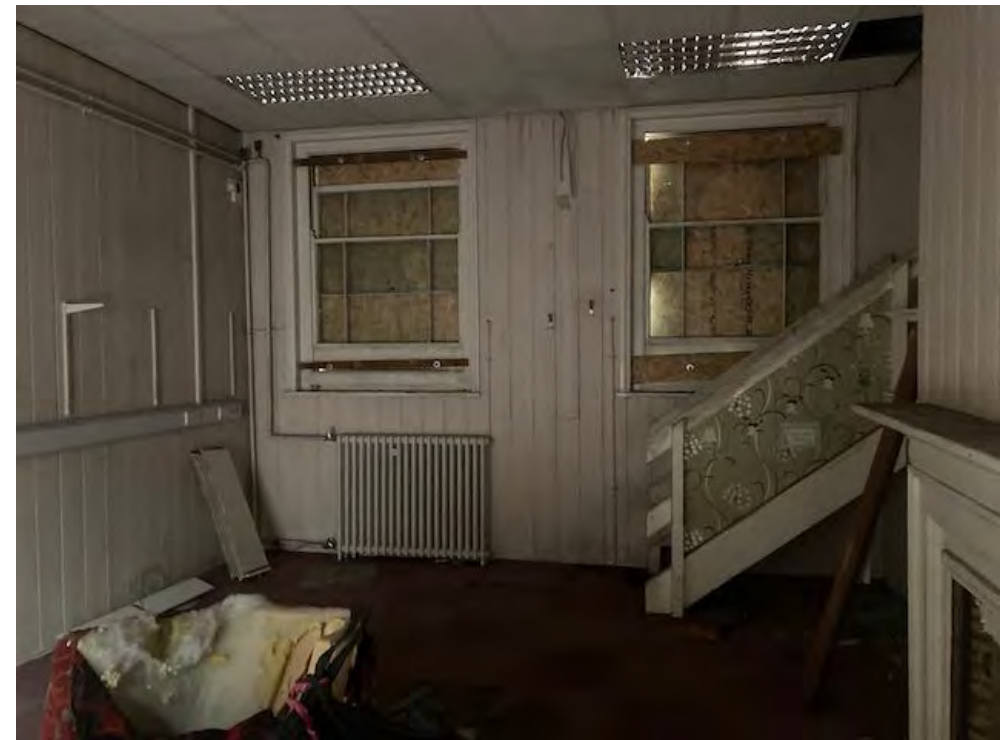
G10 office accommodation with suspended ceilings

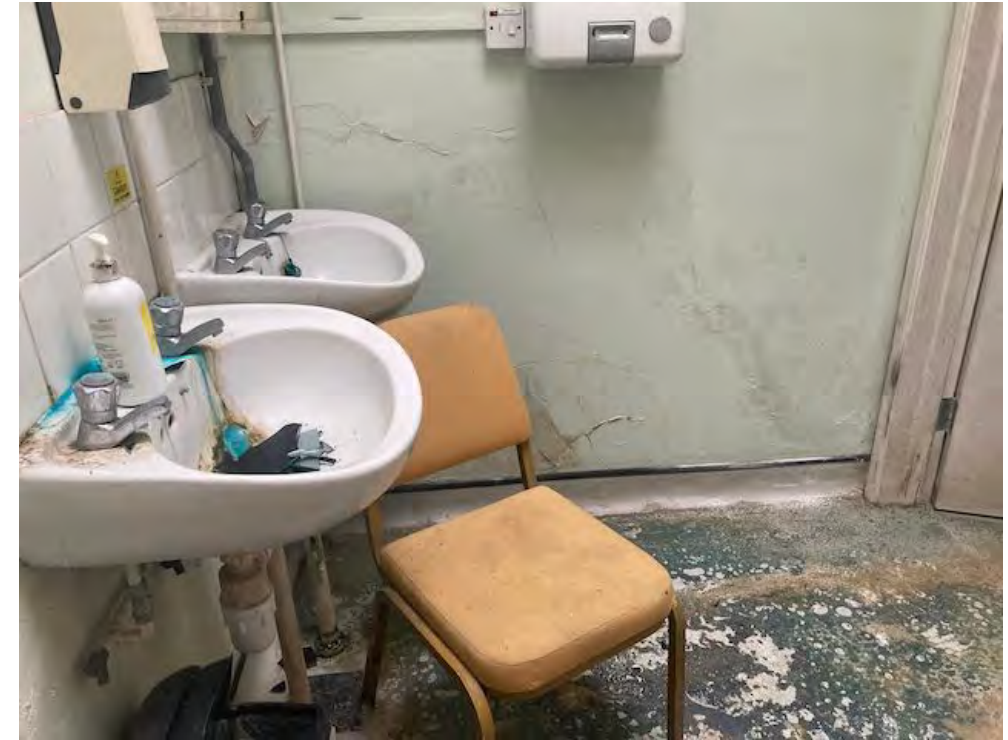
Lavatories in the eastern end of the west wing

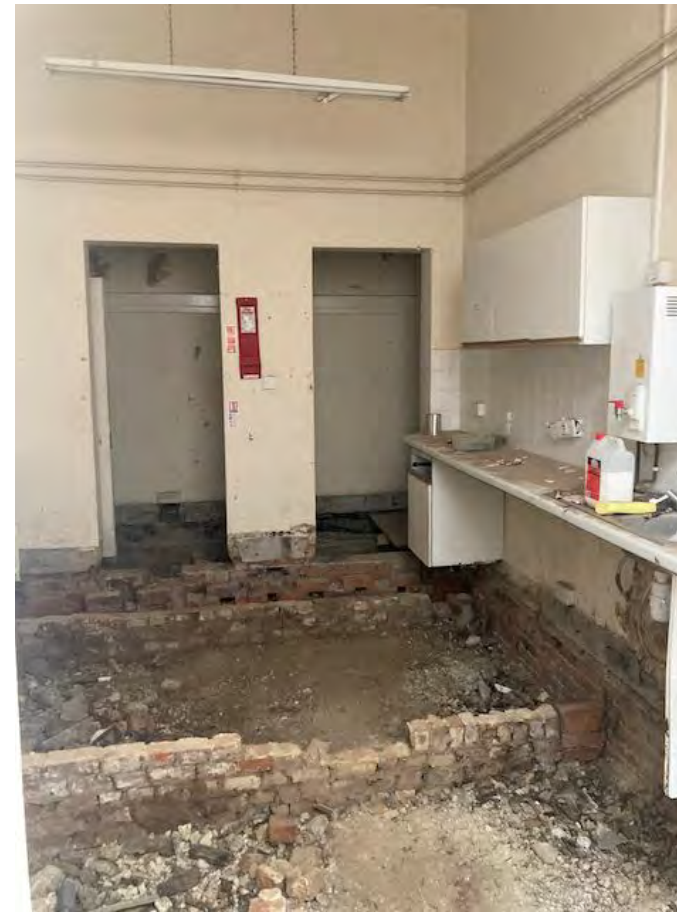
Missing floor and redundant kitchen units (believed to be the origin of the dry rot infestation).

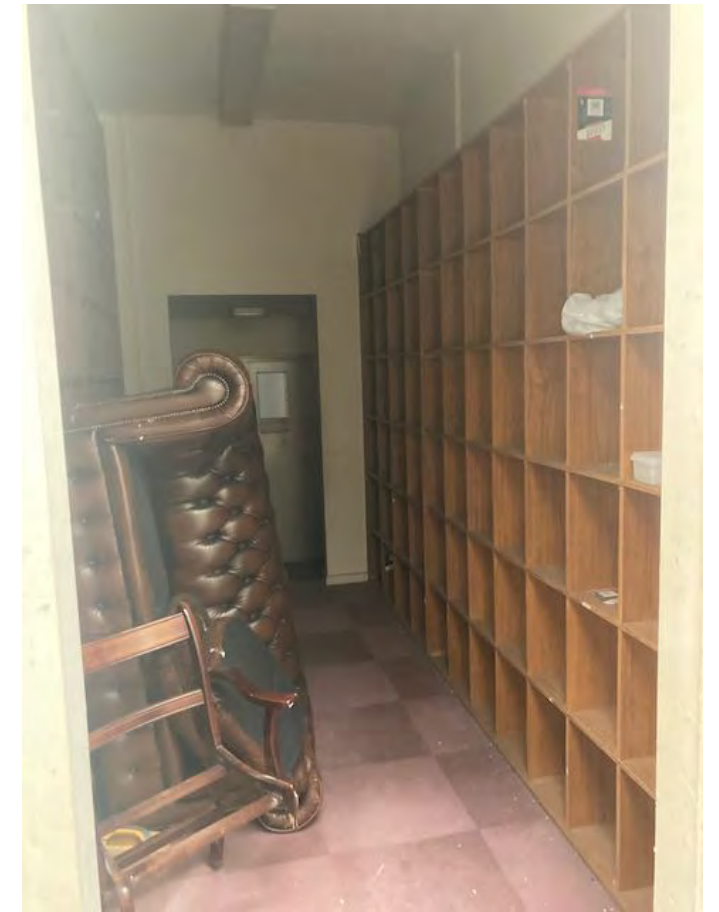
Furniture board pigeon holes in G25

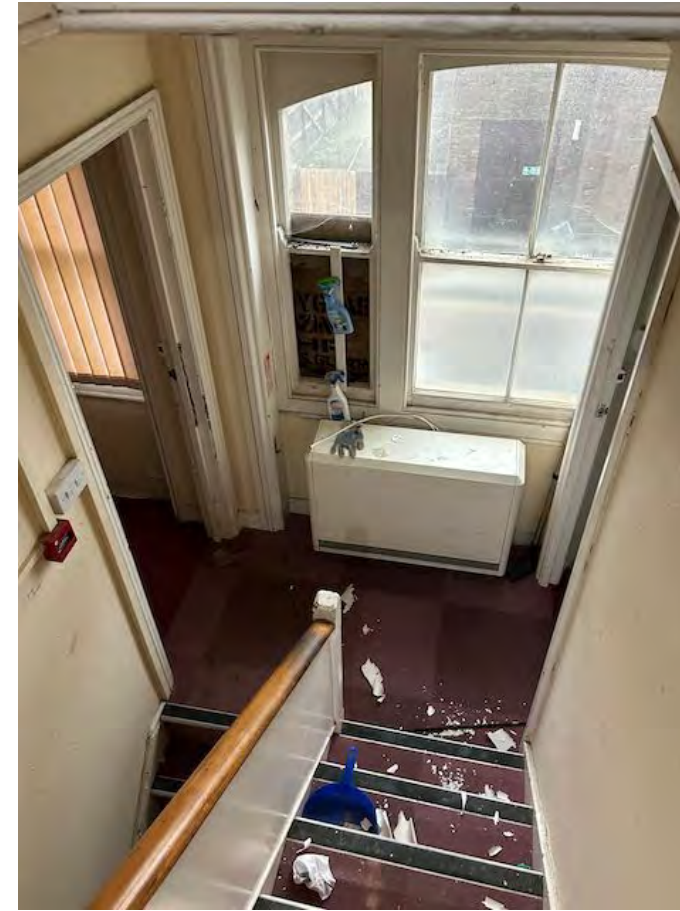
Central staircase leading to caretakers accommodation

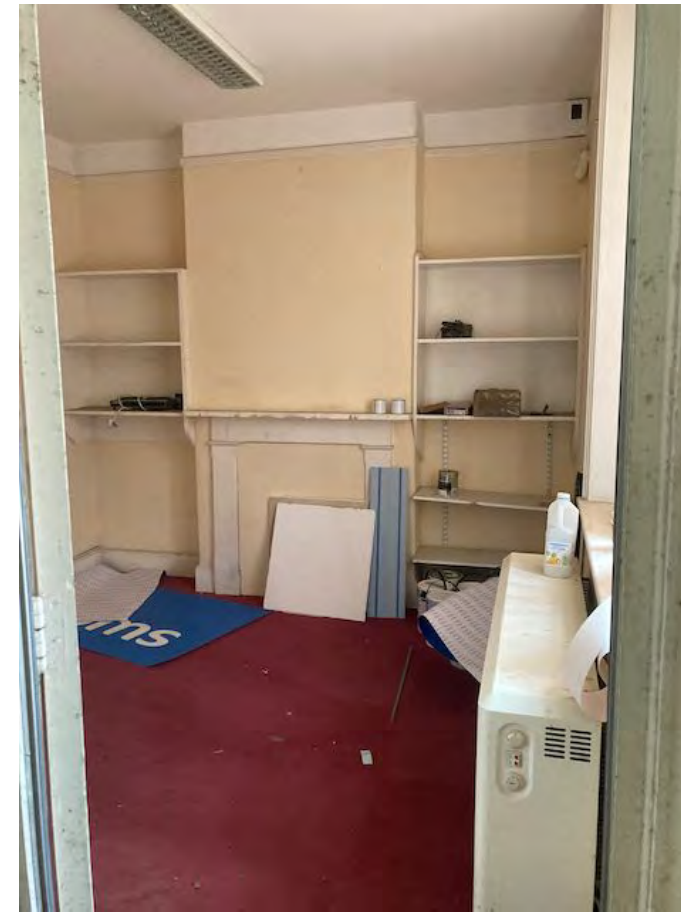
Caretaker's living room/office accommodation

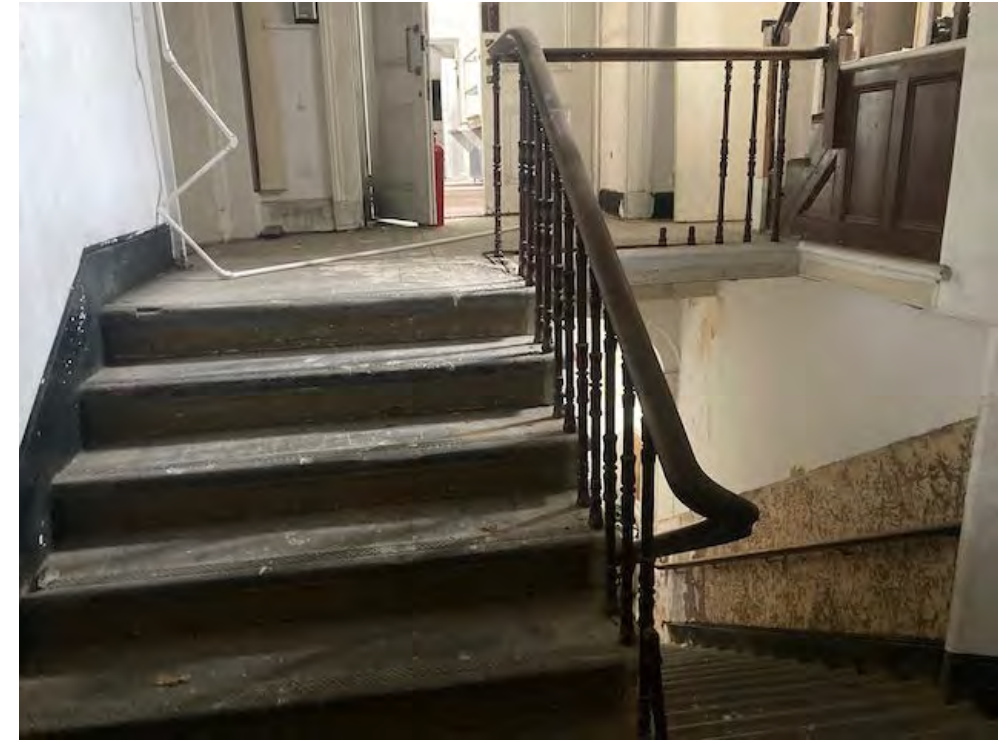
- D.27.8. To the rear of the landing is a service staircase (F23) leading to the second floor accommodation, under which there is a small storage cupboard presently full of a large number of junk items.
- D.27.9. The interior of the cupboard is boarded out and care should be taken to ensure testing for asbestos fibres is carried out to the boards. The flooring is of suspended timber type as per the landing outside.
- D.27.10. This section of the building will require significant repair works in order to make it safe and ensure that it can be returned to useful service, and to provide access to the main first floor assembly room spaces.

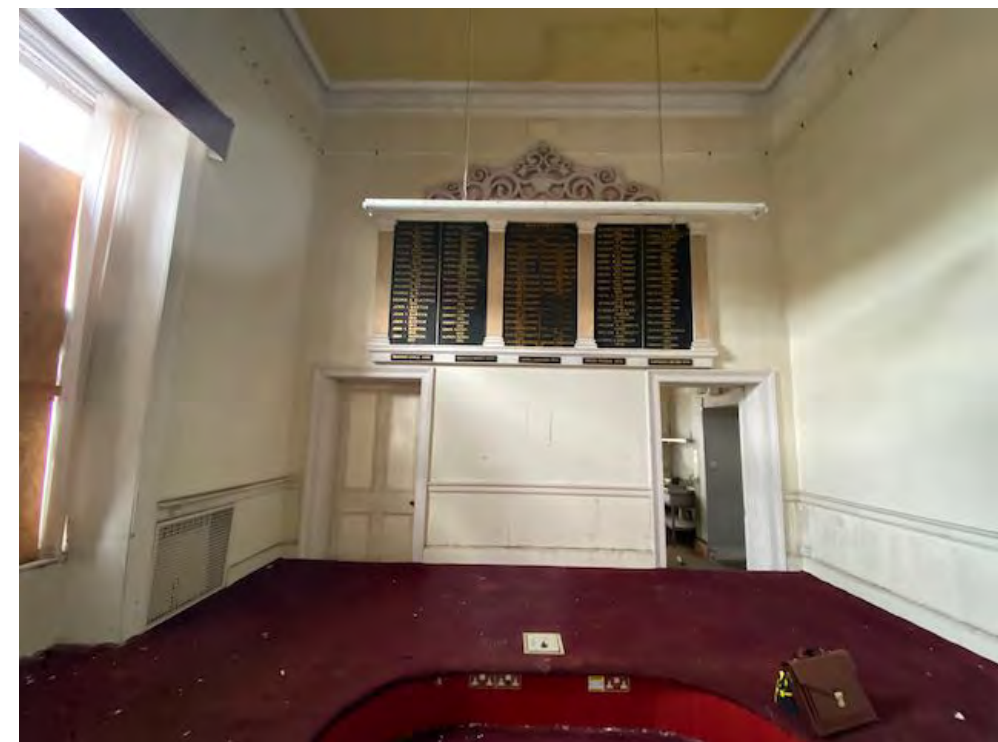
The Council honours' boards

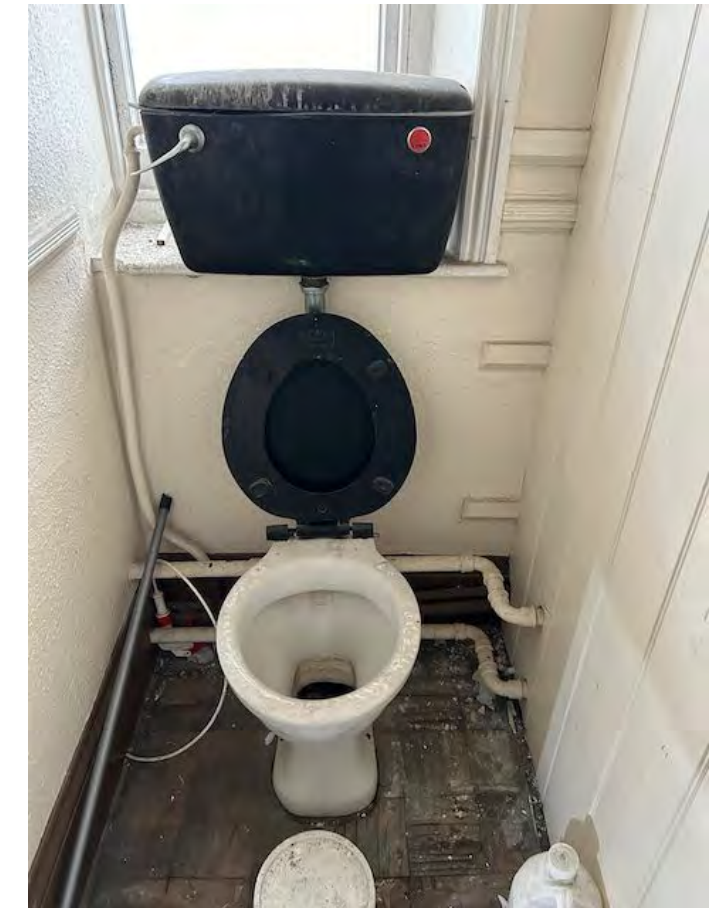
Asbestos suspected to seat and cistern

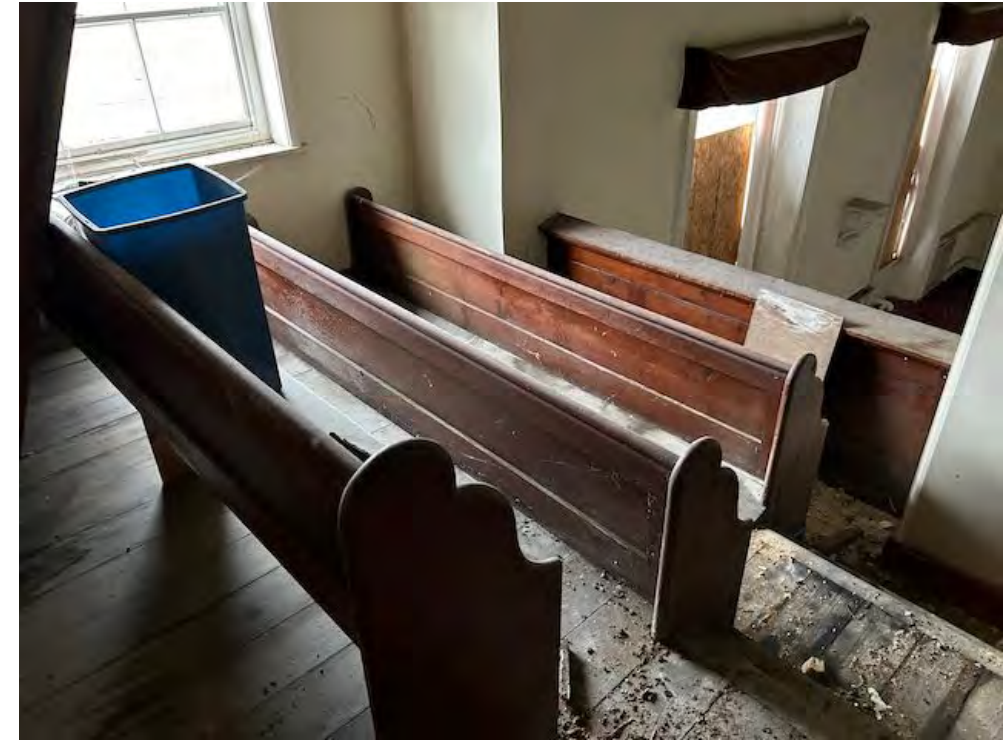
The Council Chamber gallery

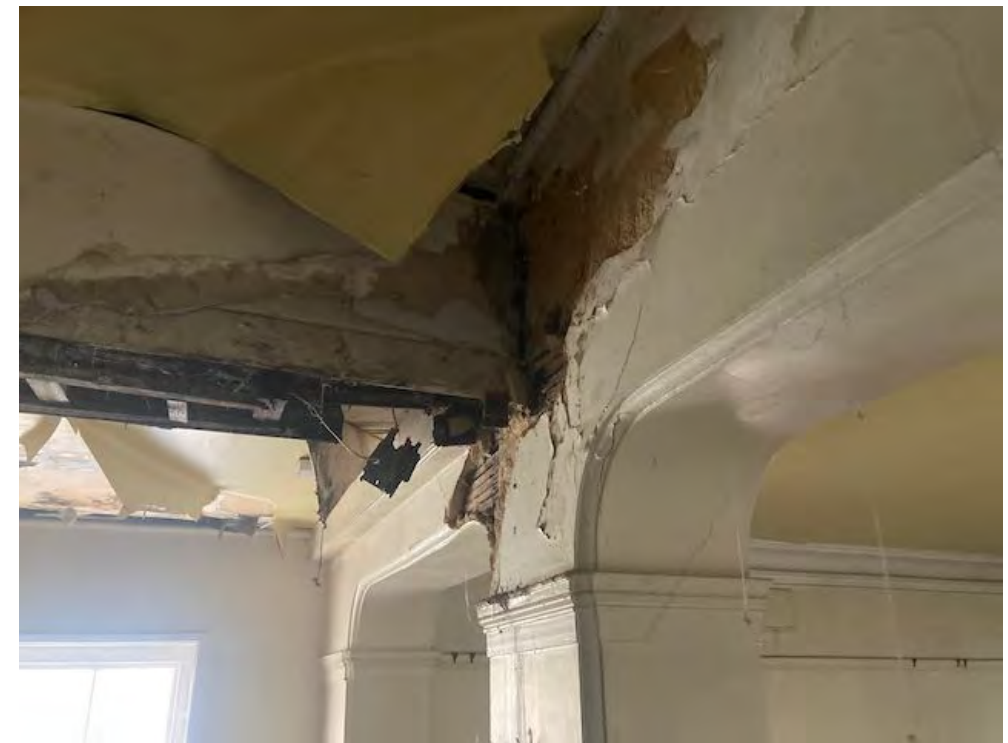
Decay to beam urgently requiring support (Urgent)

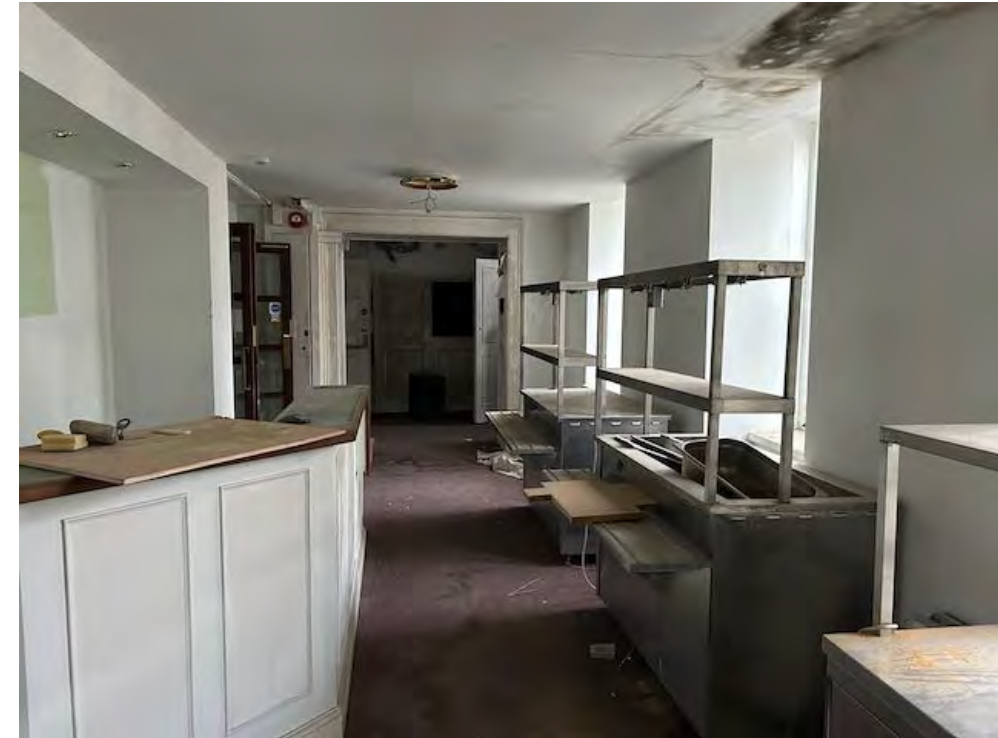
- D.31.12. The ugly modern additions to this space reflect poorly on the building's status and it is recommended that given the failures, they are removed and the full height space reinstated

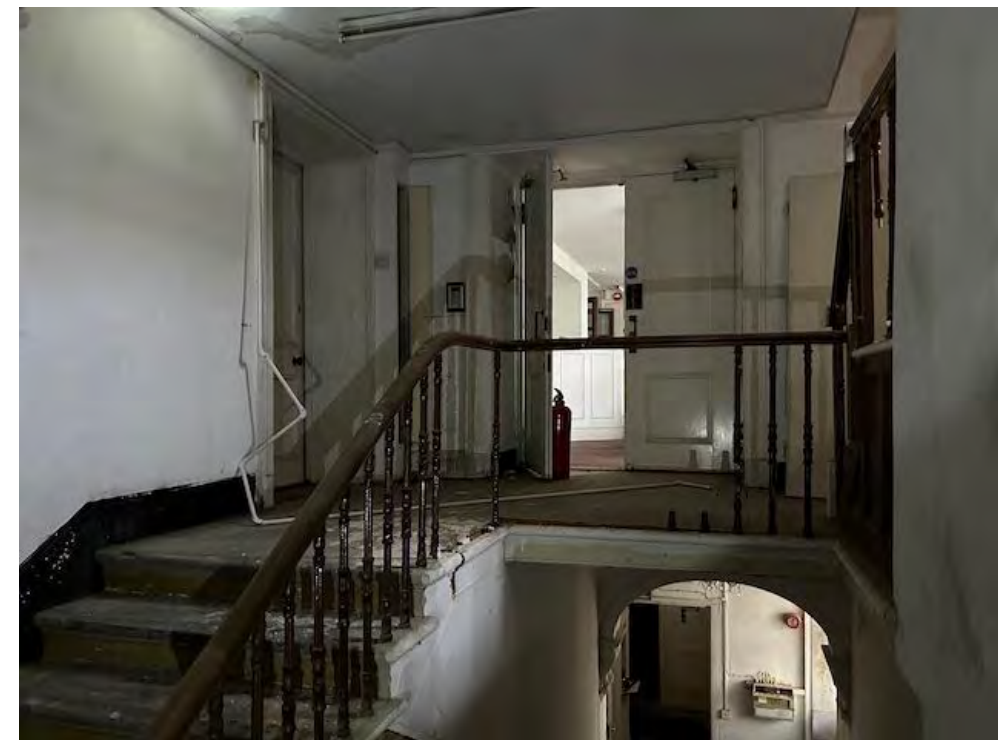
First floor foyer from main landing (Through doors)

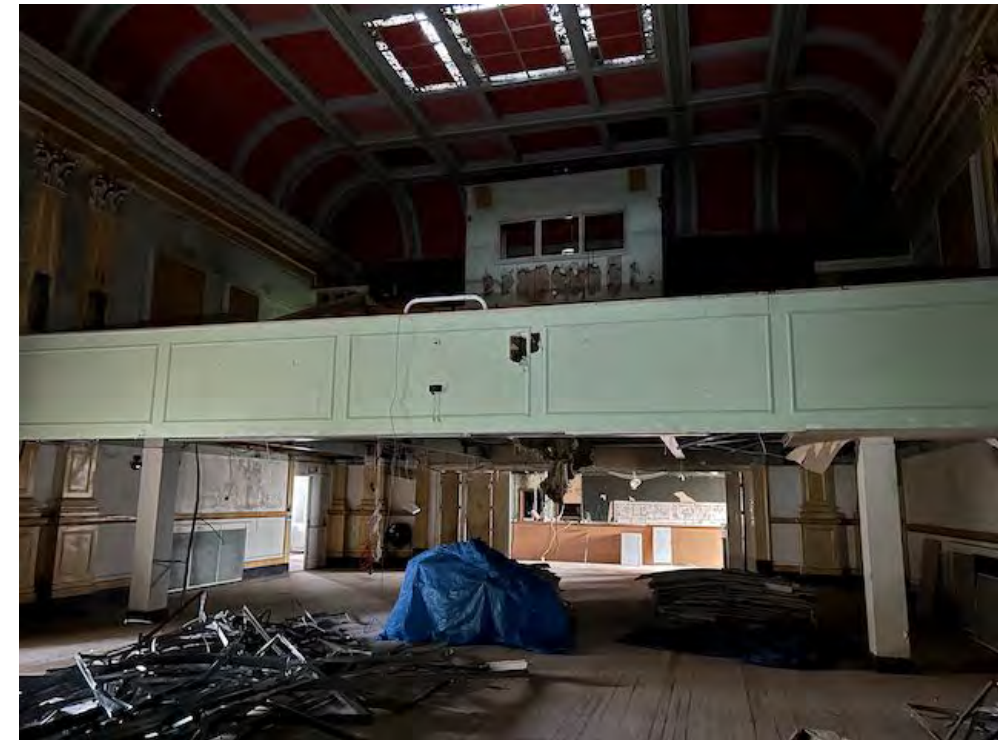
Auditorium and balcony

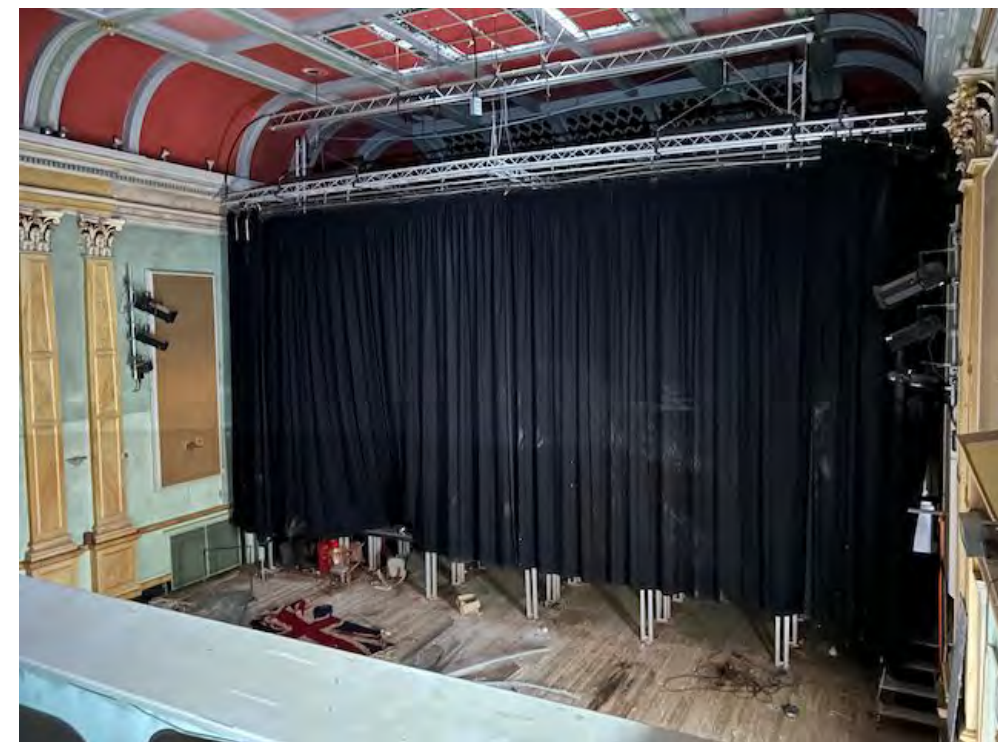
Stage at east end from gallery

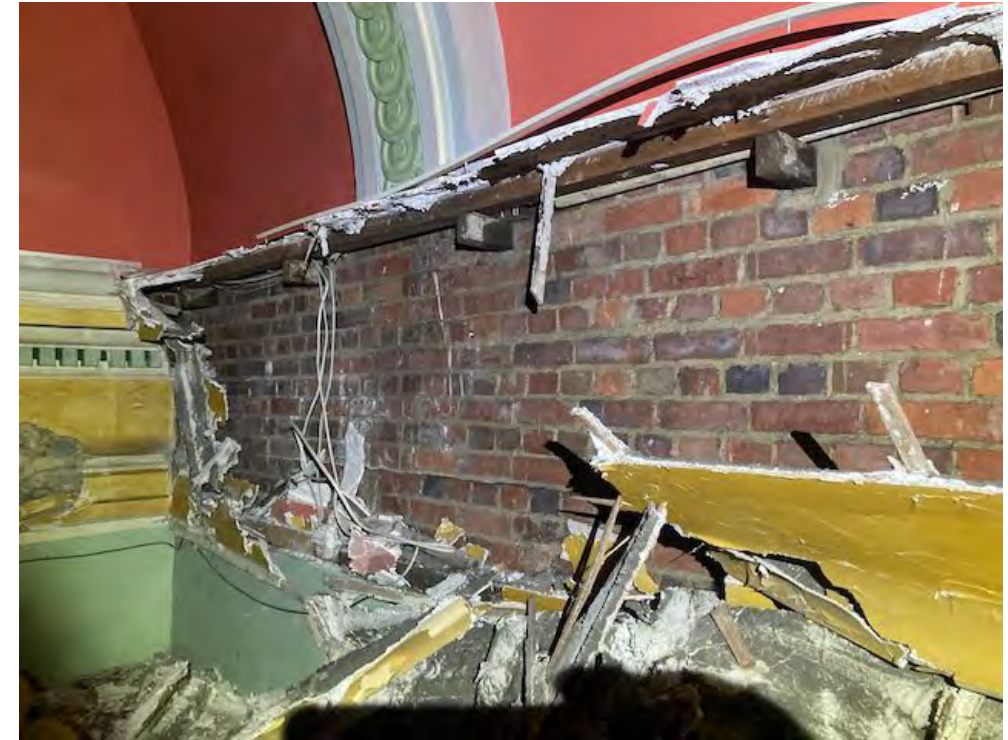
Damage to plaster coving on the north wall of the auditorium

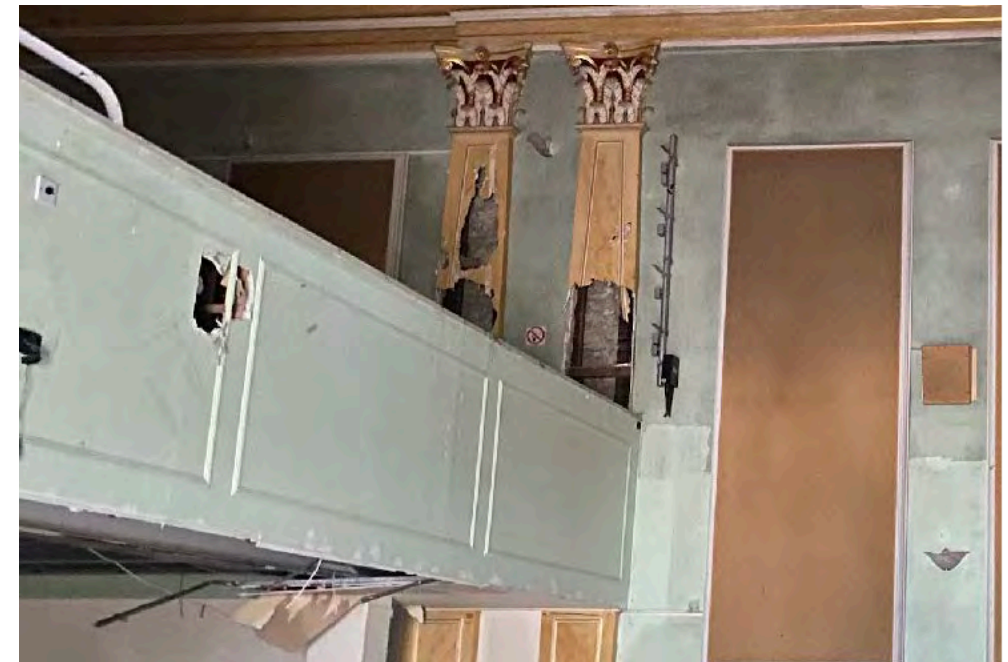
Damaged pilasters at balcony level

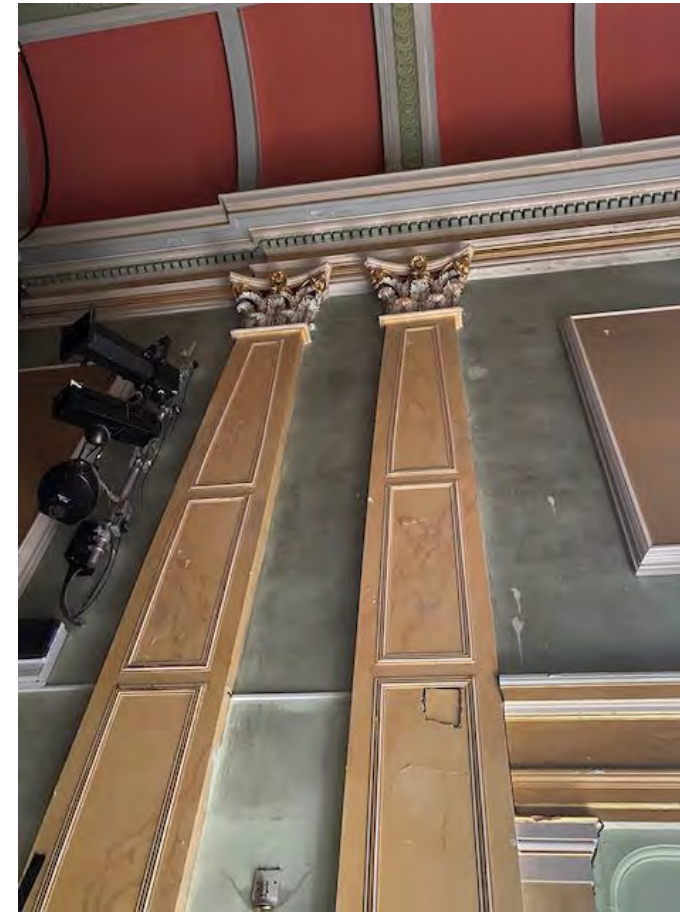
Damaged pilasters in the auditorium

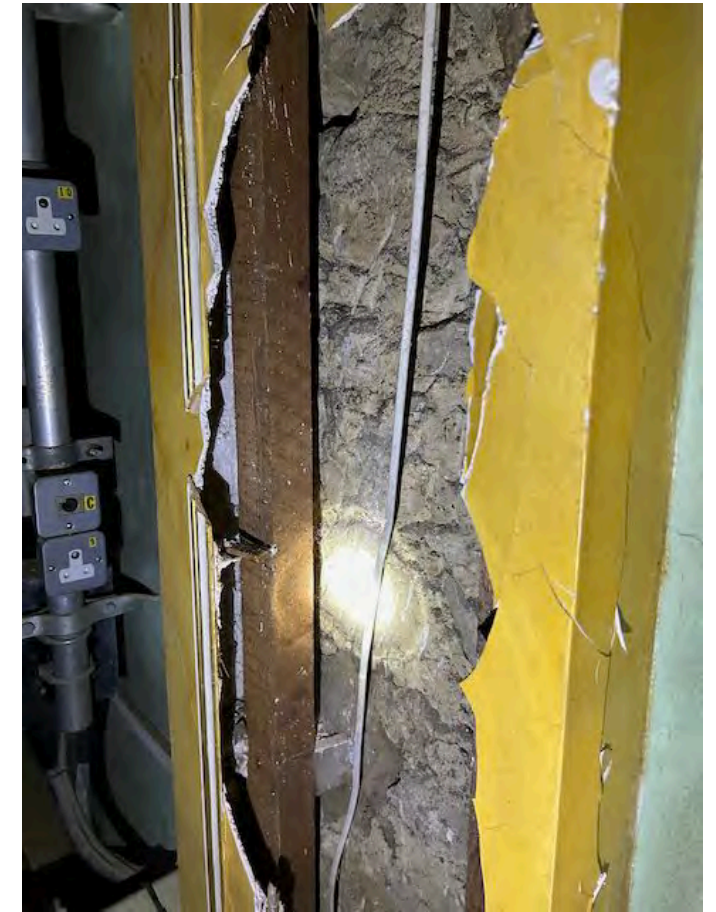
1930's timber grounds with hessian plastered finish over

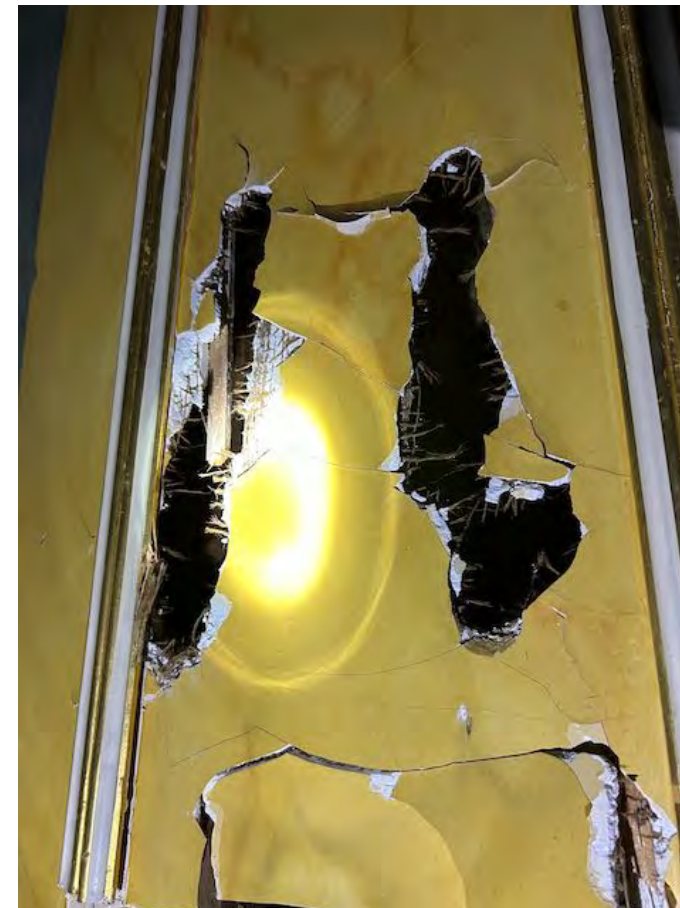
RYDE TOWN HALL, CONDITION SURVEY

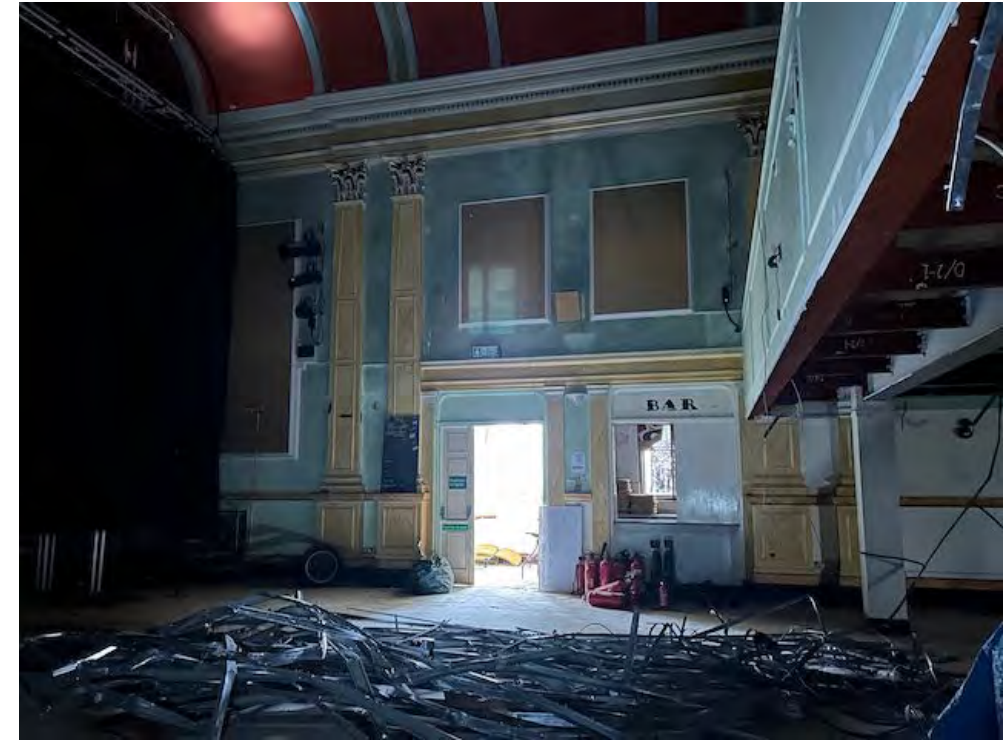
Main Auditorium with gallery to left, and small bar

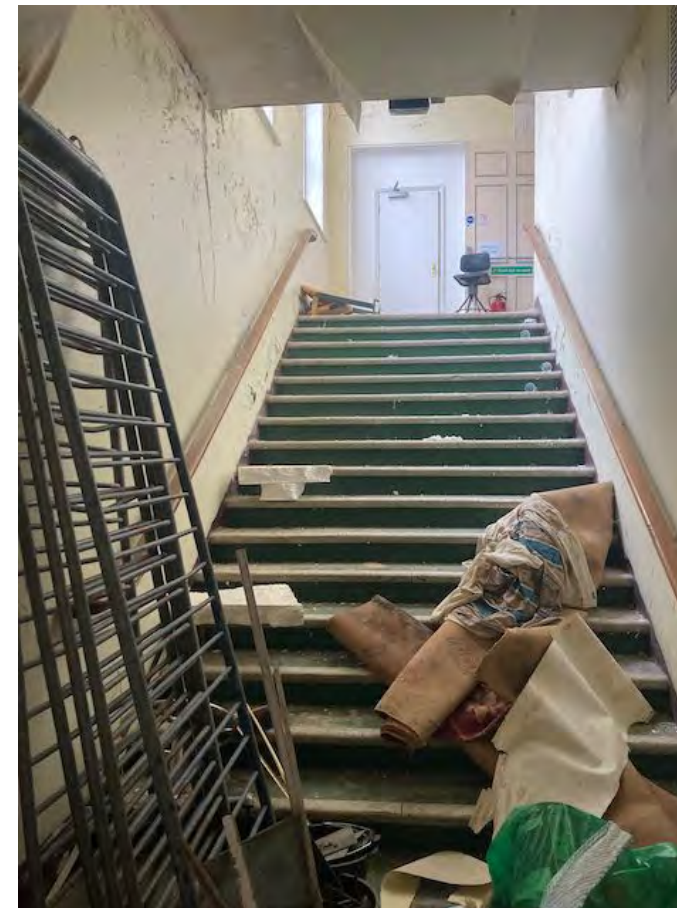
Lobby at the top of the stairs leading to the small bar and auditorium

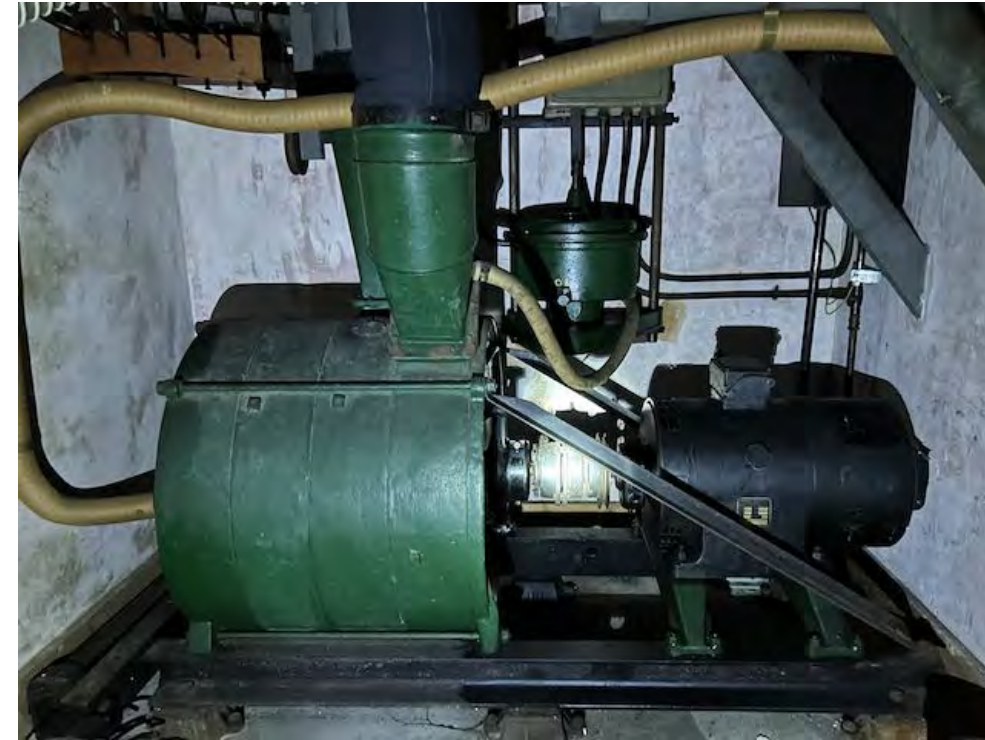
- D.36.1. There is a set of stairs leading from half landing to area at rear of the stage.
- D.36.2. The ceiling of the stairwell is of matchboarding and other types of timber board to the soffits of the stairs, some cracking and opening up of the matchboarding indicative of the movement that is being experienced by this section of the building.
- D.36.3. There is also a section of the landing which is enclosed by timber boarding which contains the upper parts of a sloping ceiling, most likely for the area below accessed separately.
- D.36.4. The walls of the landing are of solid plaster, again with some cracking indicative of movement to this area of the structure.
- D.36.5. The plaster is in poor condition, as are the decorative finishes.

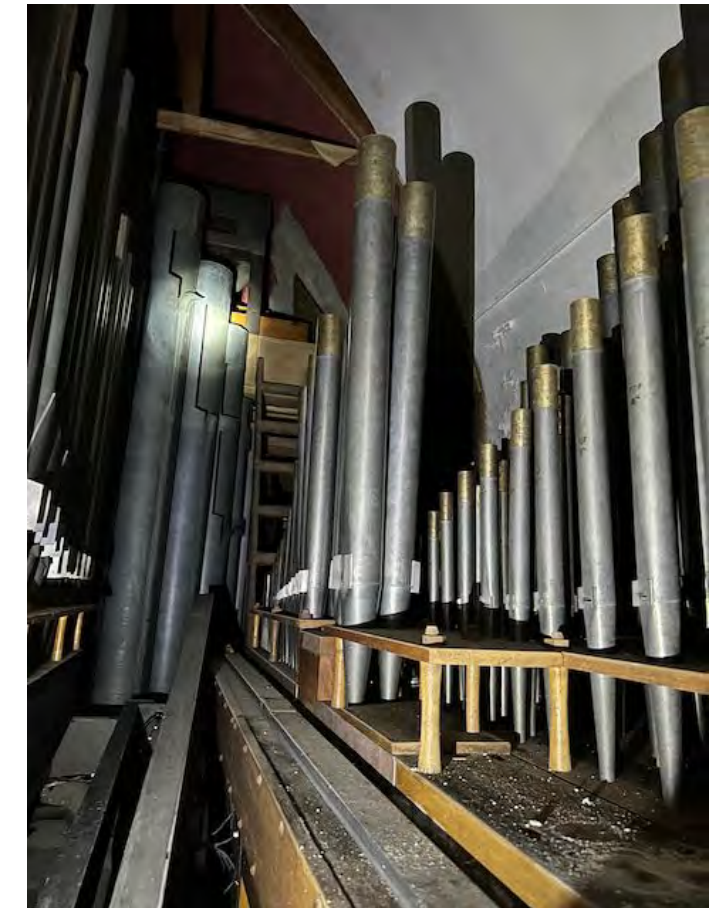
Stairs leading to the stage

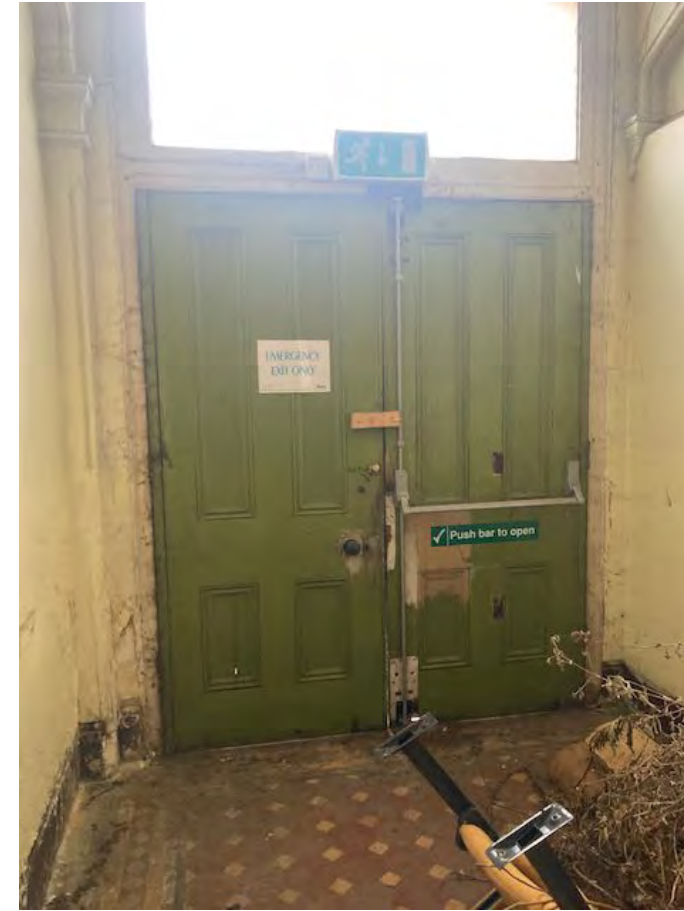
Ground floor entrance from Green Stair
Exit to Lind Street

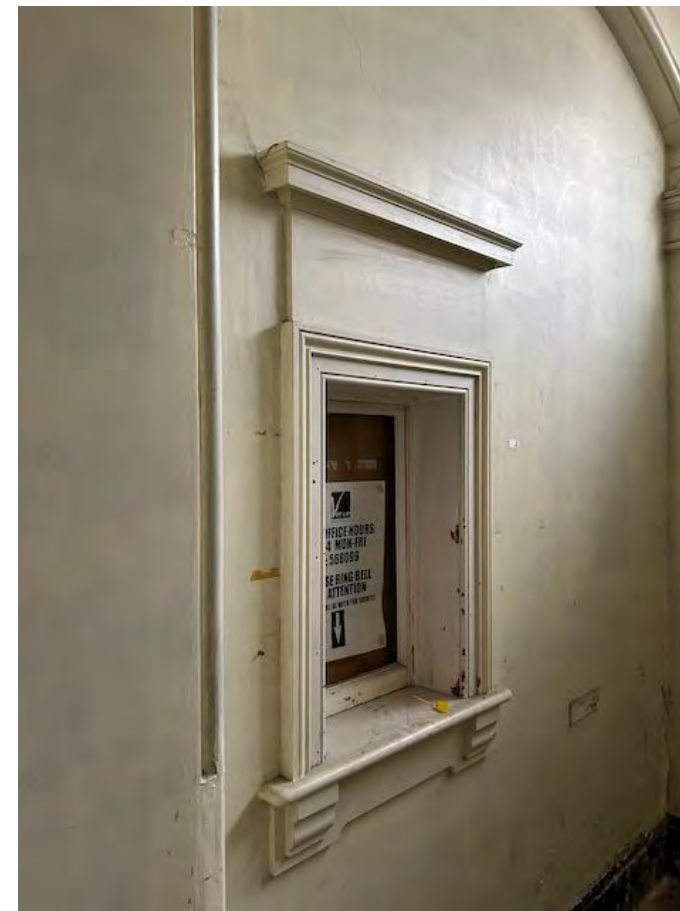
RYDE TOWN HALL, CONDITION SURVEY
