Condition Report

Ryde Town Hall

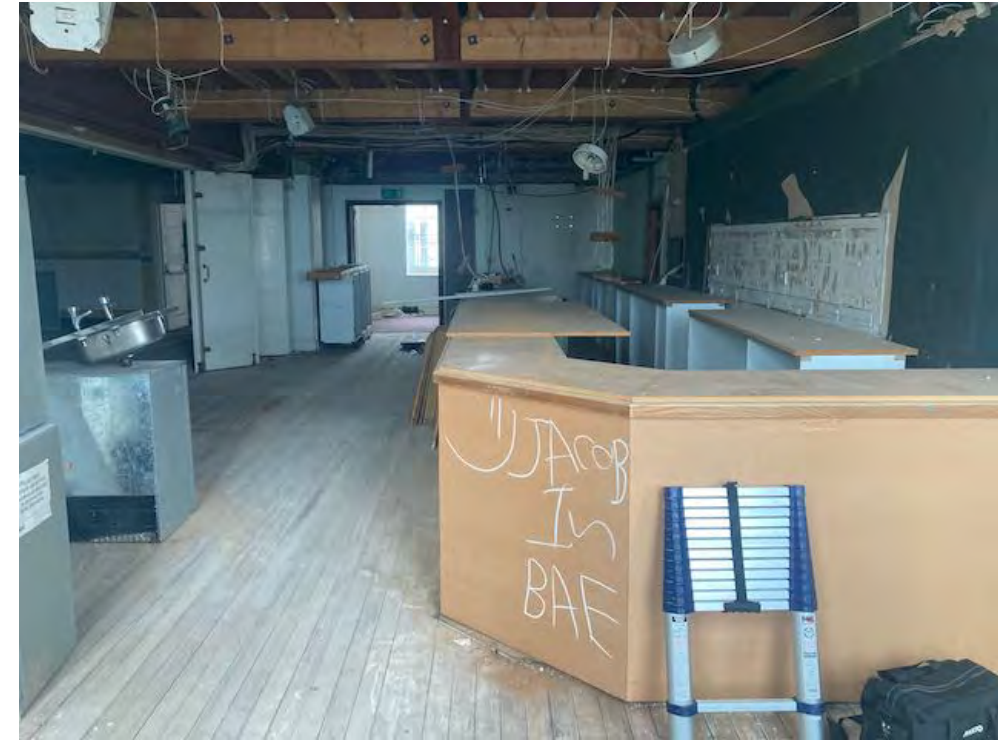
Bar area at rear of auditorium

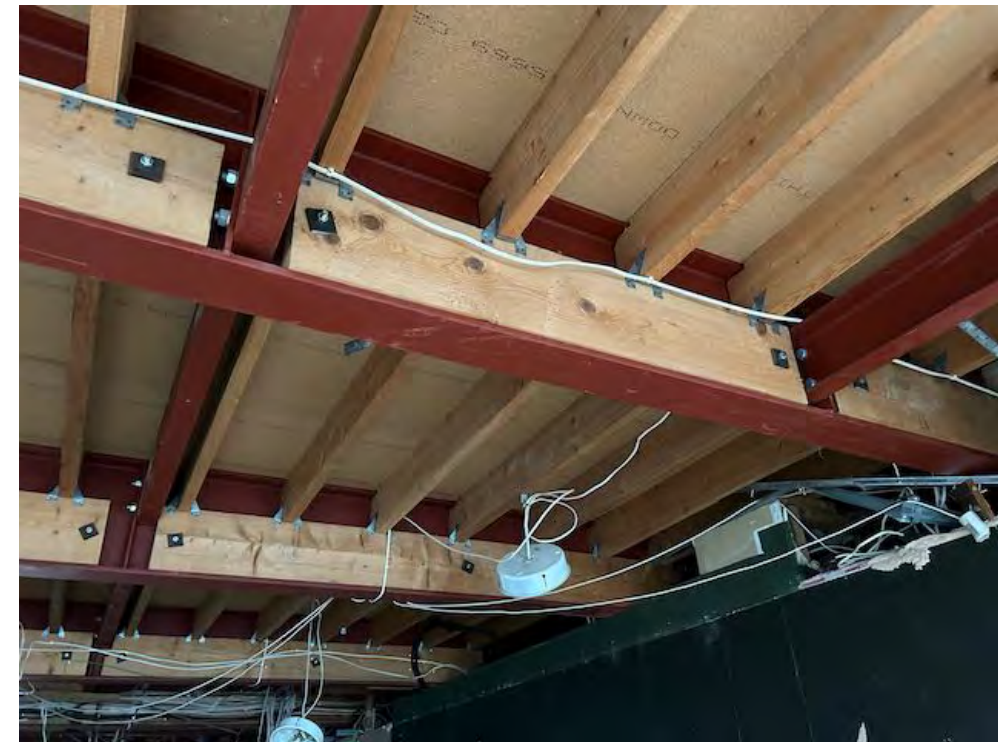
The steel frame of the mezzanine

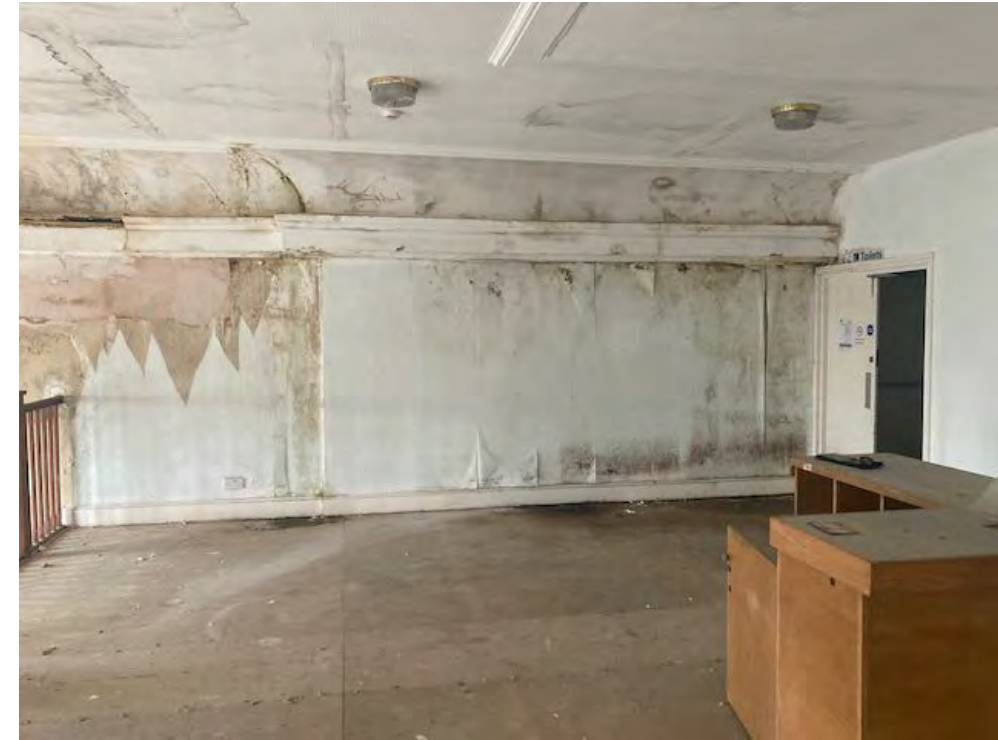
- D.41.6. In the rear corner of the room is a doorway leading directly into the rear ancillary accommodation of the main Council Chamber.

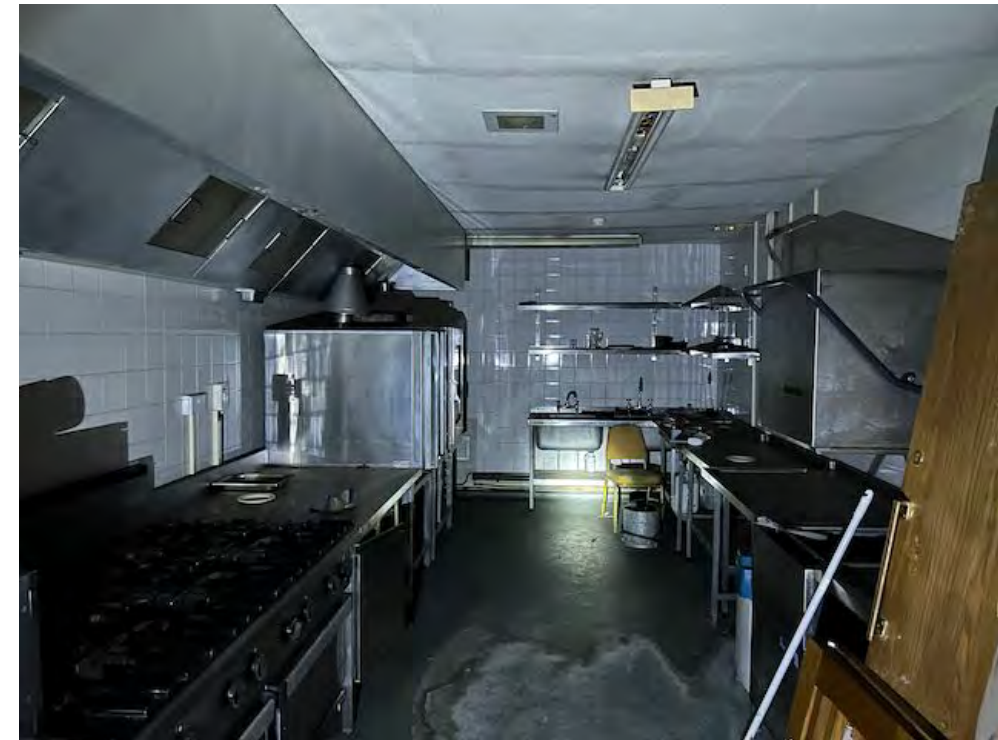
Catering area behind main bar

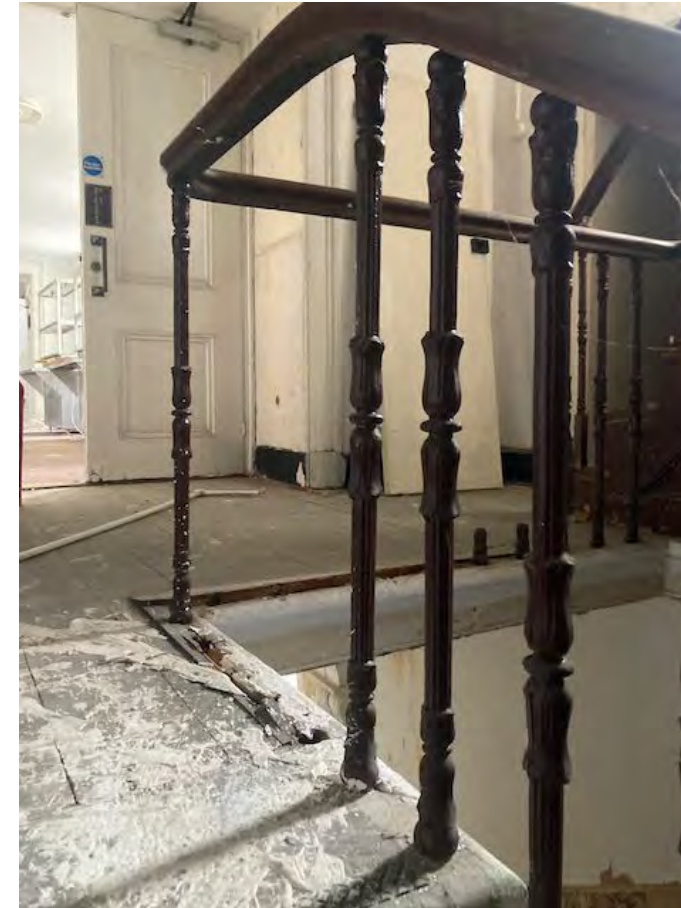
Broken spindles on staircase

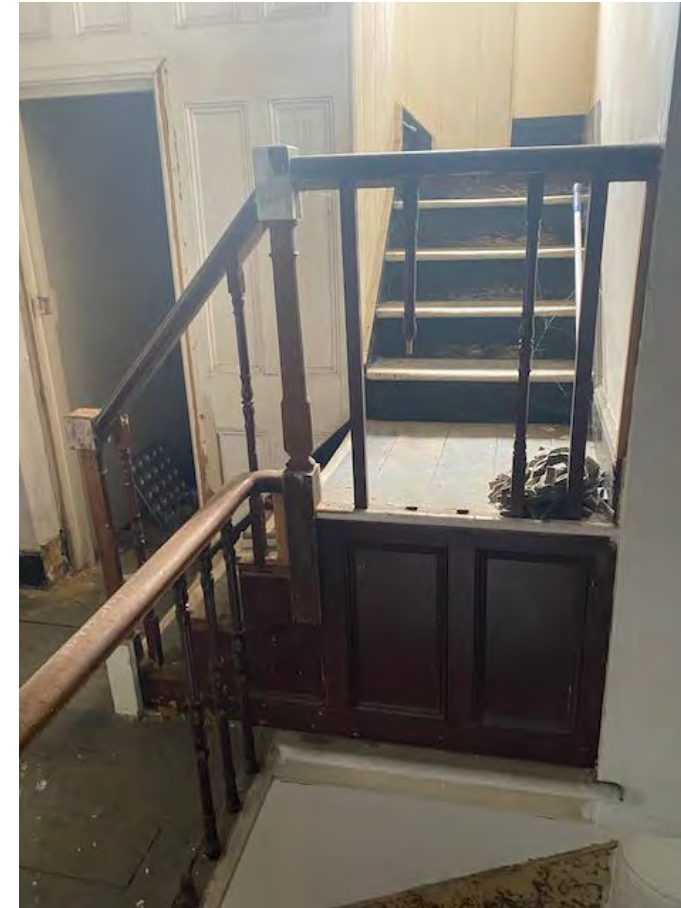
Stairwell to rear of Council Chamber

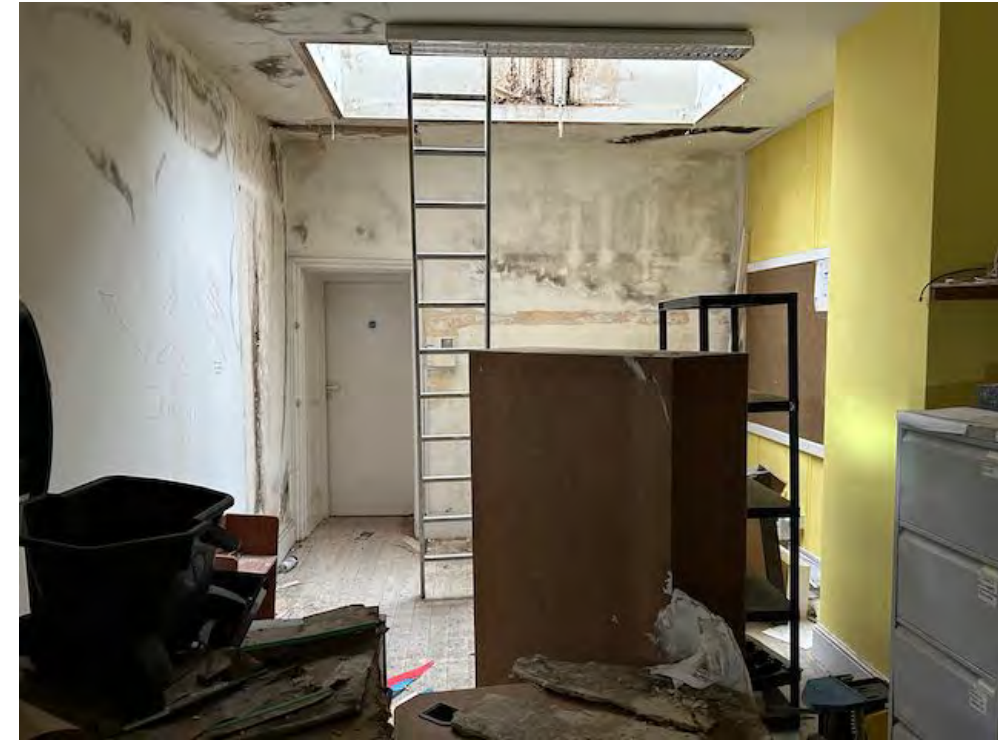
Office below clock tower

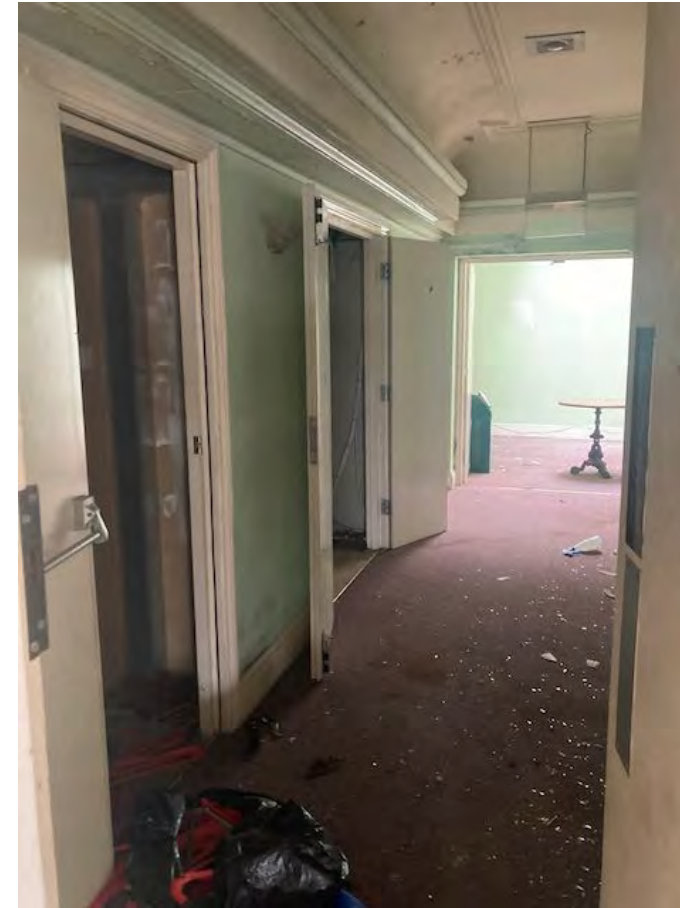
Landing S11 and lobby area behind lighting box

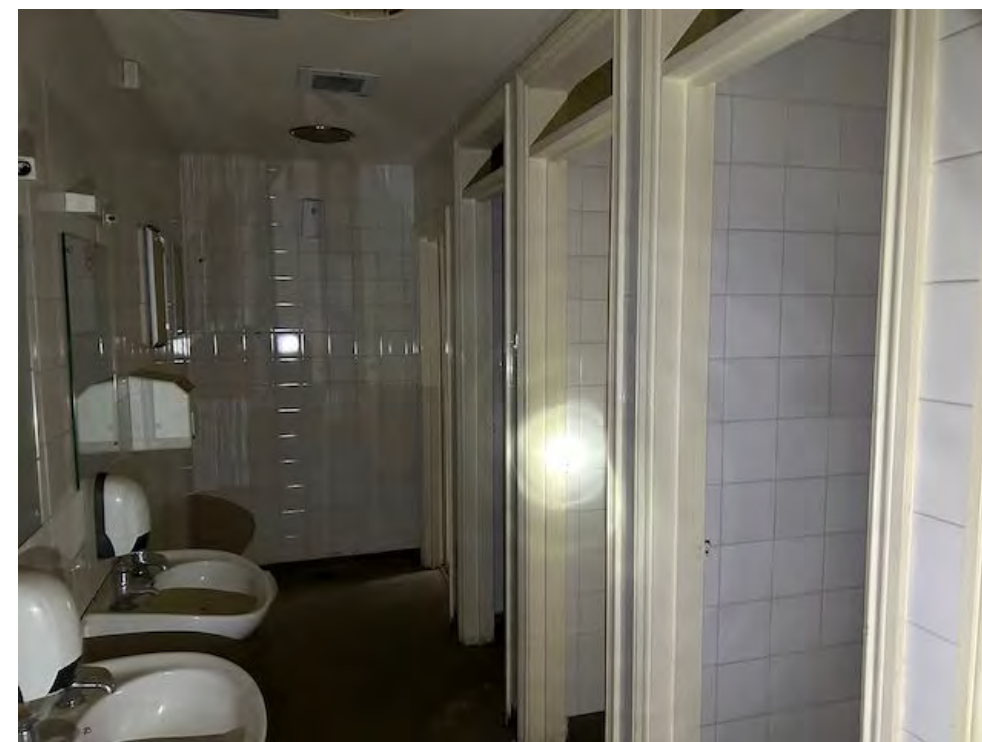
Toilets S9 with water cylinder cupboard beyond

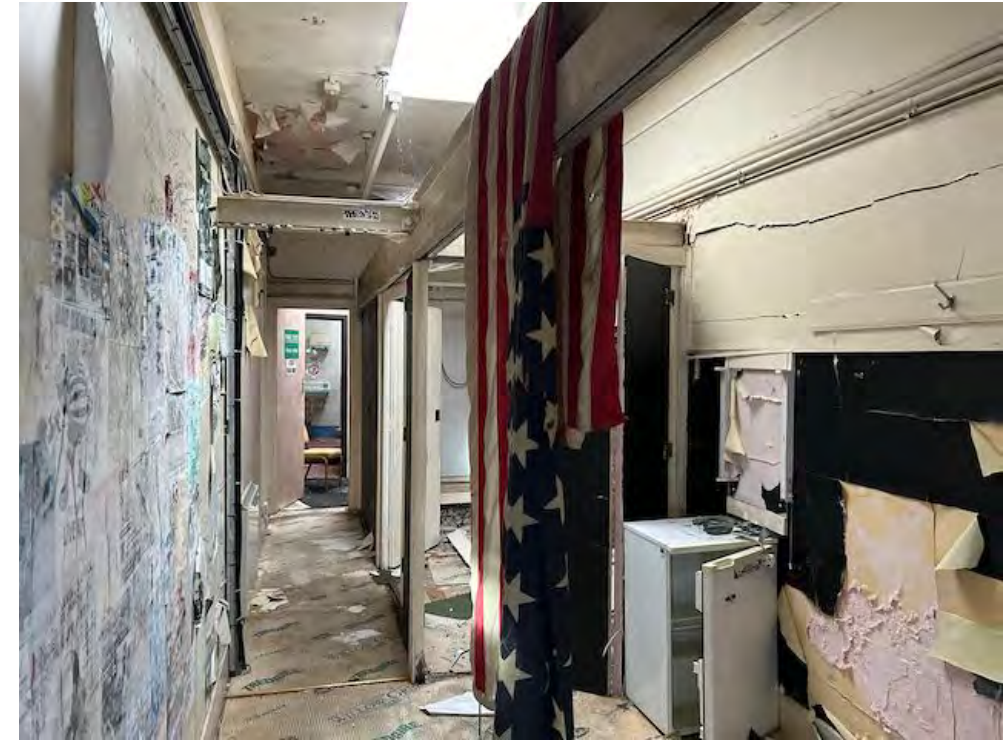
- D.46.8. Significant damage to the sanitary fittings which are beyond salvage and these will need to be removed.

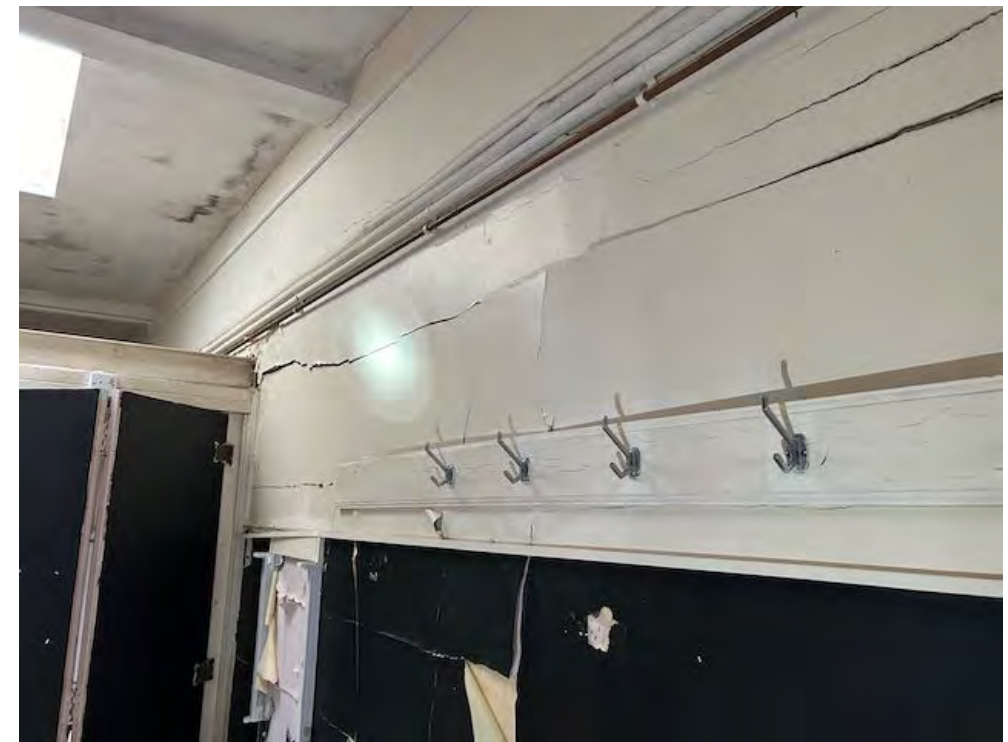
Horizontal cracking in wall due to failure of rib lath on damp south facing walls.

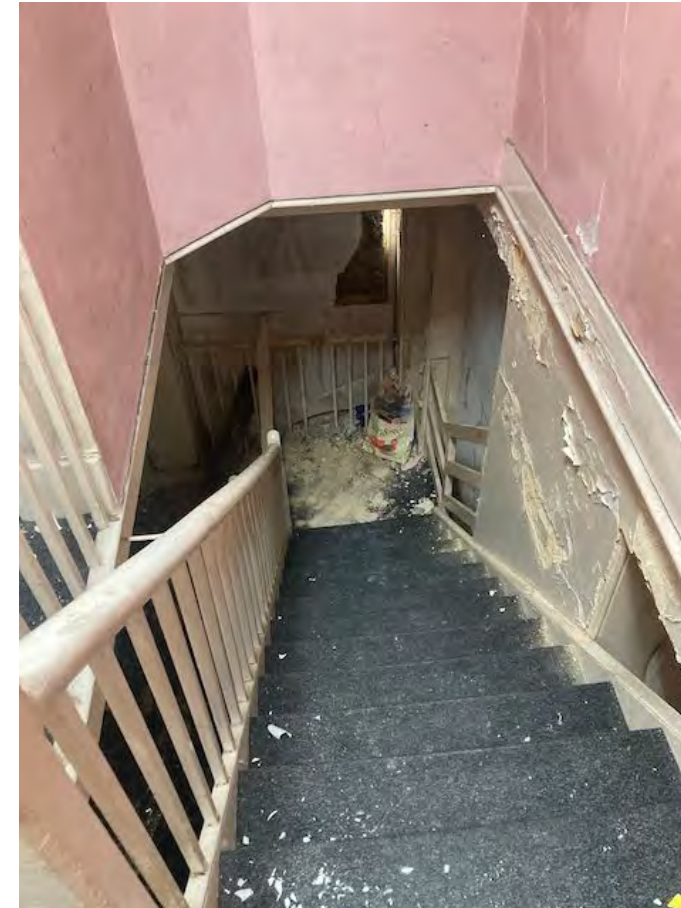
Performers' stairwell in south eastern corner

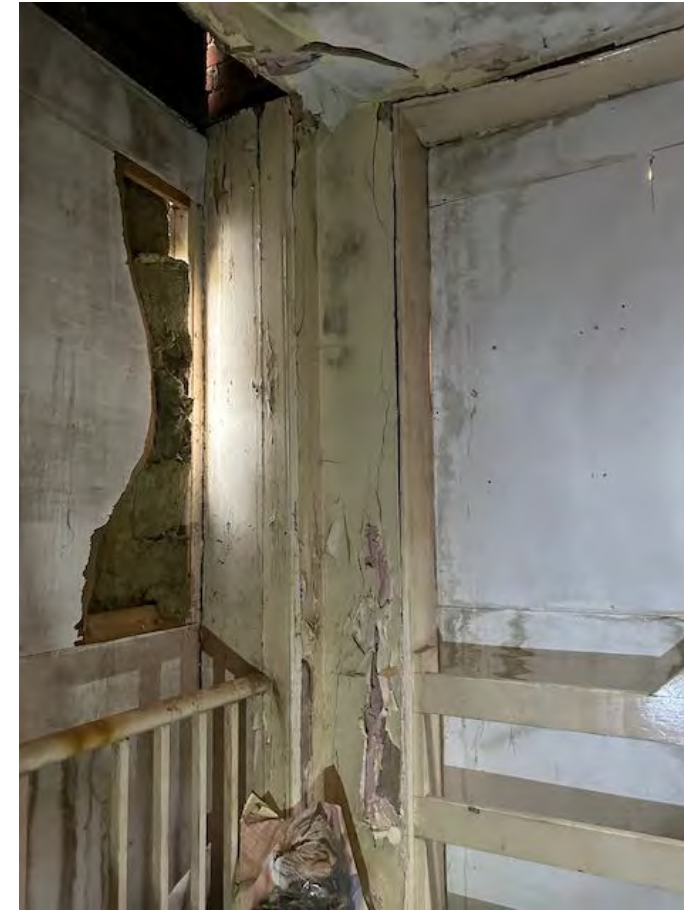
Extensive cracking to SE corner. Note close proximity of openings to the corner (south and east walls) which is a potential source of weakness.

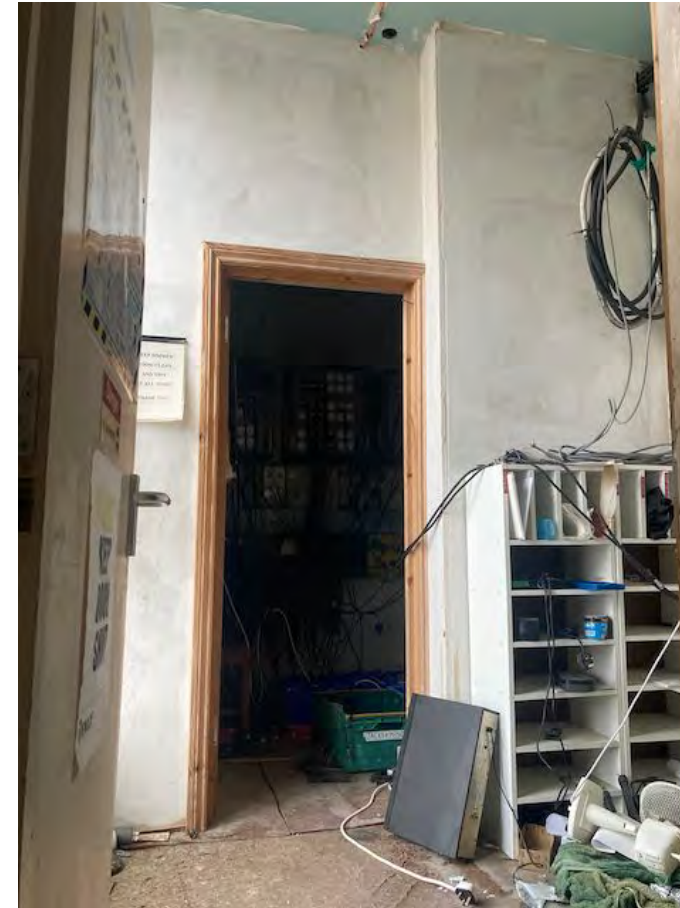
- D.48.8. The floor is of suspended timber type with softwood boards mainly covered by a decayed linoleum type floor covering. The floor seemed stable and even with no significant movement or deflection noted.

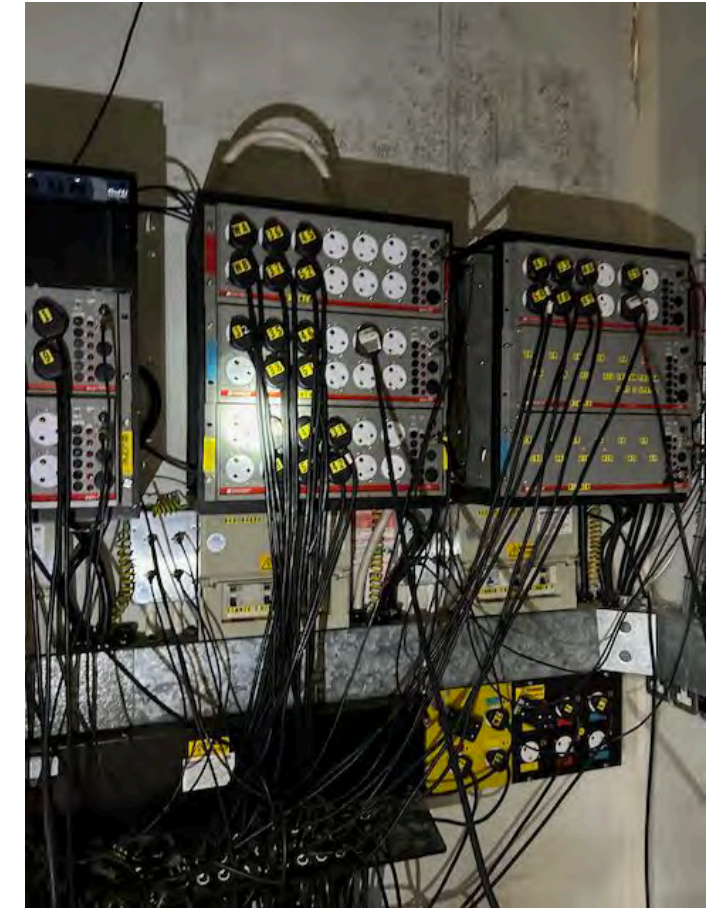
Dimmer room equipment

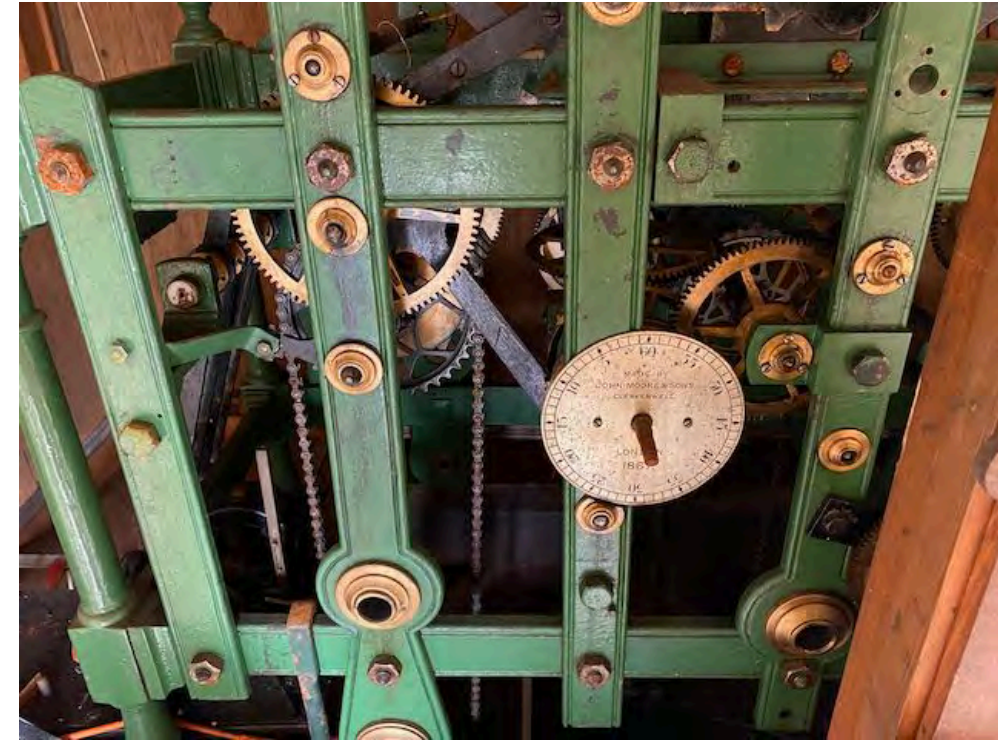
- D.50.1. The clock is a fine feat of Victorian engineering, and is ascribed to John Moore and Sons of Clerkenwell (1867). The cast iron frame of the clock is painted green, with the mechanism on view behind. The whole clock is raised on a platform above the floor, with a softwood framed case and modern stained plywood panels.
- D.50.2. We would recommend that access is provided to allow the expert opinion of a horologist to be sought, so that a detailed assessment can be made. To our uninformed eye, it appears entirely possible for the to be carefully overhauled and to be brought back into use. The introduction of an auto-winder would be a worthwhile addition, provided this can be added with sensitivity to the existing fabric.

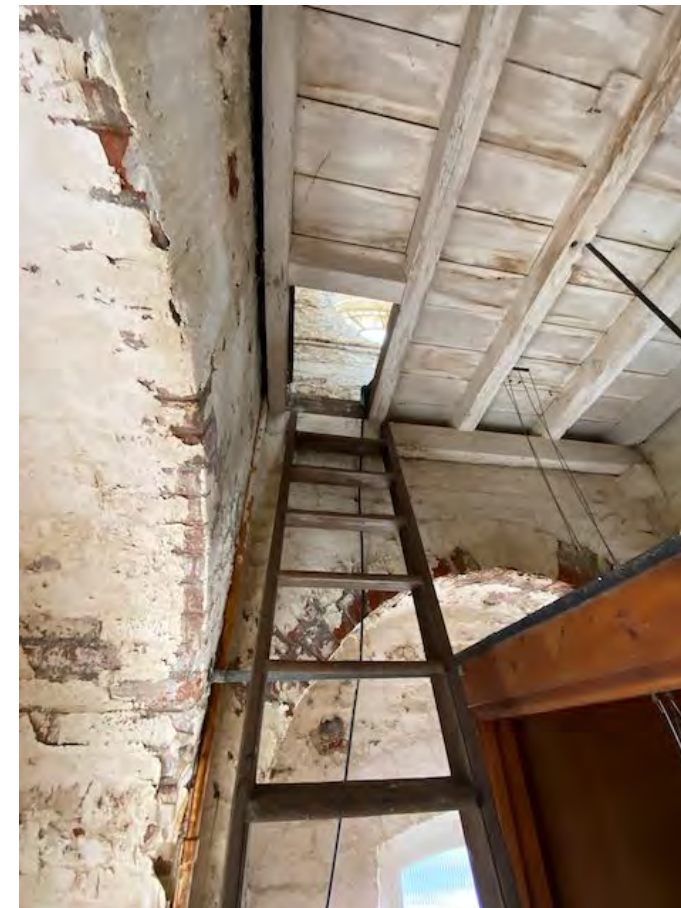
Wooden ladder providing access to clock face level

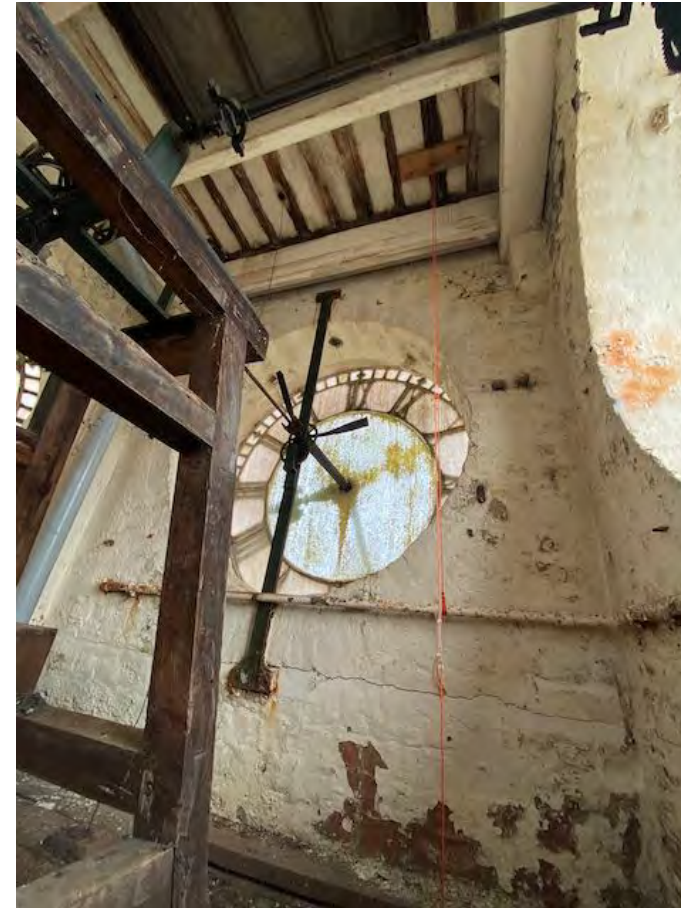
Walls inside the clock tower.

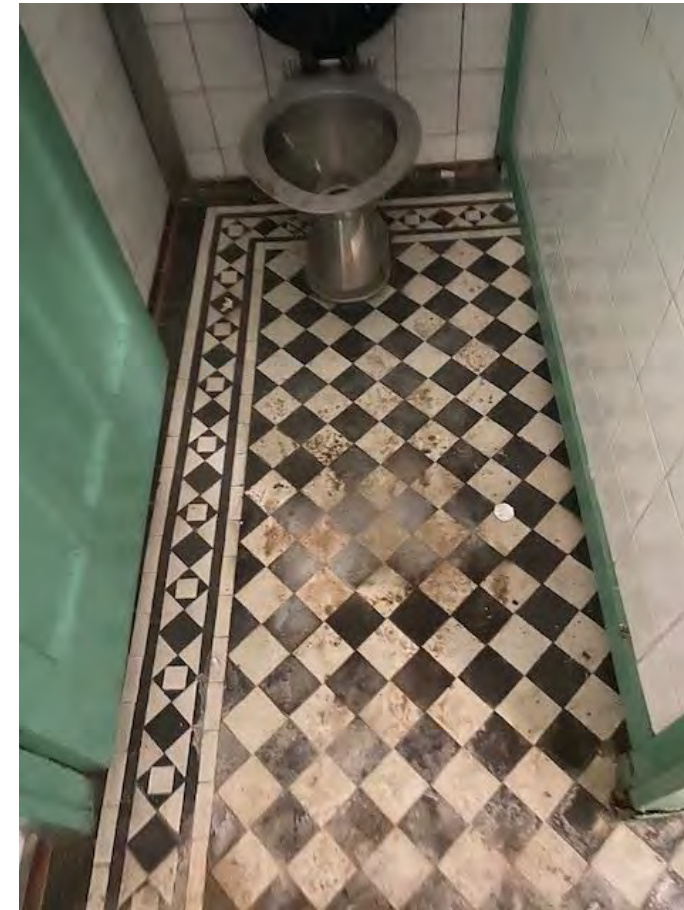
The tiled floor of the public toilets

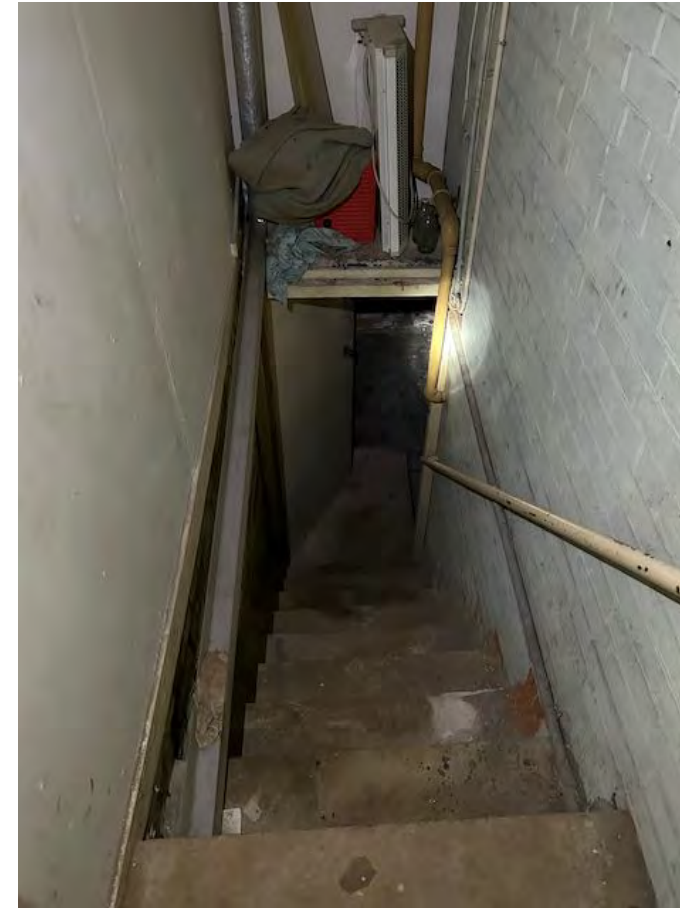
Access to boiler room

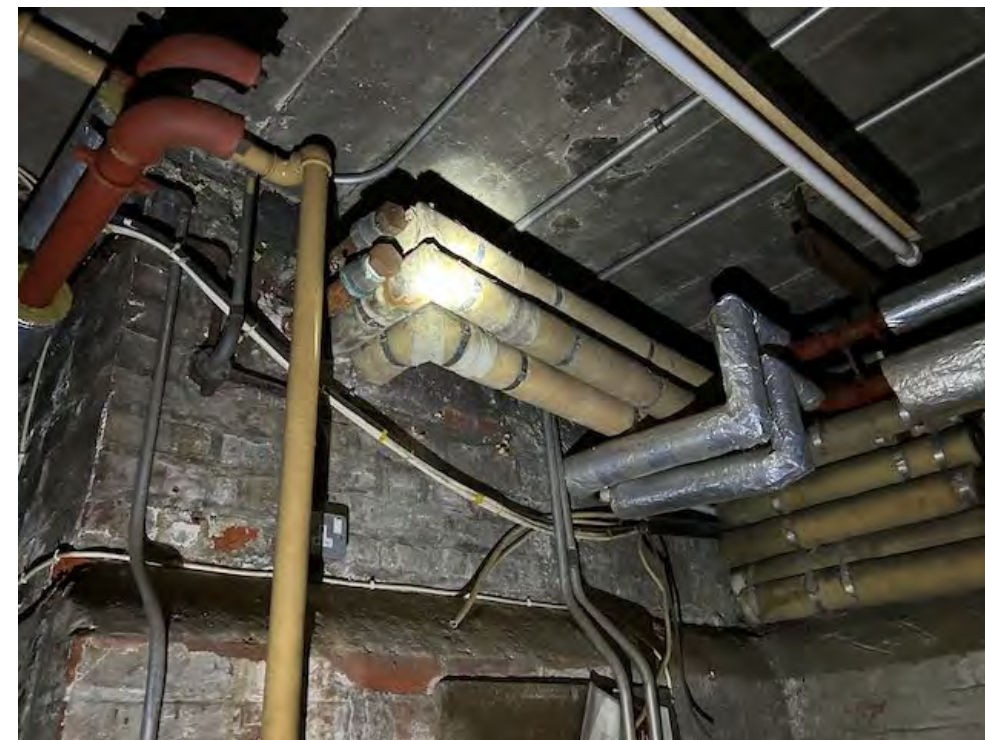
*Pipework showing different phases of work and concrete soffit to ceiling. Risk of **asbestos***

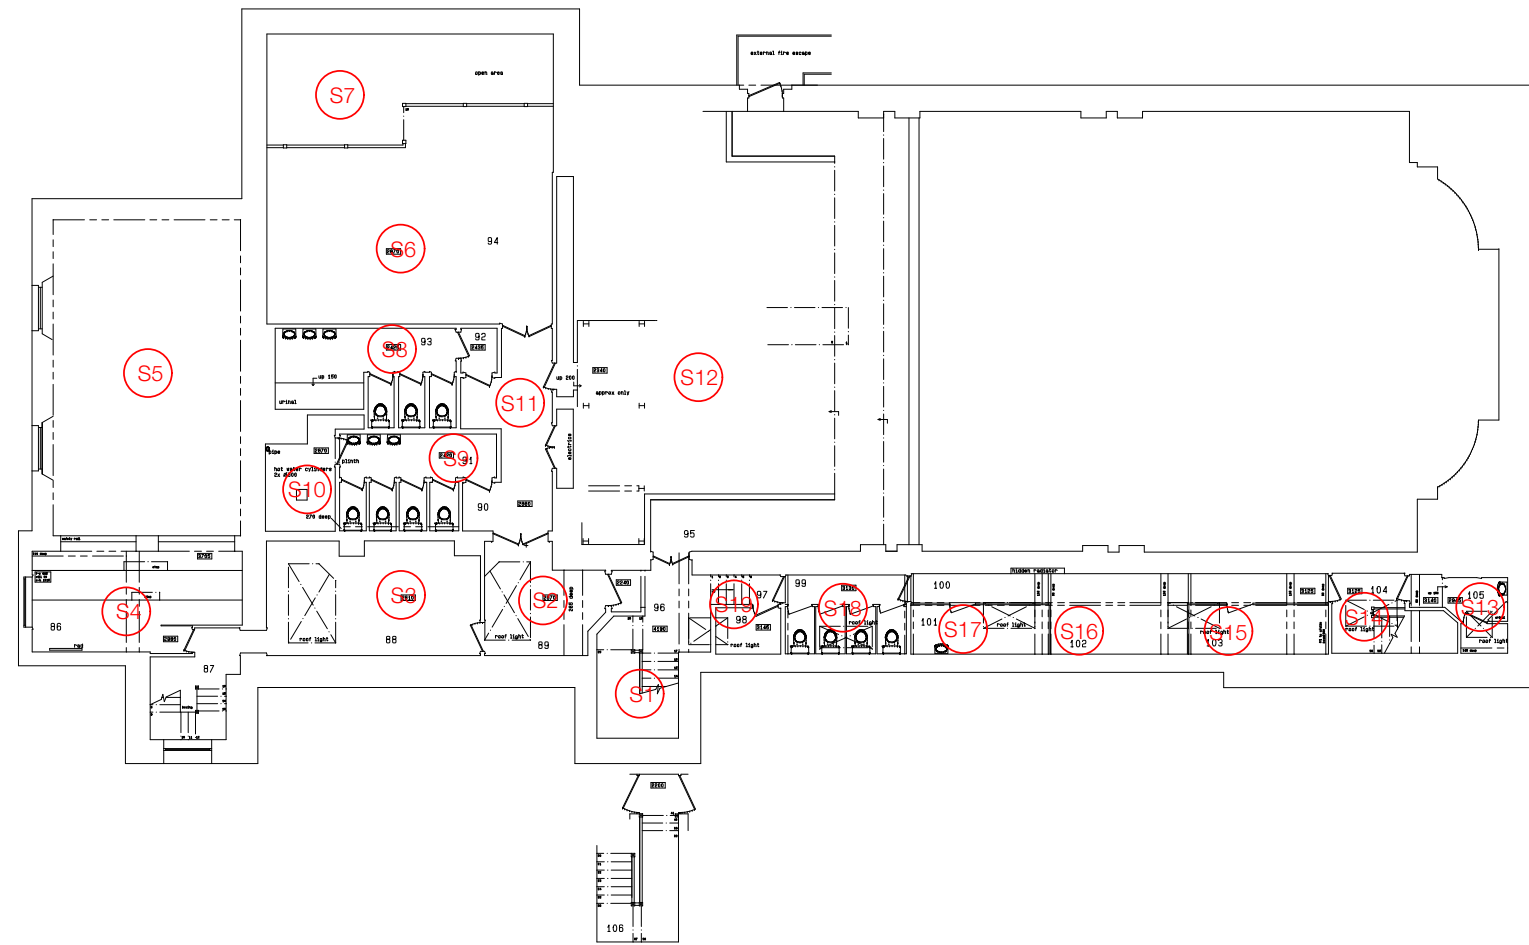
RYDE TOWN HALL, CONDITION SURVEY
