Conservation Management Plan

Ryde Town Hall

November 2023

The Goddard Partnership Limited

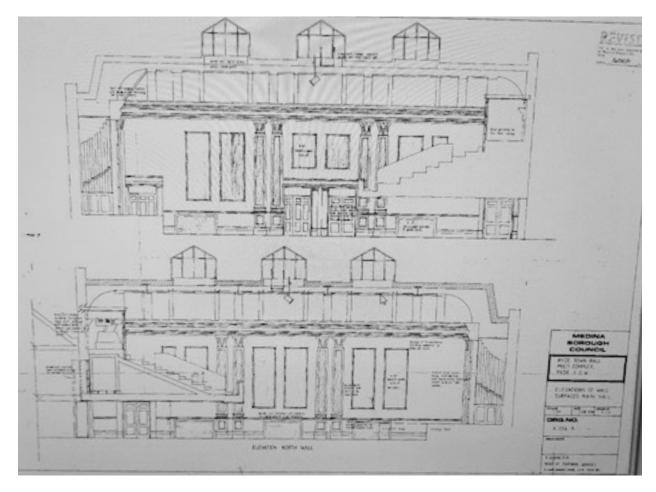
Plans for the insertion of the gallery (Listed Building Consent: LBC/20510A/M/8444 (1990)

- B.3.6. The introduction of the gallery in the main auditorium has had a very significant and a negative impact on the scale of the main space, notwithstanding the significant damage it has caused to the fabric in providing the connections to the existing structure for support. The reason for such changes were no doubt well intentioned to increase the commercial viability of the venue, but in so doing causing visual and physical harm to the asset. The removal of some of the interventions should therefore be considered a priority, but while still recognising the commercial imperative which will be needed to sustain such a large building.

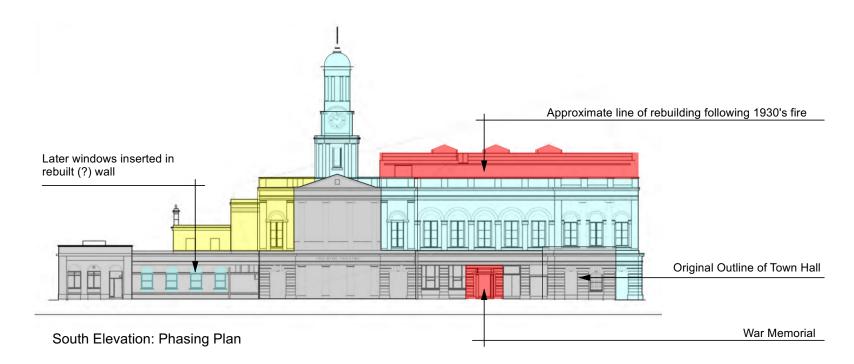
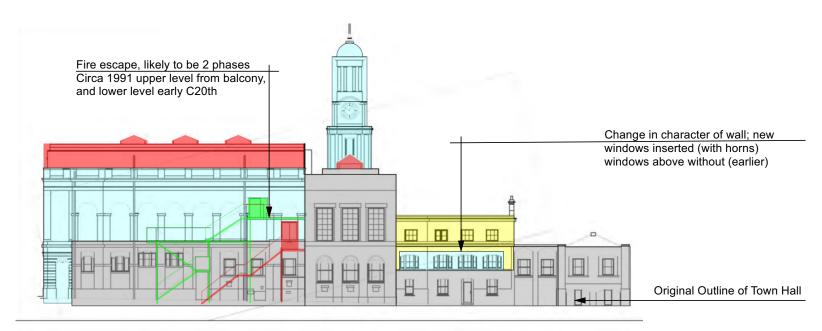
North Elevation: Phasing Plan

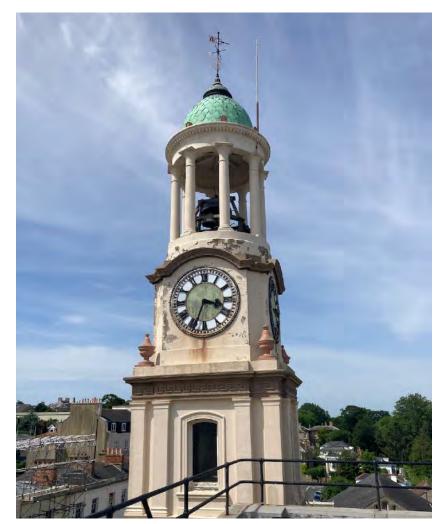
The clock and cupola viewed from the east

The cupola and clock are of high cultural, social, scientific (clock movement) and aesthetic significance.

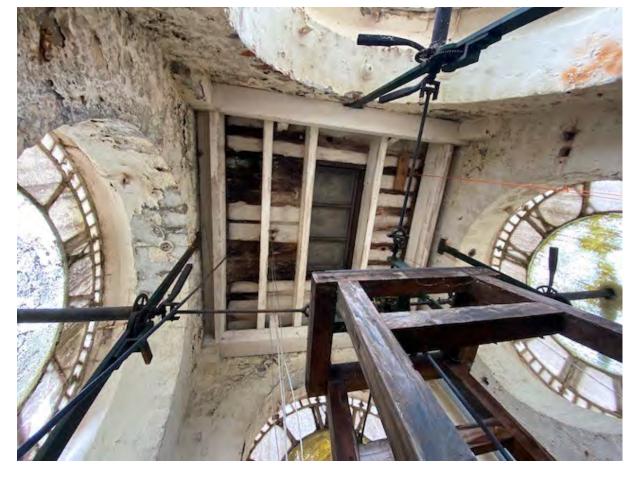
Within the Clock Tower

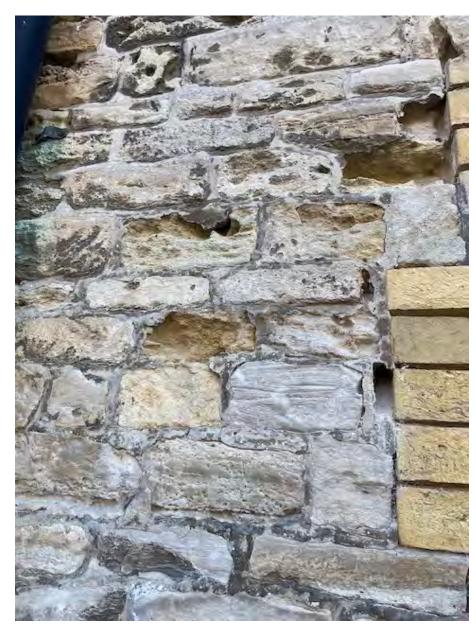
Locally sourced stone including, Bembridge 'Firestone'

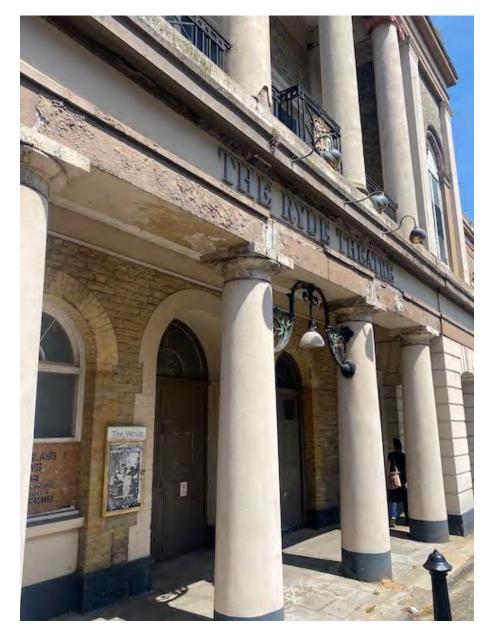
Medina cement render, with Isle of Wight stone and local bricks

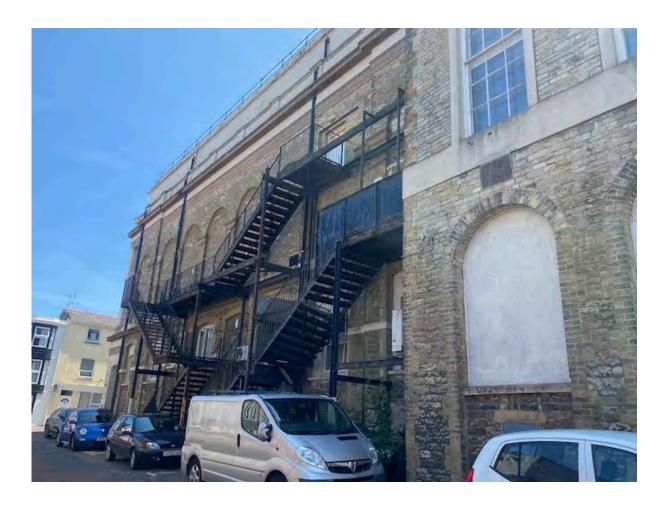
J.9.1. Of limited significance. Currently results in aesthetic harm to the North Elevation, although provides essential secondary teas of escape from the assembly room, and the gallery.

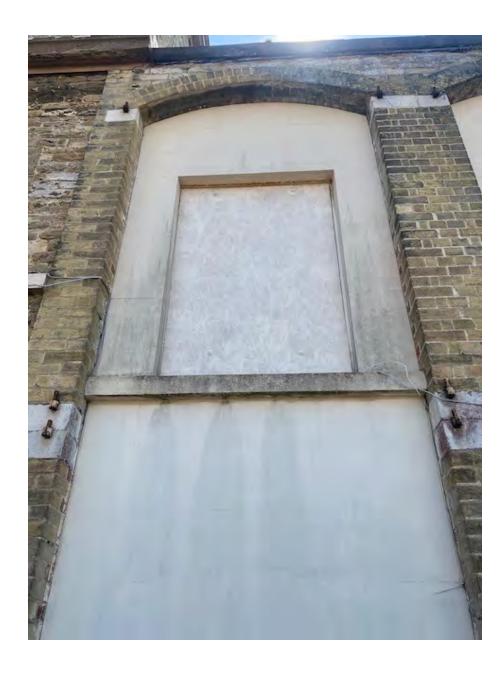
J.10.1. Pintol hinges remain to either side of the opening, which are likely to relate to the use of this part of the building by the local fire service

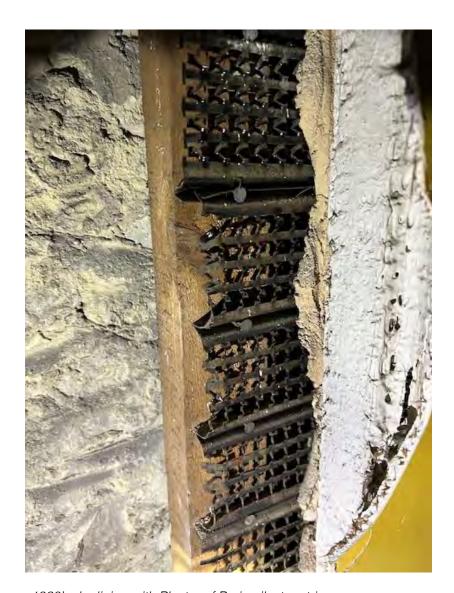
1930's dry lining with Plaster of Paris pilaster strips

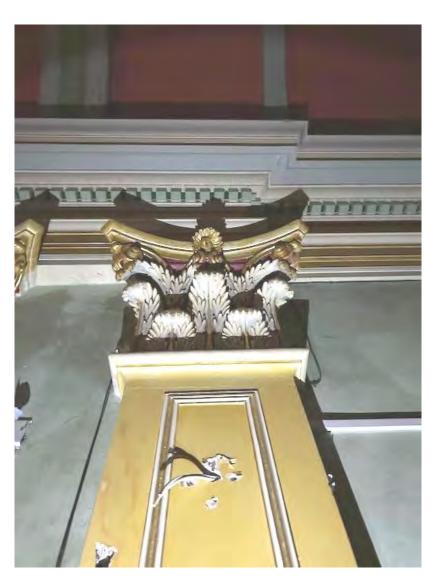
Pilaster strip, with acanthus leaf detail

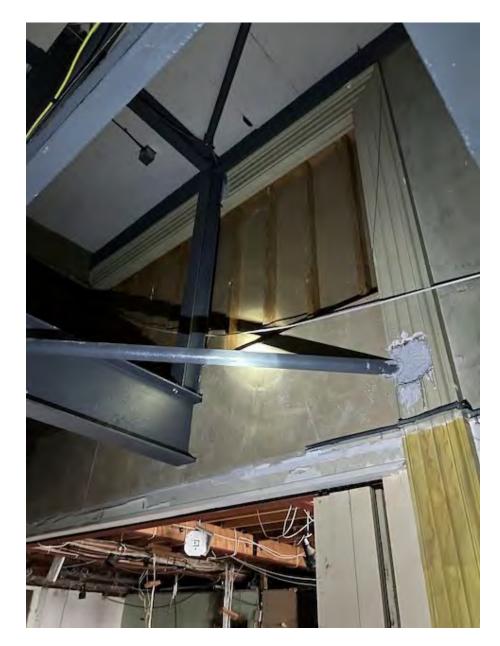
The balcony is a modern insertion and it has resulted in visual and physical harm to the fabric.

Steelwork cut through moulded plasterwork

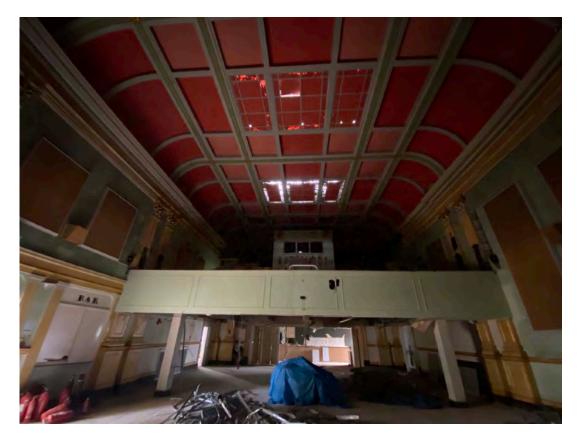
Modern Balcony inserting in 1990. Note painting over former glazed openings at roof level

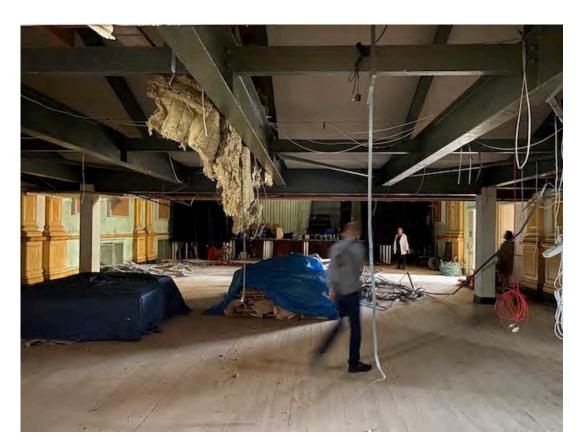
Steelwork structure (exposed following partial strip out) supporting balcony. Significant 'harm' to scale of the auditorium

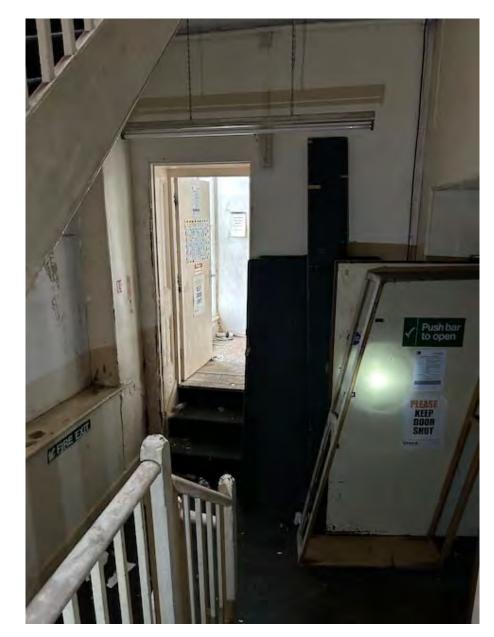
East service staircase C19.

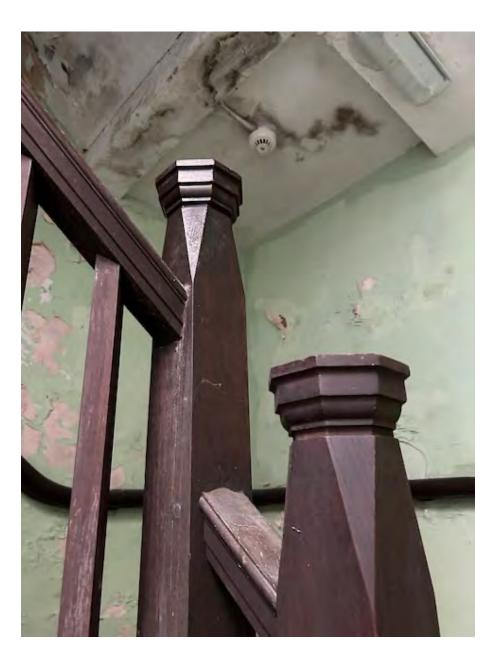
- K.1. 1930's Staircase:
- K.1.1. The staircase which leads to the second floor is a good example of a utilitarian service stair in oak. This work is part of the rebuilding following the fire in 1931.
- K.1.2. Significance: Medium
- K.2. East Service Stairs
- K.2.1. Painted stairs, Victorian
- K.2.2. **Significance Low**

1930's stairs following the fire (oak)
