**THE GUILDHALL
HIGH STREET
NEWPORT
ISLE OF WIGHT**

Building Condition Survey Report

The Guildhall, High Street, Newport, Isle of Wight PO30 2EH

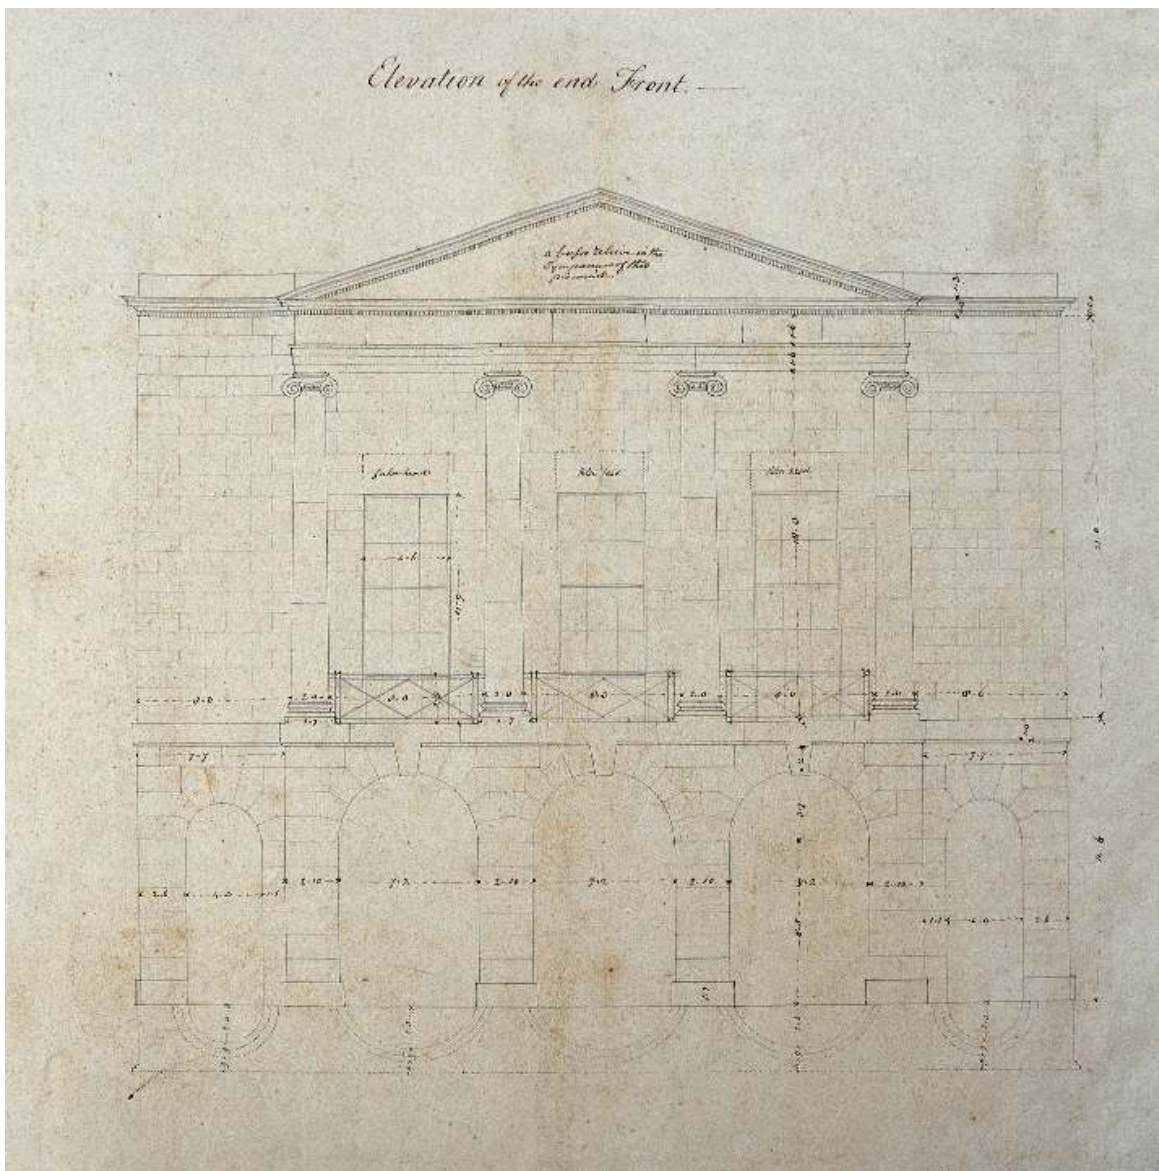
Figure 1: Drawing of the west portico elevation

Drawing produced for the design of the Guildhall. Construction was completed in 1819.

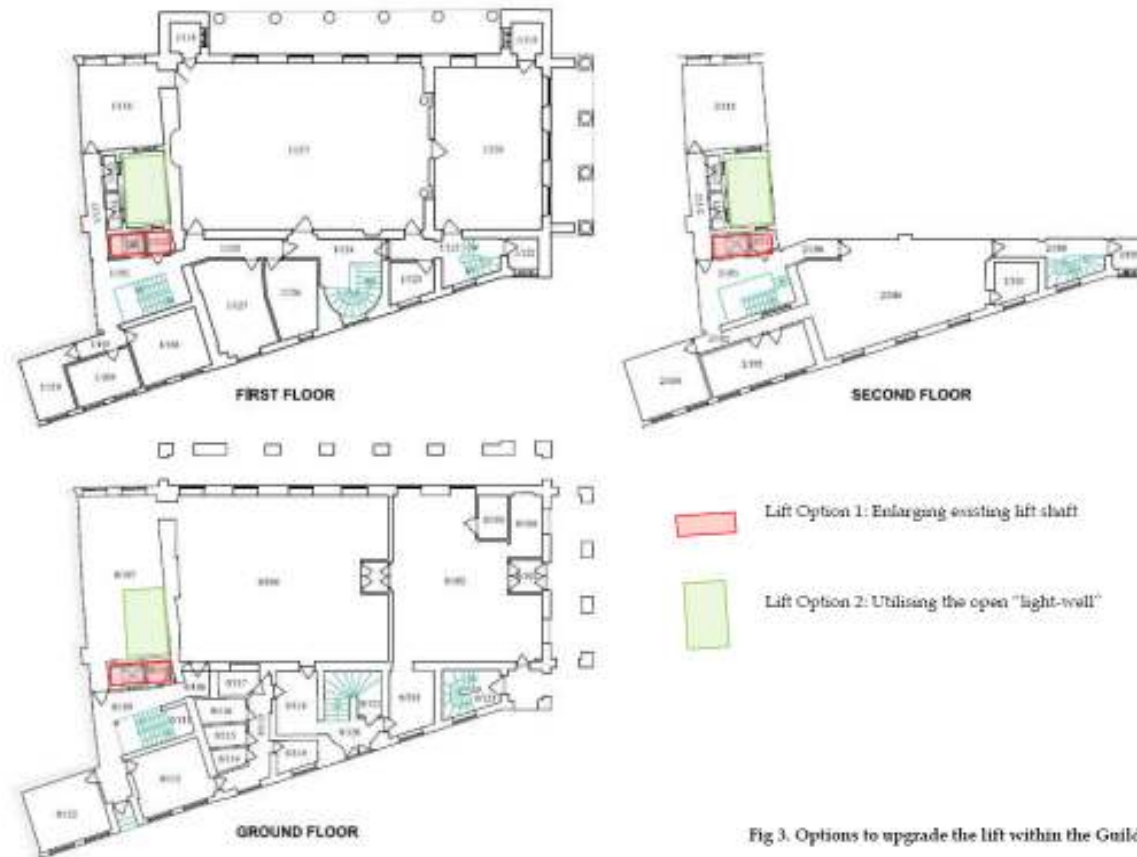
Fig 3. Options to upgrade the lift within the Guildhall

An initial review of the physical constraints to improving the existing lift provision was made. This review assessed the constraints of the construction and avoided the conflict of introducing a lift in the historic main building and northern elements. This limited the options available to provide improved lift provision to the following two locations:
