Ryde Town Hall: Stage 3 Feasibility Study and Business Case

HCC Property Services, Three Minsters House, 76 High Street, Winchester, SO23 8UL

> On behalf of: Regeneration Team Isle of Wight Council County Hall Newport Isle of Wight PO30 1UD

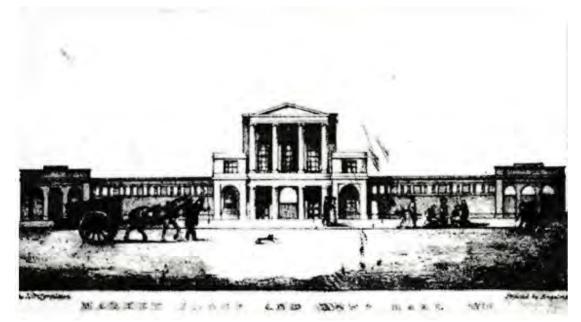
Fig 2.1.1 Town Hall South Elevation - as constructed in 1831

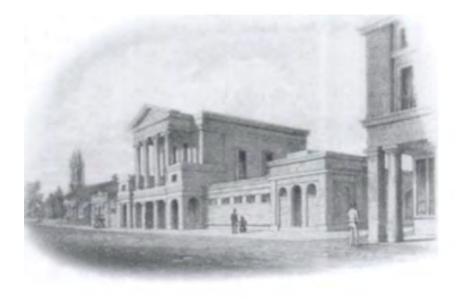
Fig 2.3.1 Assumed original Form, South Elevation, viewed from Lind Street - Before 1856

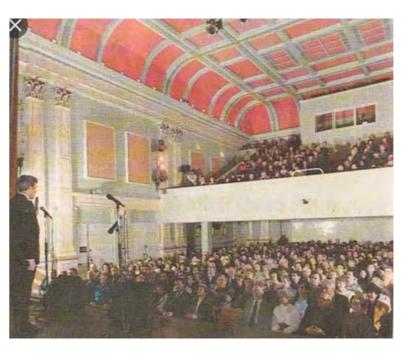
Fig 2.3.8

Reopening of the Theatre with new 2nd Floor balcony, 1991

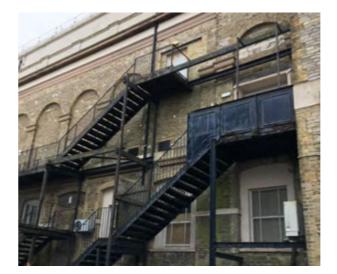
Fig 2.6.3 North Elevation Theatre and Bar Fire Escape Stairs

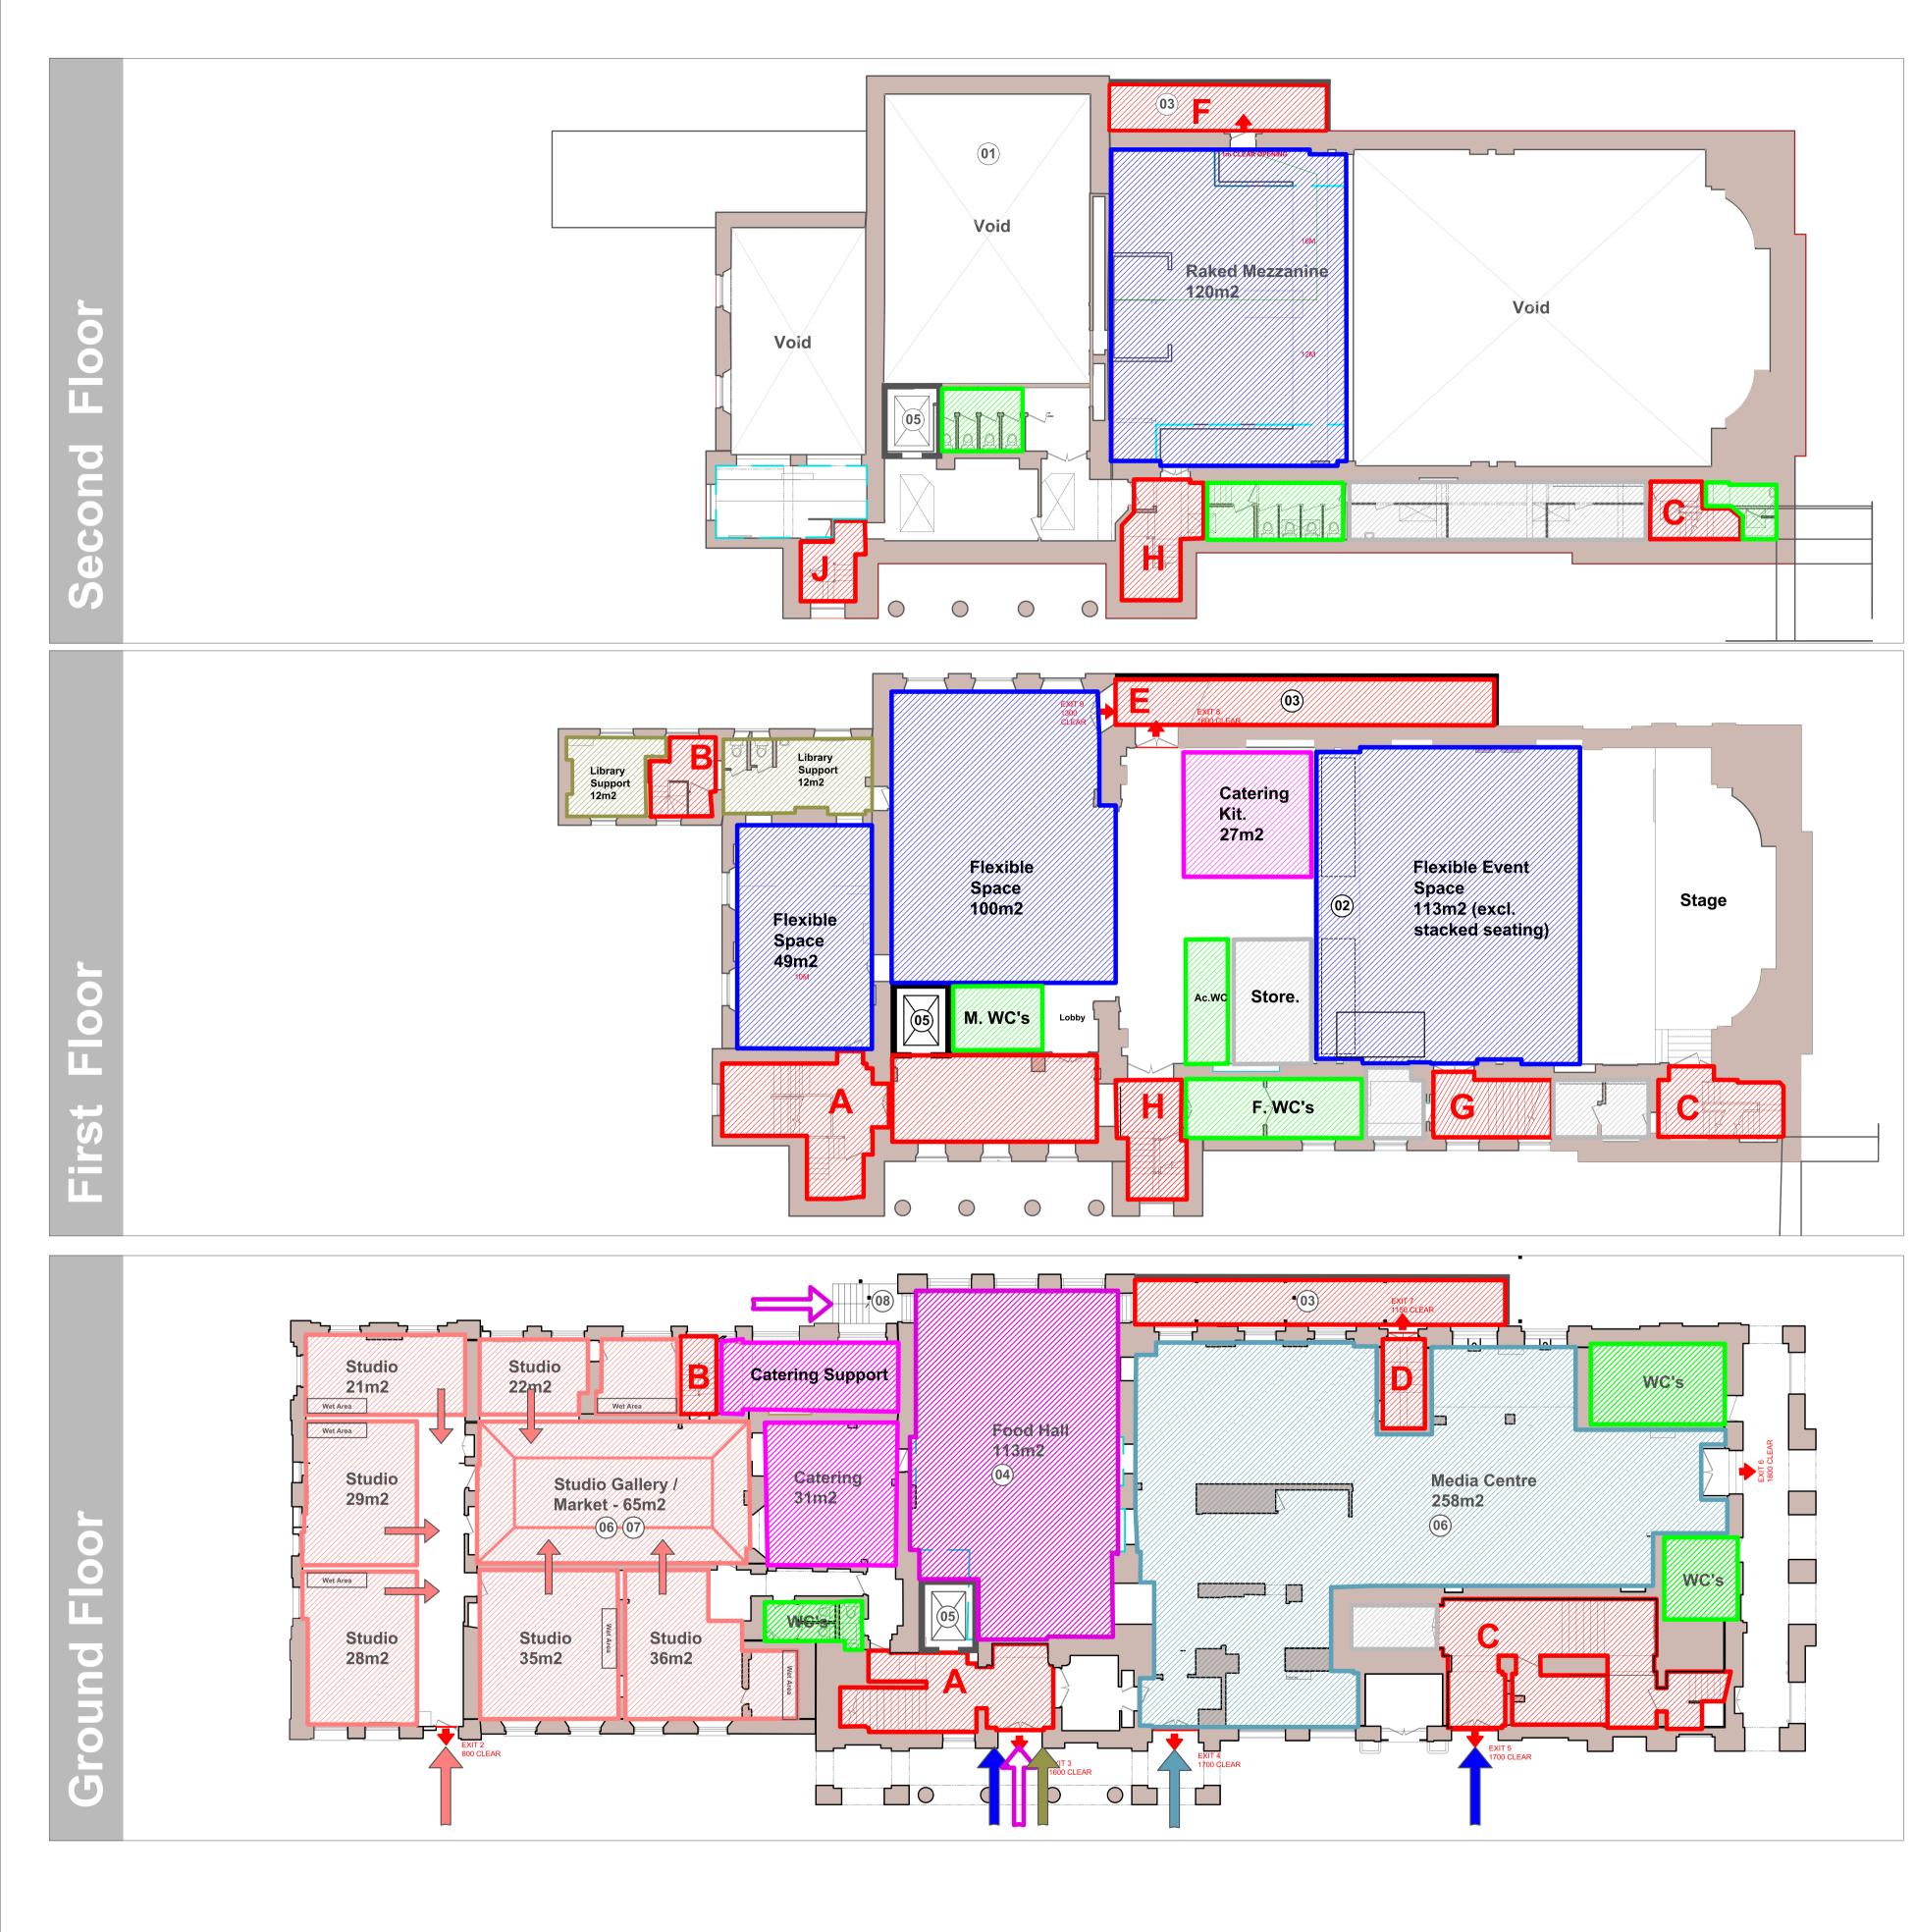
EXAMPLE OPTION 1: Food Hall | Creative Studios | Media Centre Flexible Spaces

Function:	Total Area	Occupancy Based on AD: B Floor Space Factors	Notes:		
	Lettable Event Space	Theatre: 113m2 FF Theatre: 120m2 SF	209: Seating Deployed at FF level 226: Seating Retracted	313: Total seated occupancy inc.2nd floor mezz. Areas excl. stage		
		Chamber: 49m2 Small Hall: 100m2	49 100			
	Creative Studios	284m2	57			
	Media Centre	258m2	180			
	Food Hall	113m2	113	Possible access from Market St.		
	Catering	27m2				
	wc	WC				
	Storage	Storage		FF&E Storage to support flexible uses		
	Fire Escape					
Key Cons	truction Interve	entions:				
01 Remo	01 Removal of Central hall Second Floor Mezzanine					
02 Repla	02 Replacement of fixed seating with retractable bleacher seating					
03 New e	enclosed North	Fire Escape Sta	air Tower			
04 Remo	oval of raised flo	oor to create lev	el access to GF Hall			
05 Addit	ion of Evacuati	on Lift				
06 Remo	oval of modern	partitioning to e	nable new studio/gallery fur	oction

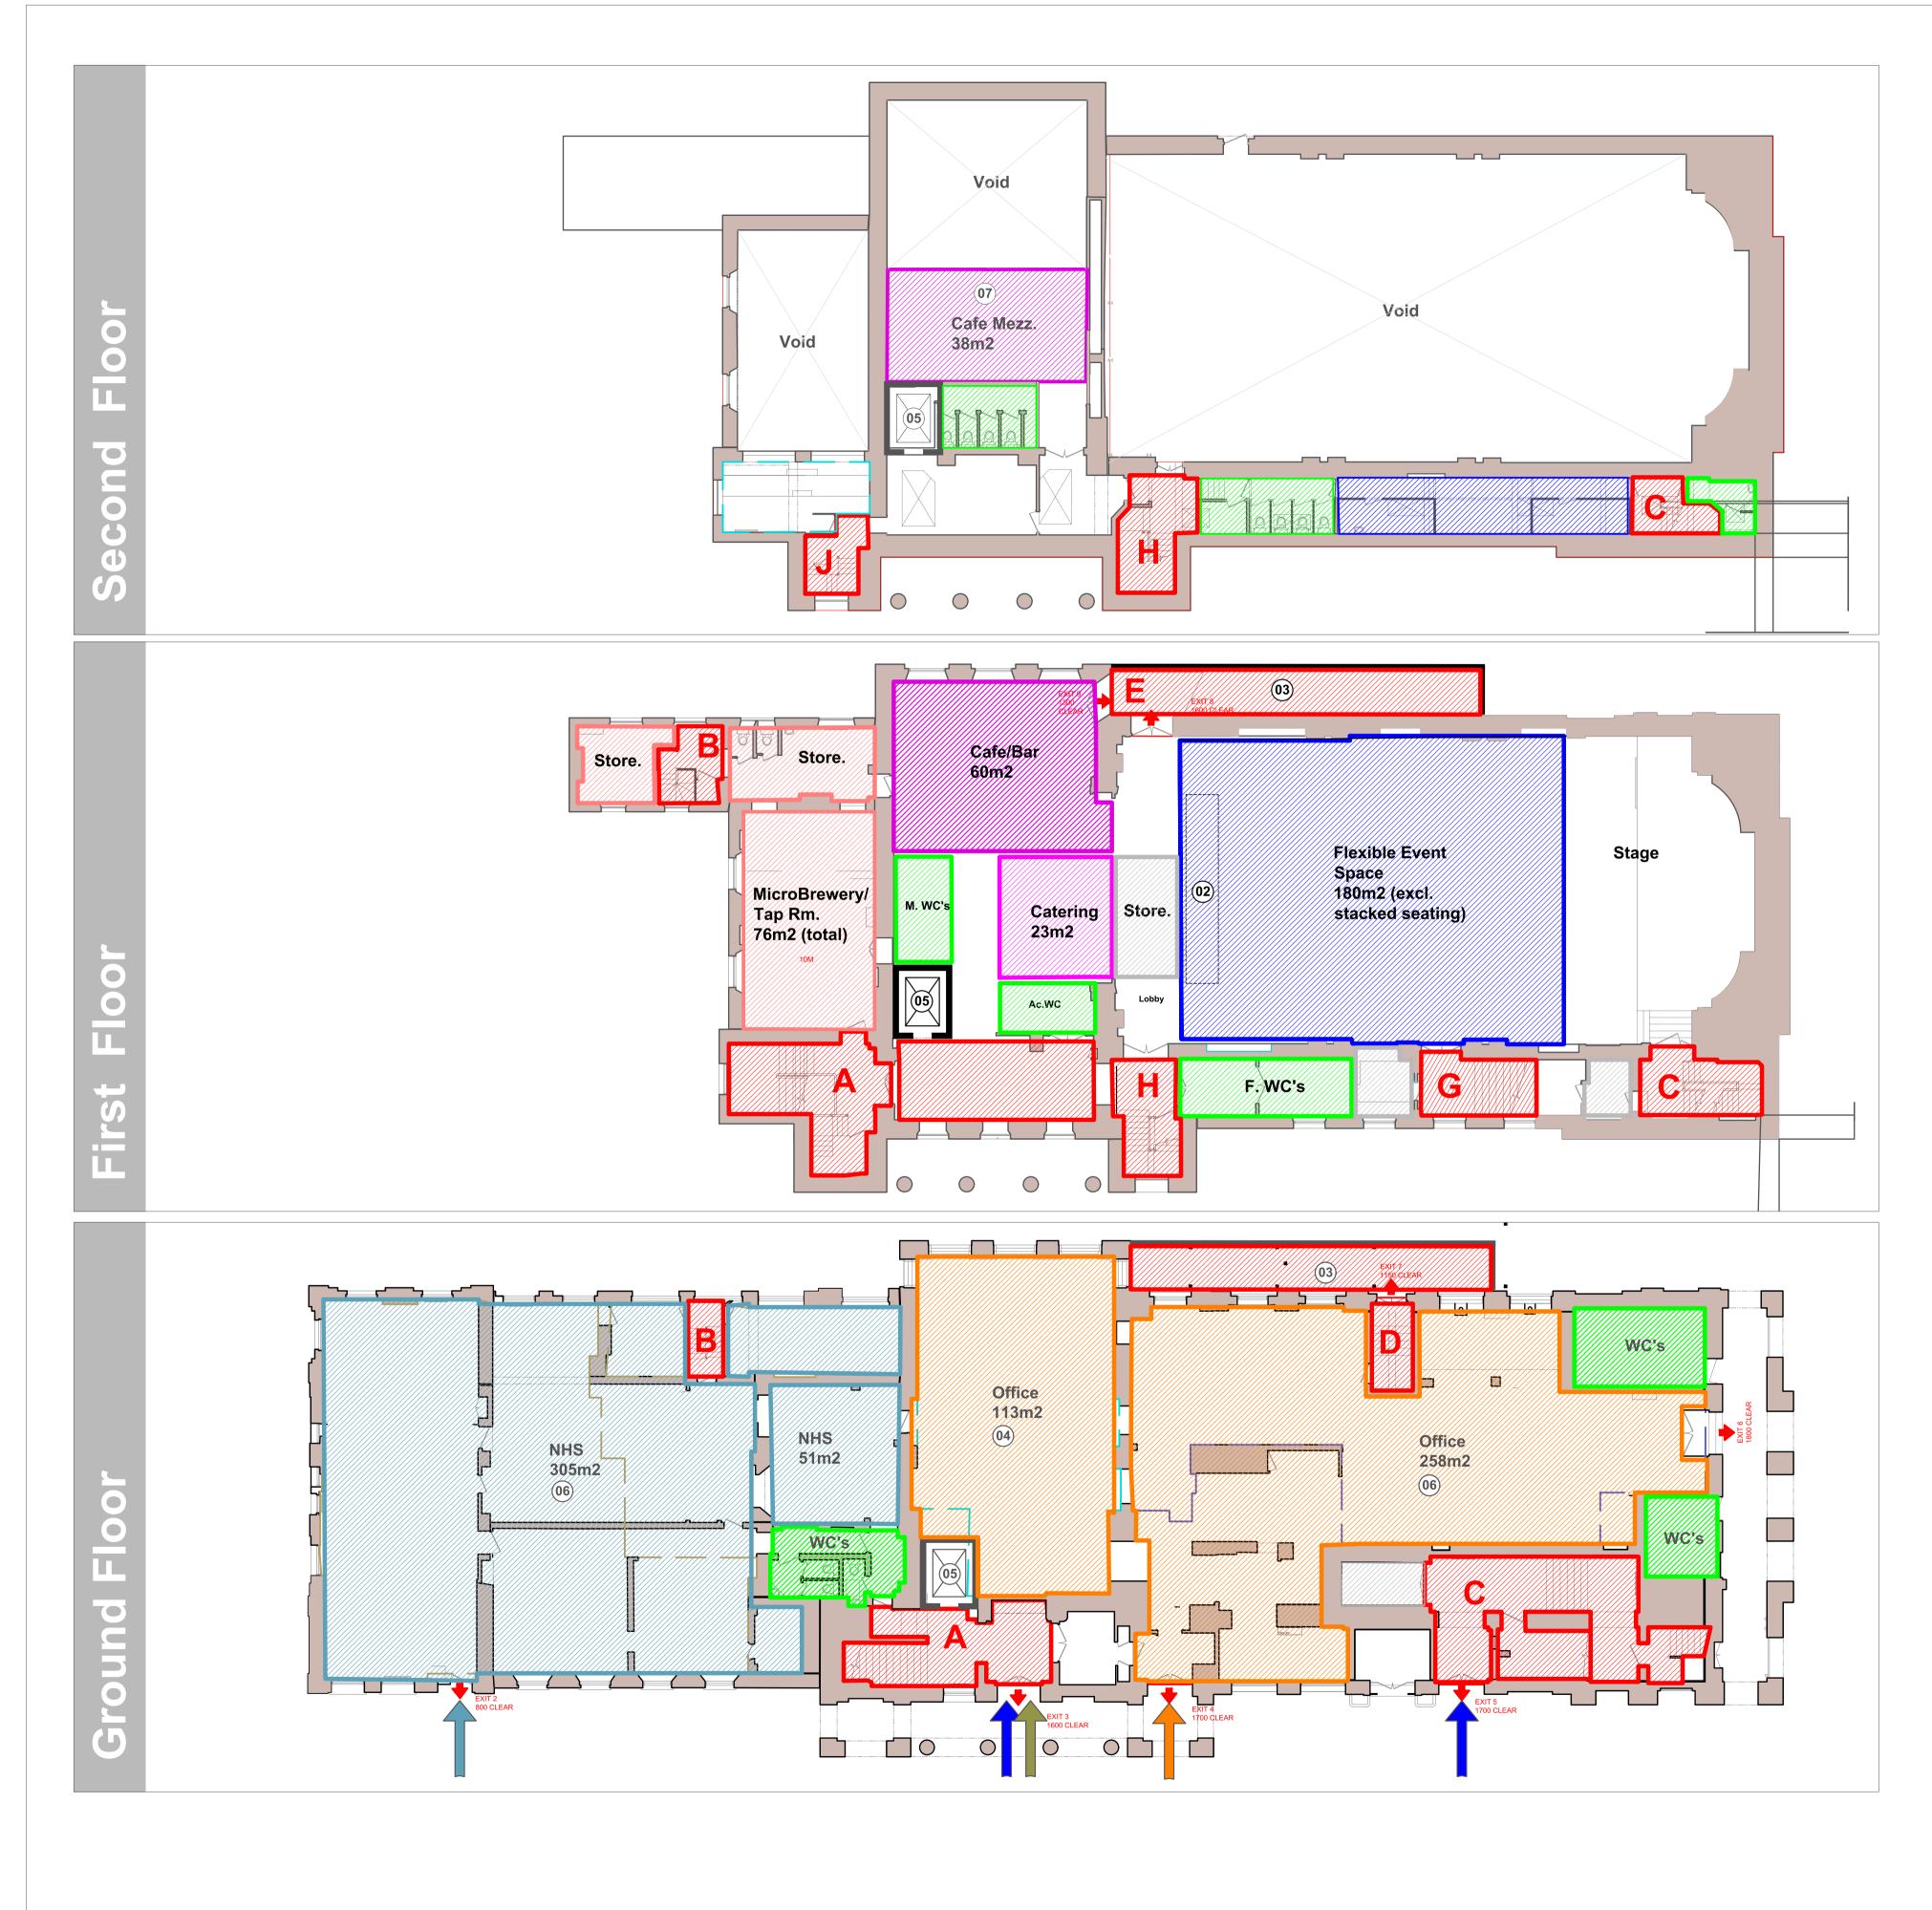
Function:	Total Area	Occupancy Based on AD: B Floor Space Factors	Notes:
Lettable Event Space	Theatre: 233m2	360: Seating Deployed: 466: Seating Retracted	Assumes removal of SF mezzanine
	Chamber: 49m2	49	
MicroBrewery / Tap Rm	76m2	60	
NHS	357m2	56	
Cafe bar	98m2	196	Area includes reduced SF mezzanine
Catering	23m2		
Office	371m2	61	
wc	WC		
Storage	Storage		FF&E Storage to support flexible uses
Fire Escape

Major Construction Interventions:
01 Removal of Large Hall Second Floor Mezzanine
02 Replacement of fixed seating with retractable bleacher seating
03 New enclosed North Fire Escape Stair Tower
04 Removal of raised floor to create level access to GF Hall
05 Addition of Evacuation Lift
06 Removal of modern partitioning to enable new NHS and Office functions
07 Reduction in size of 2nd floor bar mezzanine

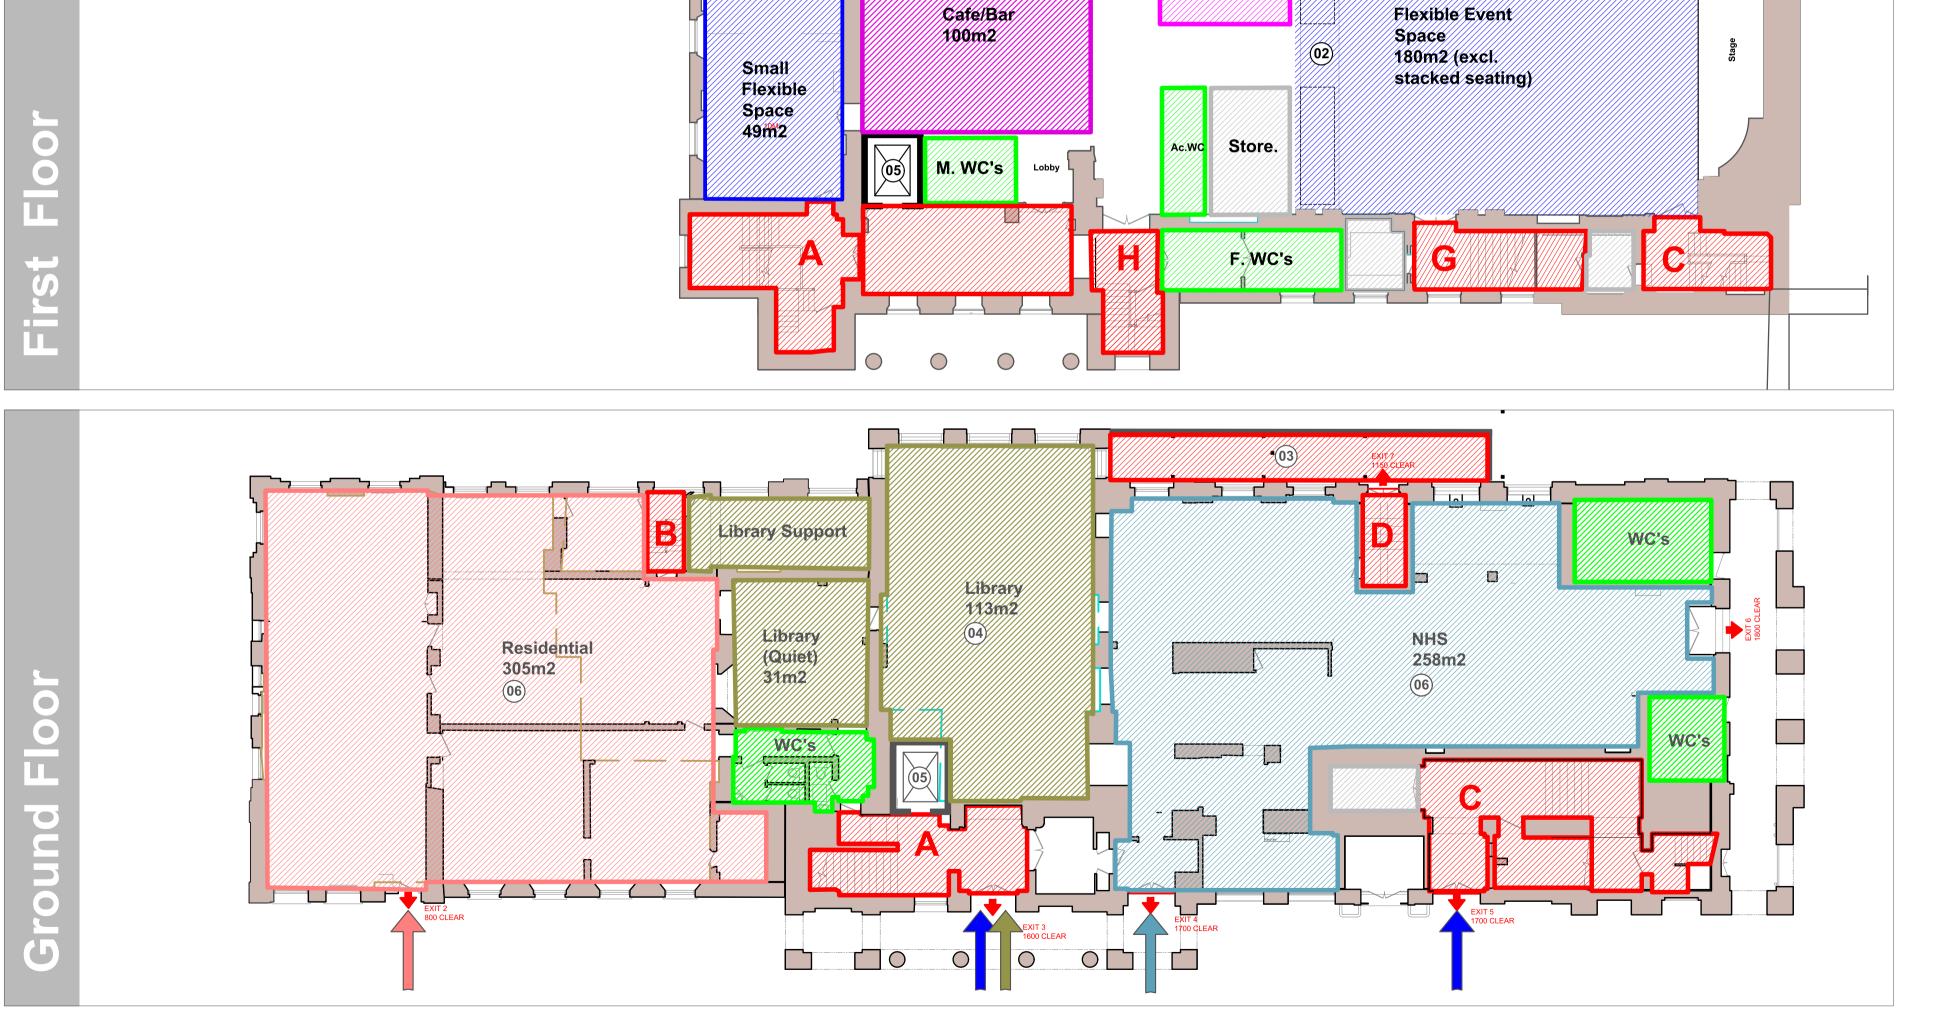
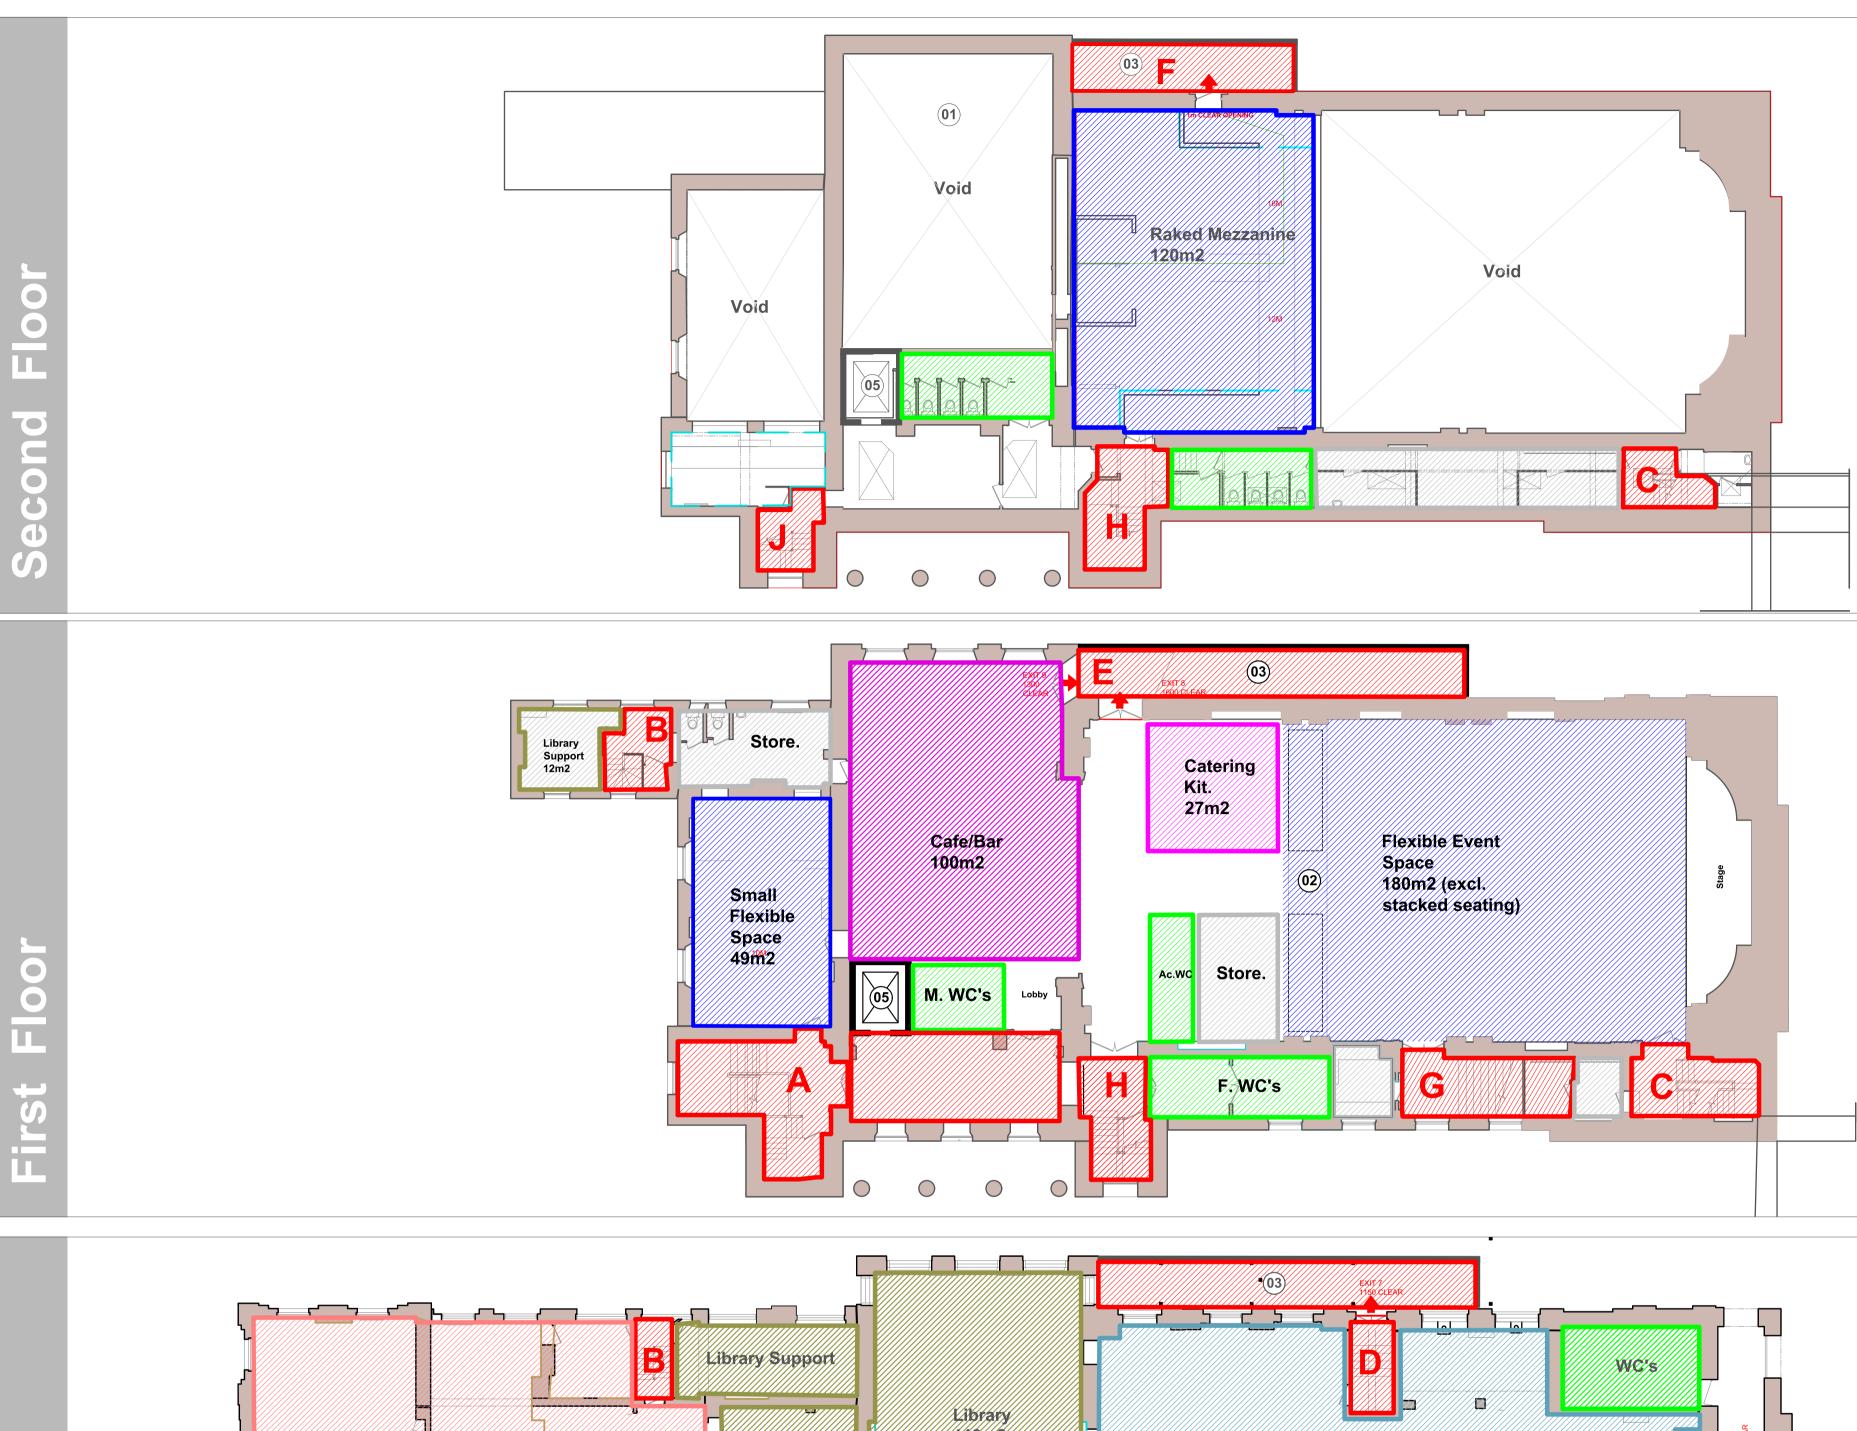
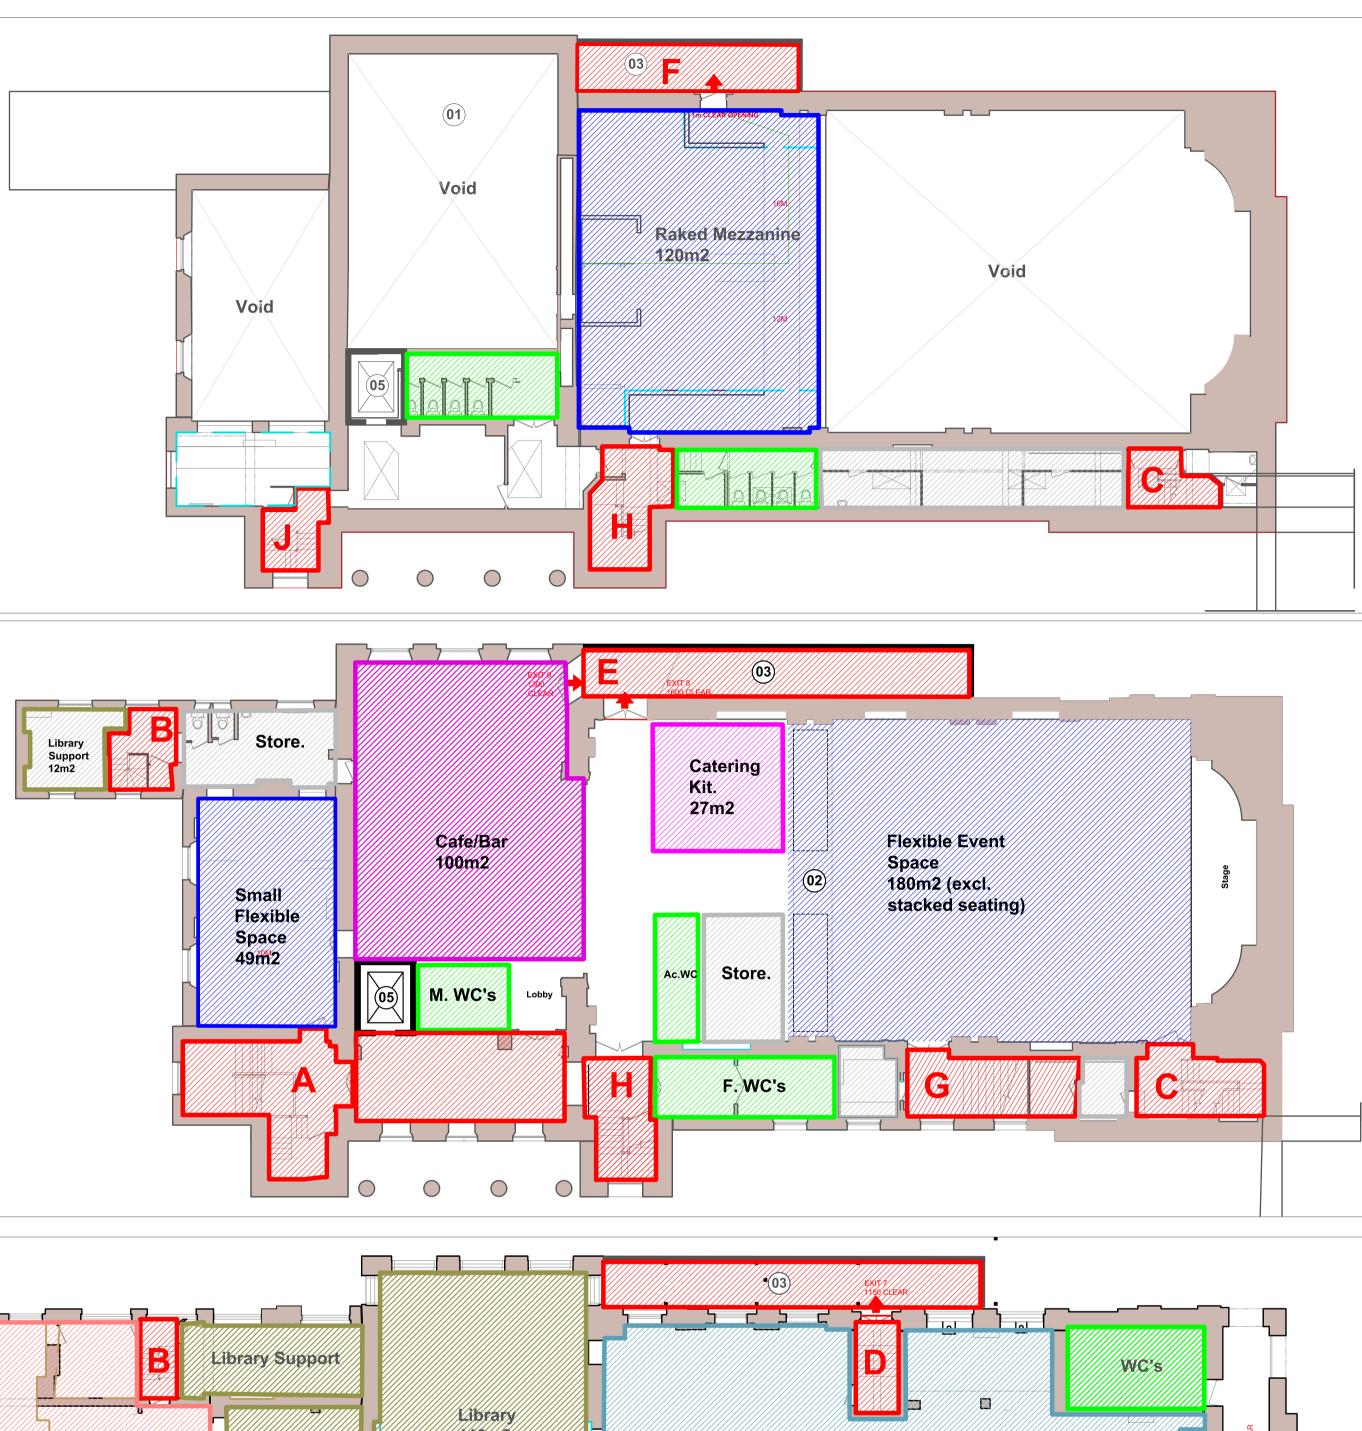
EXAMPLE OPTION 4: Library | Residential | Flexible Auditorium | NHS

Function:	Total Area	Occupancy Based on AD: B Floor Space Factors	Notes:
Lettable Event Space	Theatre: 202m2 FF Theatre: 120m2 SF	360: Seating Deployed at FF level 360: Seating Retracted	464 Total seated occupancy inc.2nd floor mezz. Areas excl. stage
	Chamber: 49m2	49	
Library	164m2	164	
Residential	284m2	-	
NHS	258m2	180	
Cafe bar	113m2	226	
Catering	27m2		
wc	wc		
Storage	Storage		FF&E Storage to support flexible use
Fire Escape

- Major Construction Interventions:
- (01) Removal of Central hall Second Floor Mezzanine (02) Replacement of fixed seating with retractable bleacher seating
- (03) New enclosed North Fire Escape Stair Tower
- (04) Removal of raised floor to create level access to GF Hall
- (05) Addition of Evacuation Lift
- (06) Removal of modern partitioning to enable new NHS and Residential functions

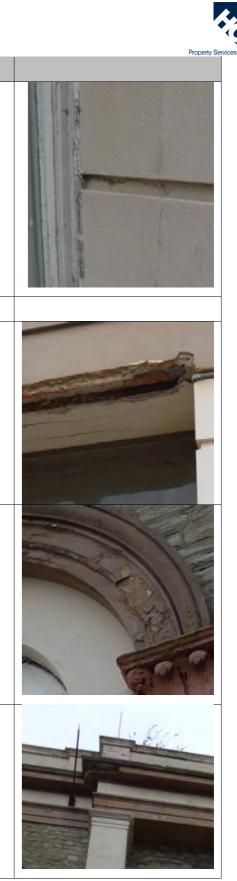
South Elevation	
Refer to SE report for review of cracking in SE	Allow 35m2
corner. Repairs to render in location of cracks and	
generally across this elevation, incl within reveals of	
GW windows.	
Removal of buddleia at parapet level. SE corner	
Repair to leading edge of theatre FE door lintel – inc	2 linear m
repair to exposed rusted steel structural elements.	
Repairs to delaminating stone work above FF	
window arches	
Repairs to delaminated stonework at cornice level,	
East Bay, LHS.

Repairs to stone acanthus decoration at base of FF window arches.	4No.	
Replace missing brickwork RHS reveal, West door	0.5m2	
Repairs to Doric column capital GF		
Repairs to column at base and render cornice below.		HE RYDE T

General cracking to render. Allow to repair	25m2
Missing render elements, below pediment. Allow to repair.	5m2

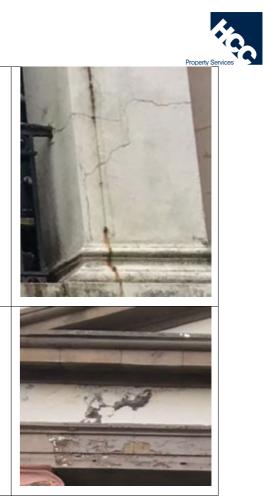
West Elevation	
Remove buddleia and repair cornice.	Allow 15 linear m
Repair missing pointing	5m2

Replace hard pointing where damaging surrounding masonry, NE corner.	10m2	
Repair render to HL window infil SW corner.	1m2	
High Level, auditorium west elevation, significant render crack	Ref: SE report recommendations and allow to repair render 5m2	
High Level above chamber gallery/stair. Parapet dropping to north end, assumed to be supported on timber frame structure visible above ceiling from within chamber gallery.	Ref: SE report recommendations and allow to repair render 5m2

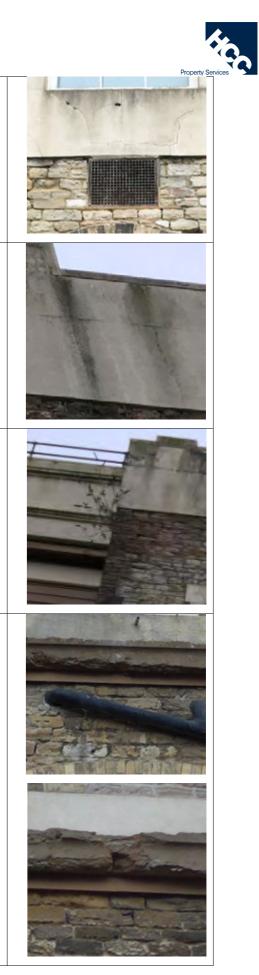
North Elevation	
2No. Fire escape stairs badly corroded. Please also refer to	
section 7.0 – External stairs in this use and location are non-	A STATEMENT IN THE PARTY OF
compliant with current approved documents. Allow to fully	A REAL PROPERTY OF THE REAL PR
replace with compliant new stair enclosures.	
	2000 OBH E. O. SHIPPE
	U HIRI

Render cracking below all FF windows, central bay, and lintels above. Allow general render repairs	15m2
Render cracking to parapet, central bay. Allow to repair	1m2
Buddleia to be removed, east return central bay HL, West bay	
FF level.	
Stabilisa friabla stanowark Wast bay 44	
Stabilise friable stonework, West bay, HL.

Repair cracked stone cills, west bay, FF.		
Repointing required, West bay, LL	20m2	
Graffiti removal	10m2	Dep

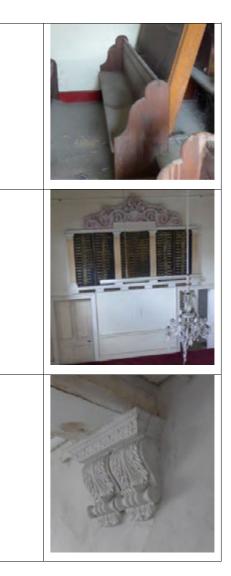
West Stair - Pair of consoles with acanthus leaf and decorated cornice. To be retained and cracking repaired.

R	Organ to be retained. Recommend specialist inspection.
	Original panelled doors, circa 25No. Retain, repair and redecorate. Allow for 10No. upgrades to FD30s
	Timber wall linings
A CONTRACTOR	North West office GF.
	Central bay office GF (former Corn Exchange)
	Retain, repair and redecorate.
	Decorative linings to chamber gallery. Retain, repair and redecorate.
	Decorative plasterwork to GF West staircase. Retain, repair and redecorat

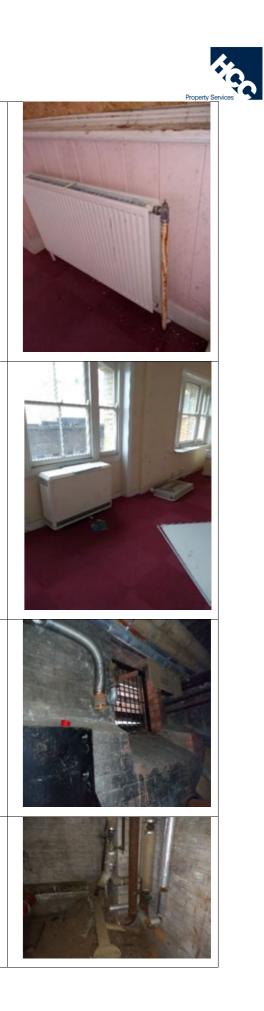
Existing Heating Pipework evidence of leaking, corrosion and

Valve unserviceable.

Kitchen M&E Services in need of complete

refurbishment/replacement

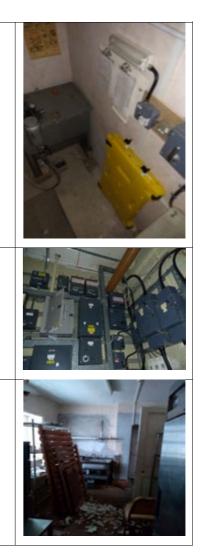
Typical Electrical Services damaged and unrepairable	
Existing BT incoming Panel	
Fire Alarm detector
